BMW A.G.

3 Series - E90

# Engine & Servicing

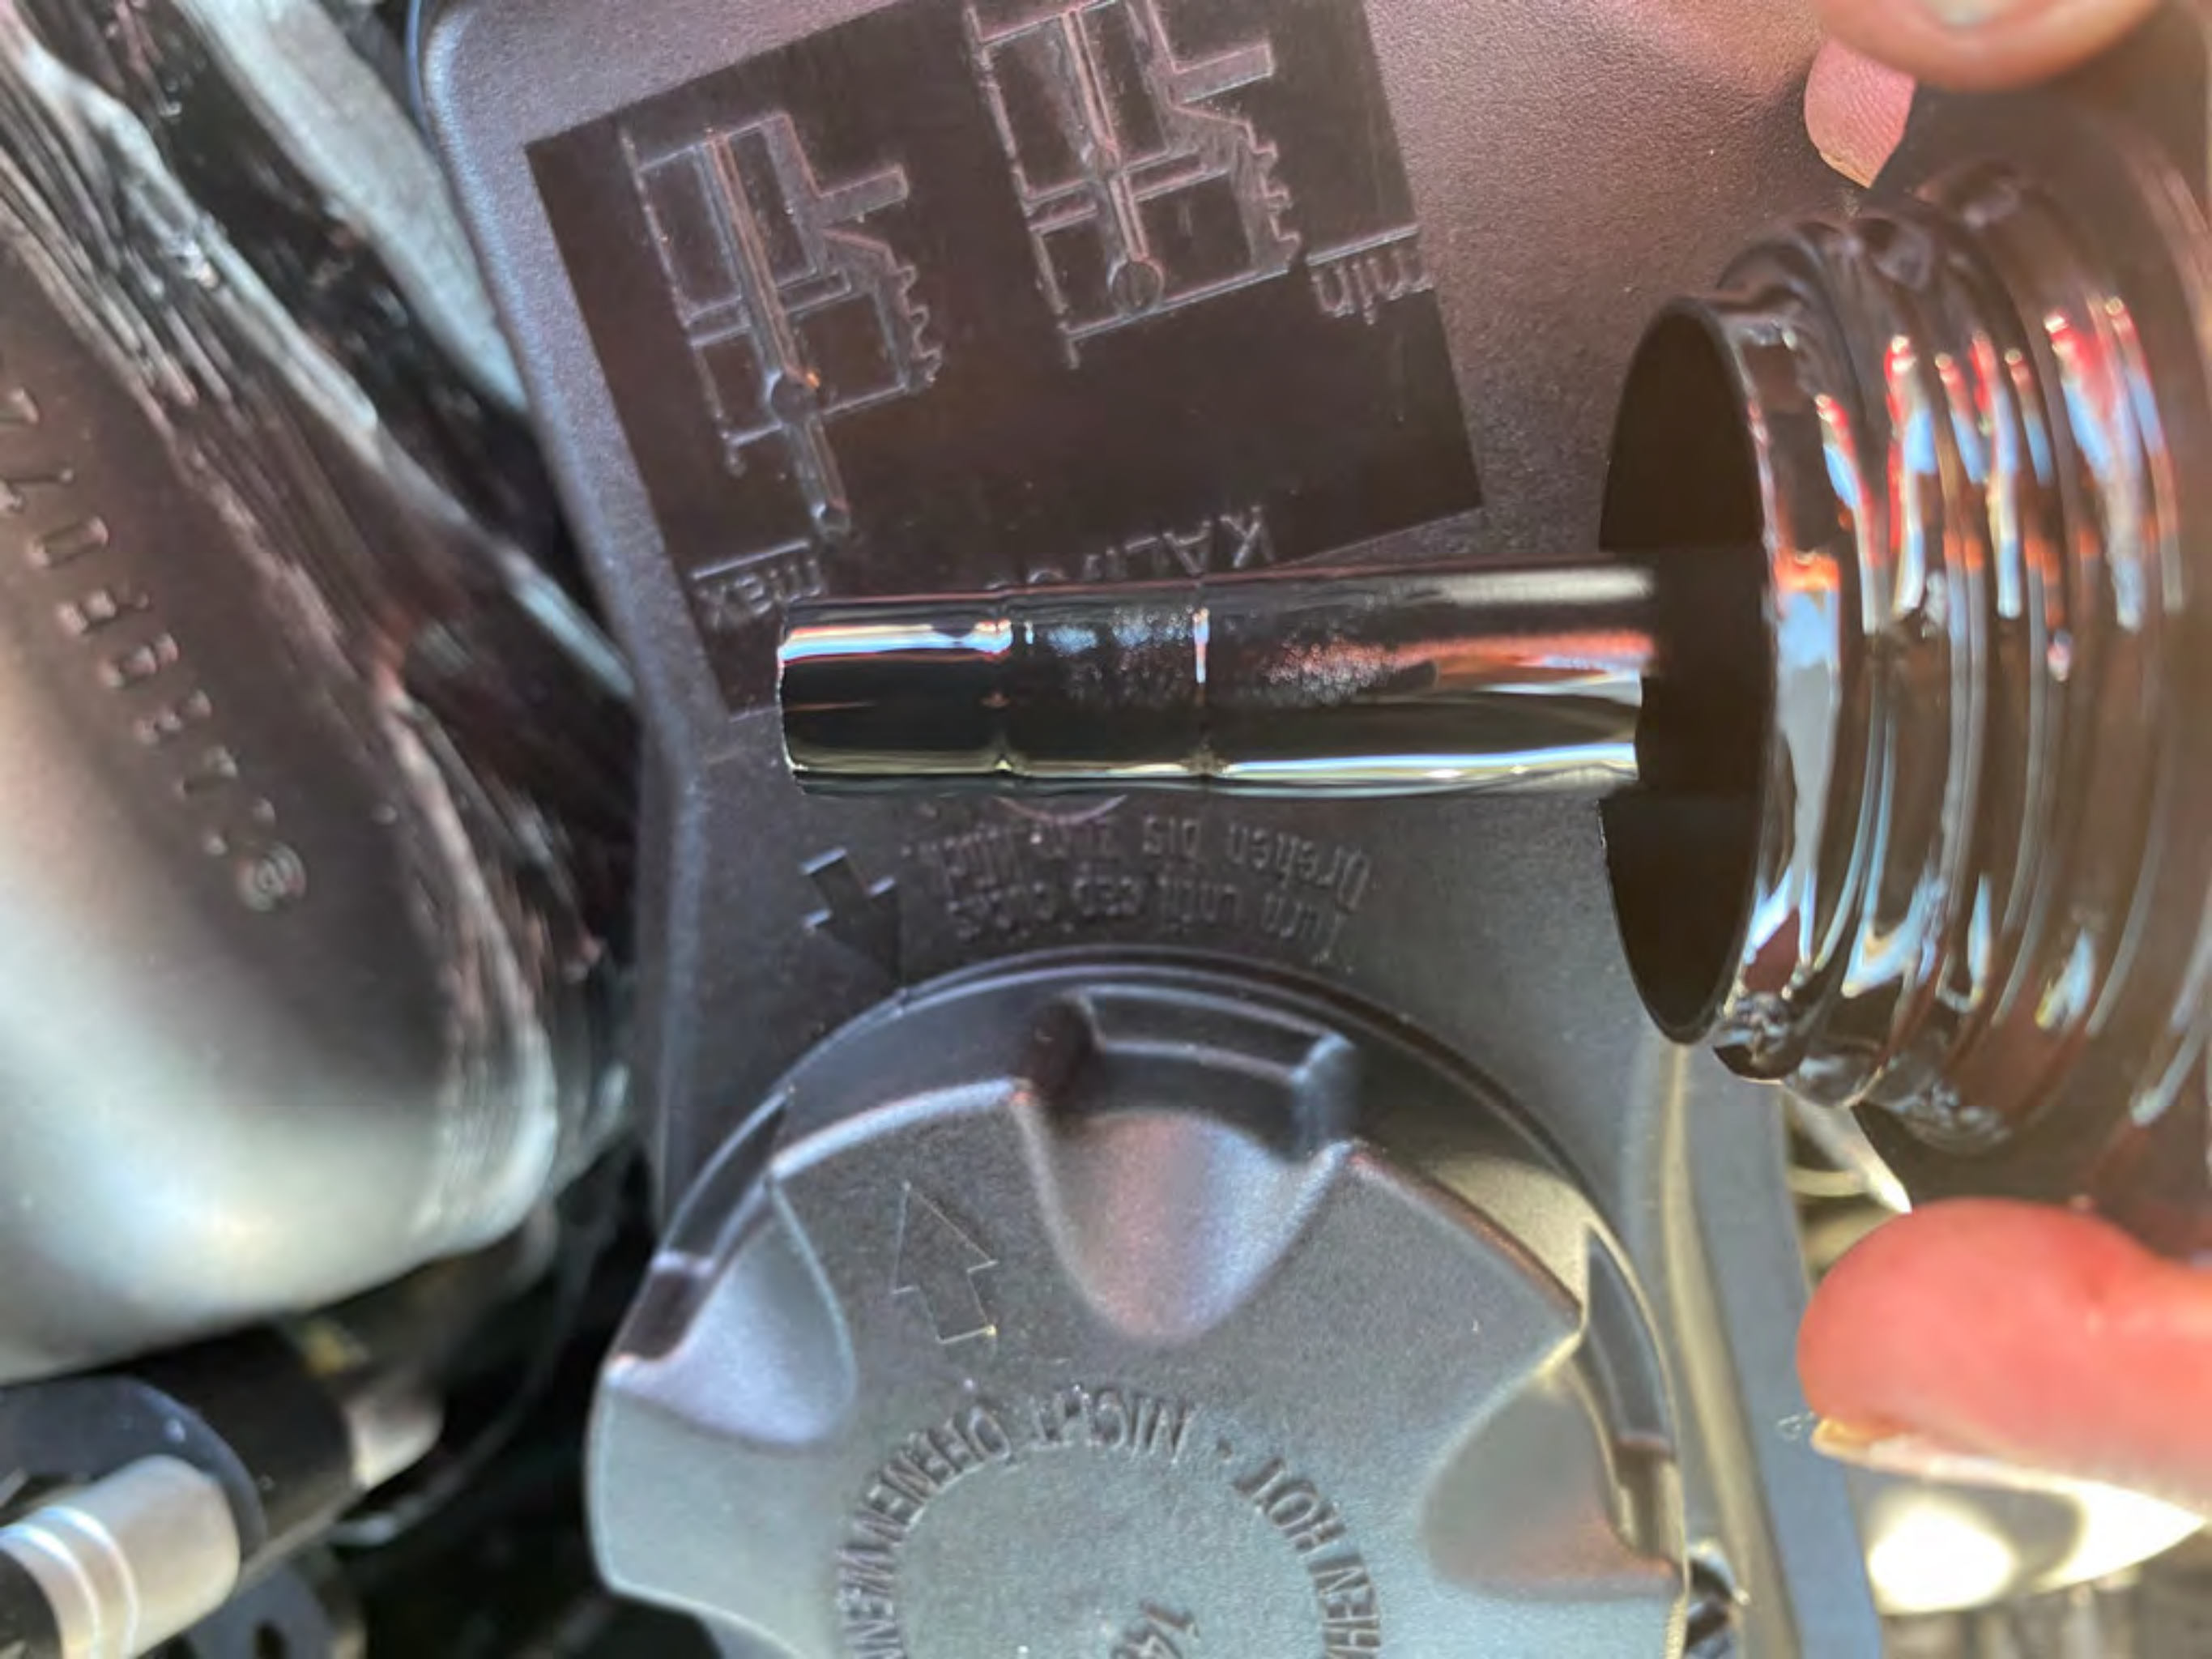
Power steering  
reservoir cap  
(slight leak)

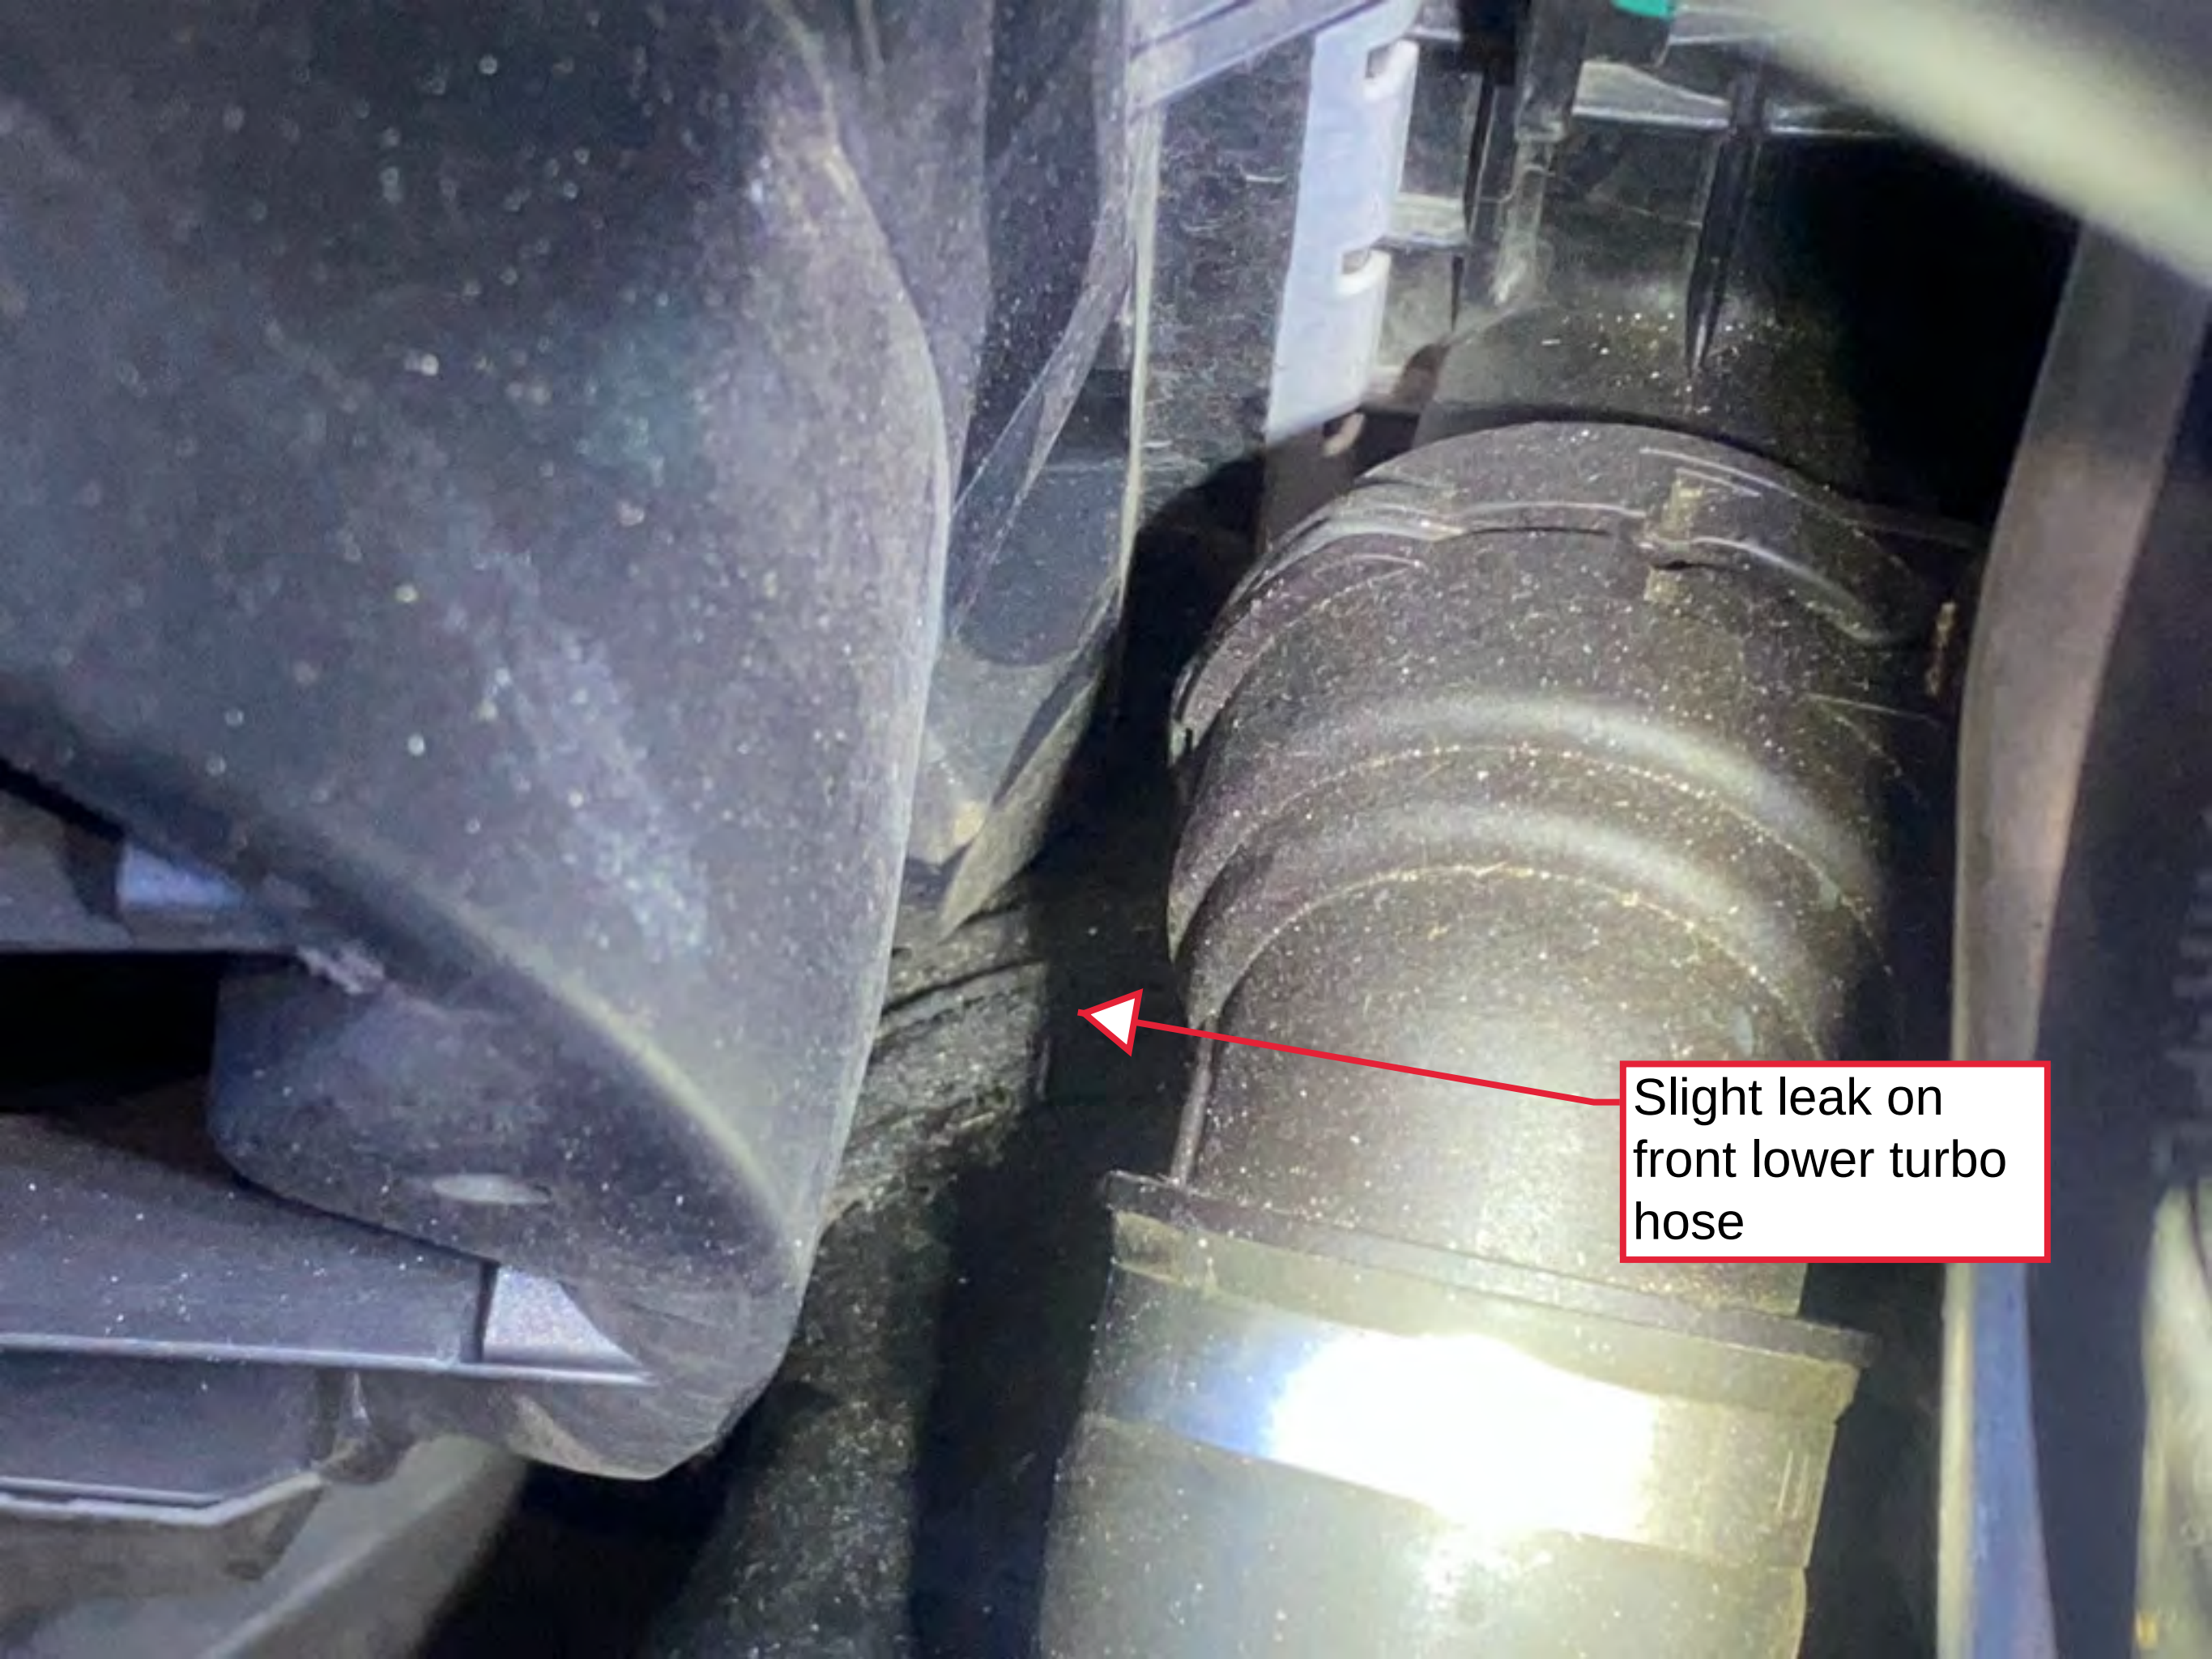
Slight leak on  
front lower turbo  
hose

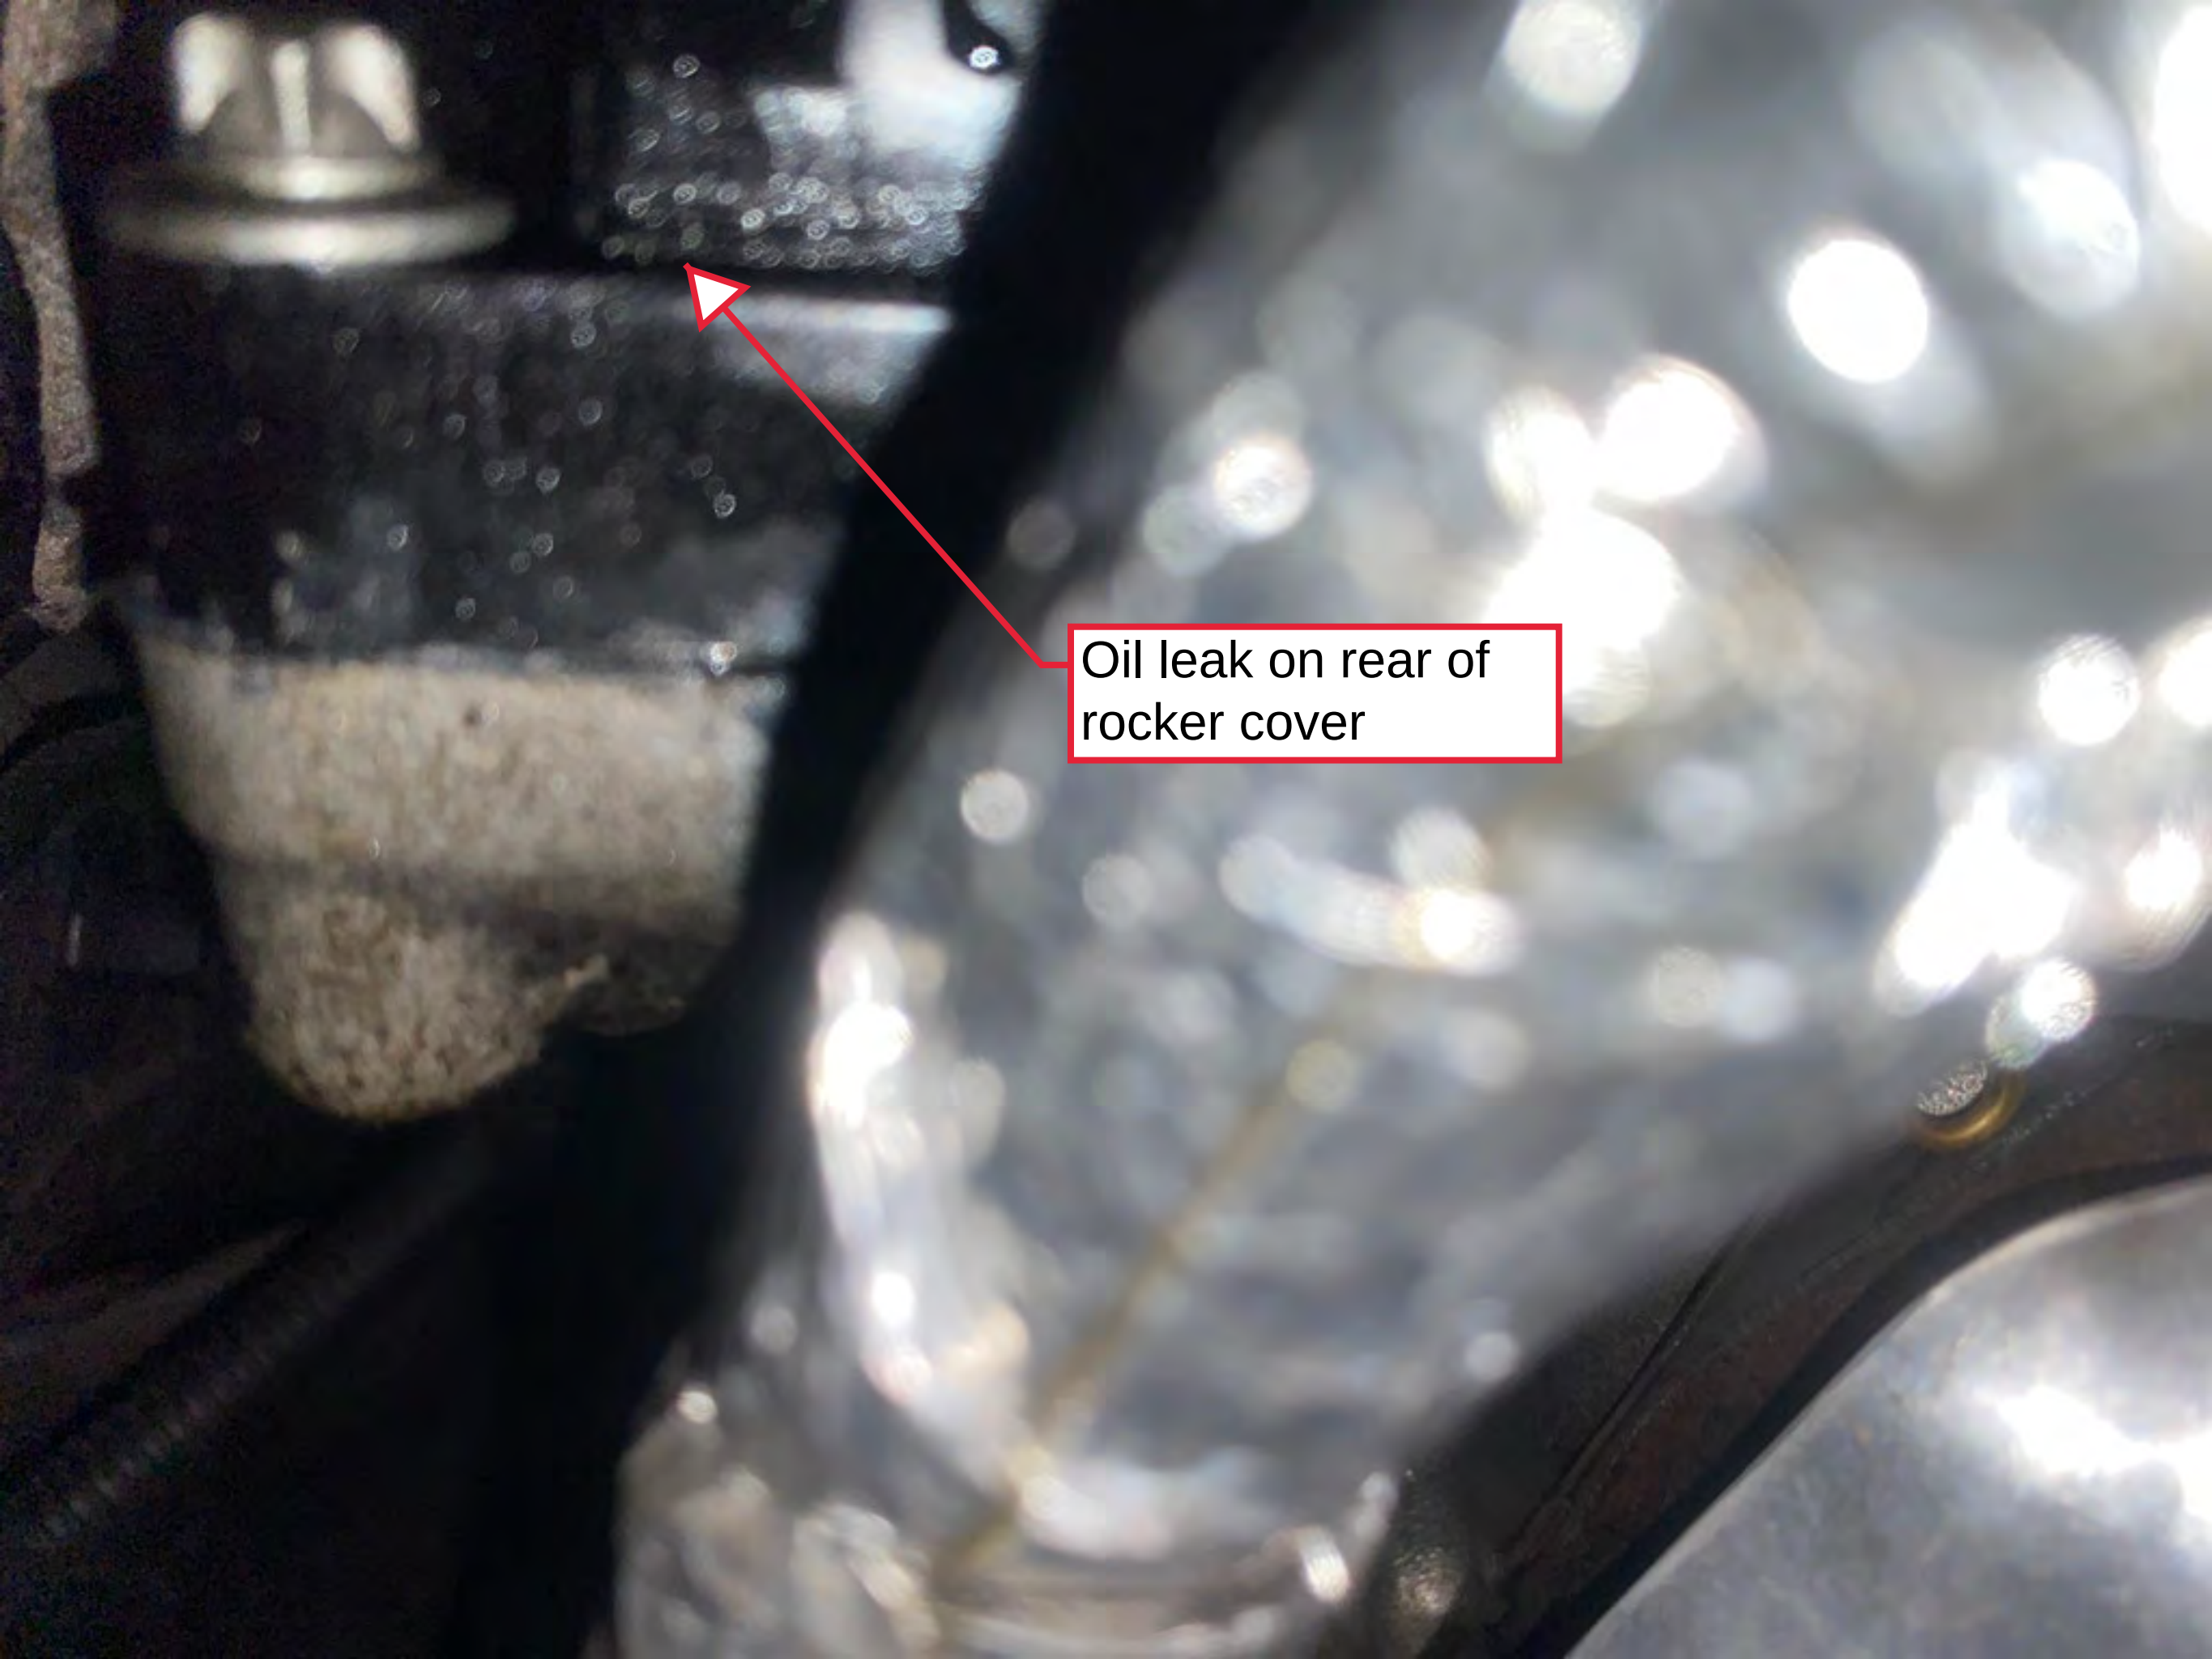
Oil leak on rear of  
rocker cover

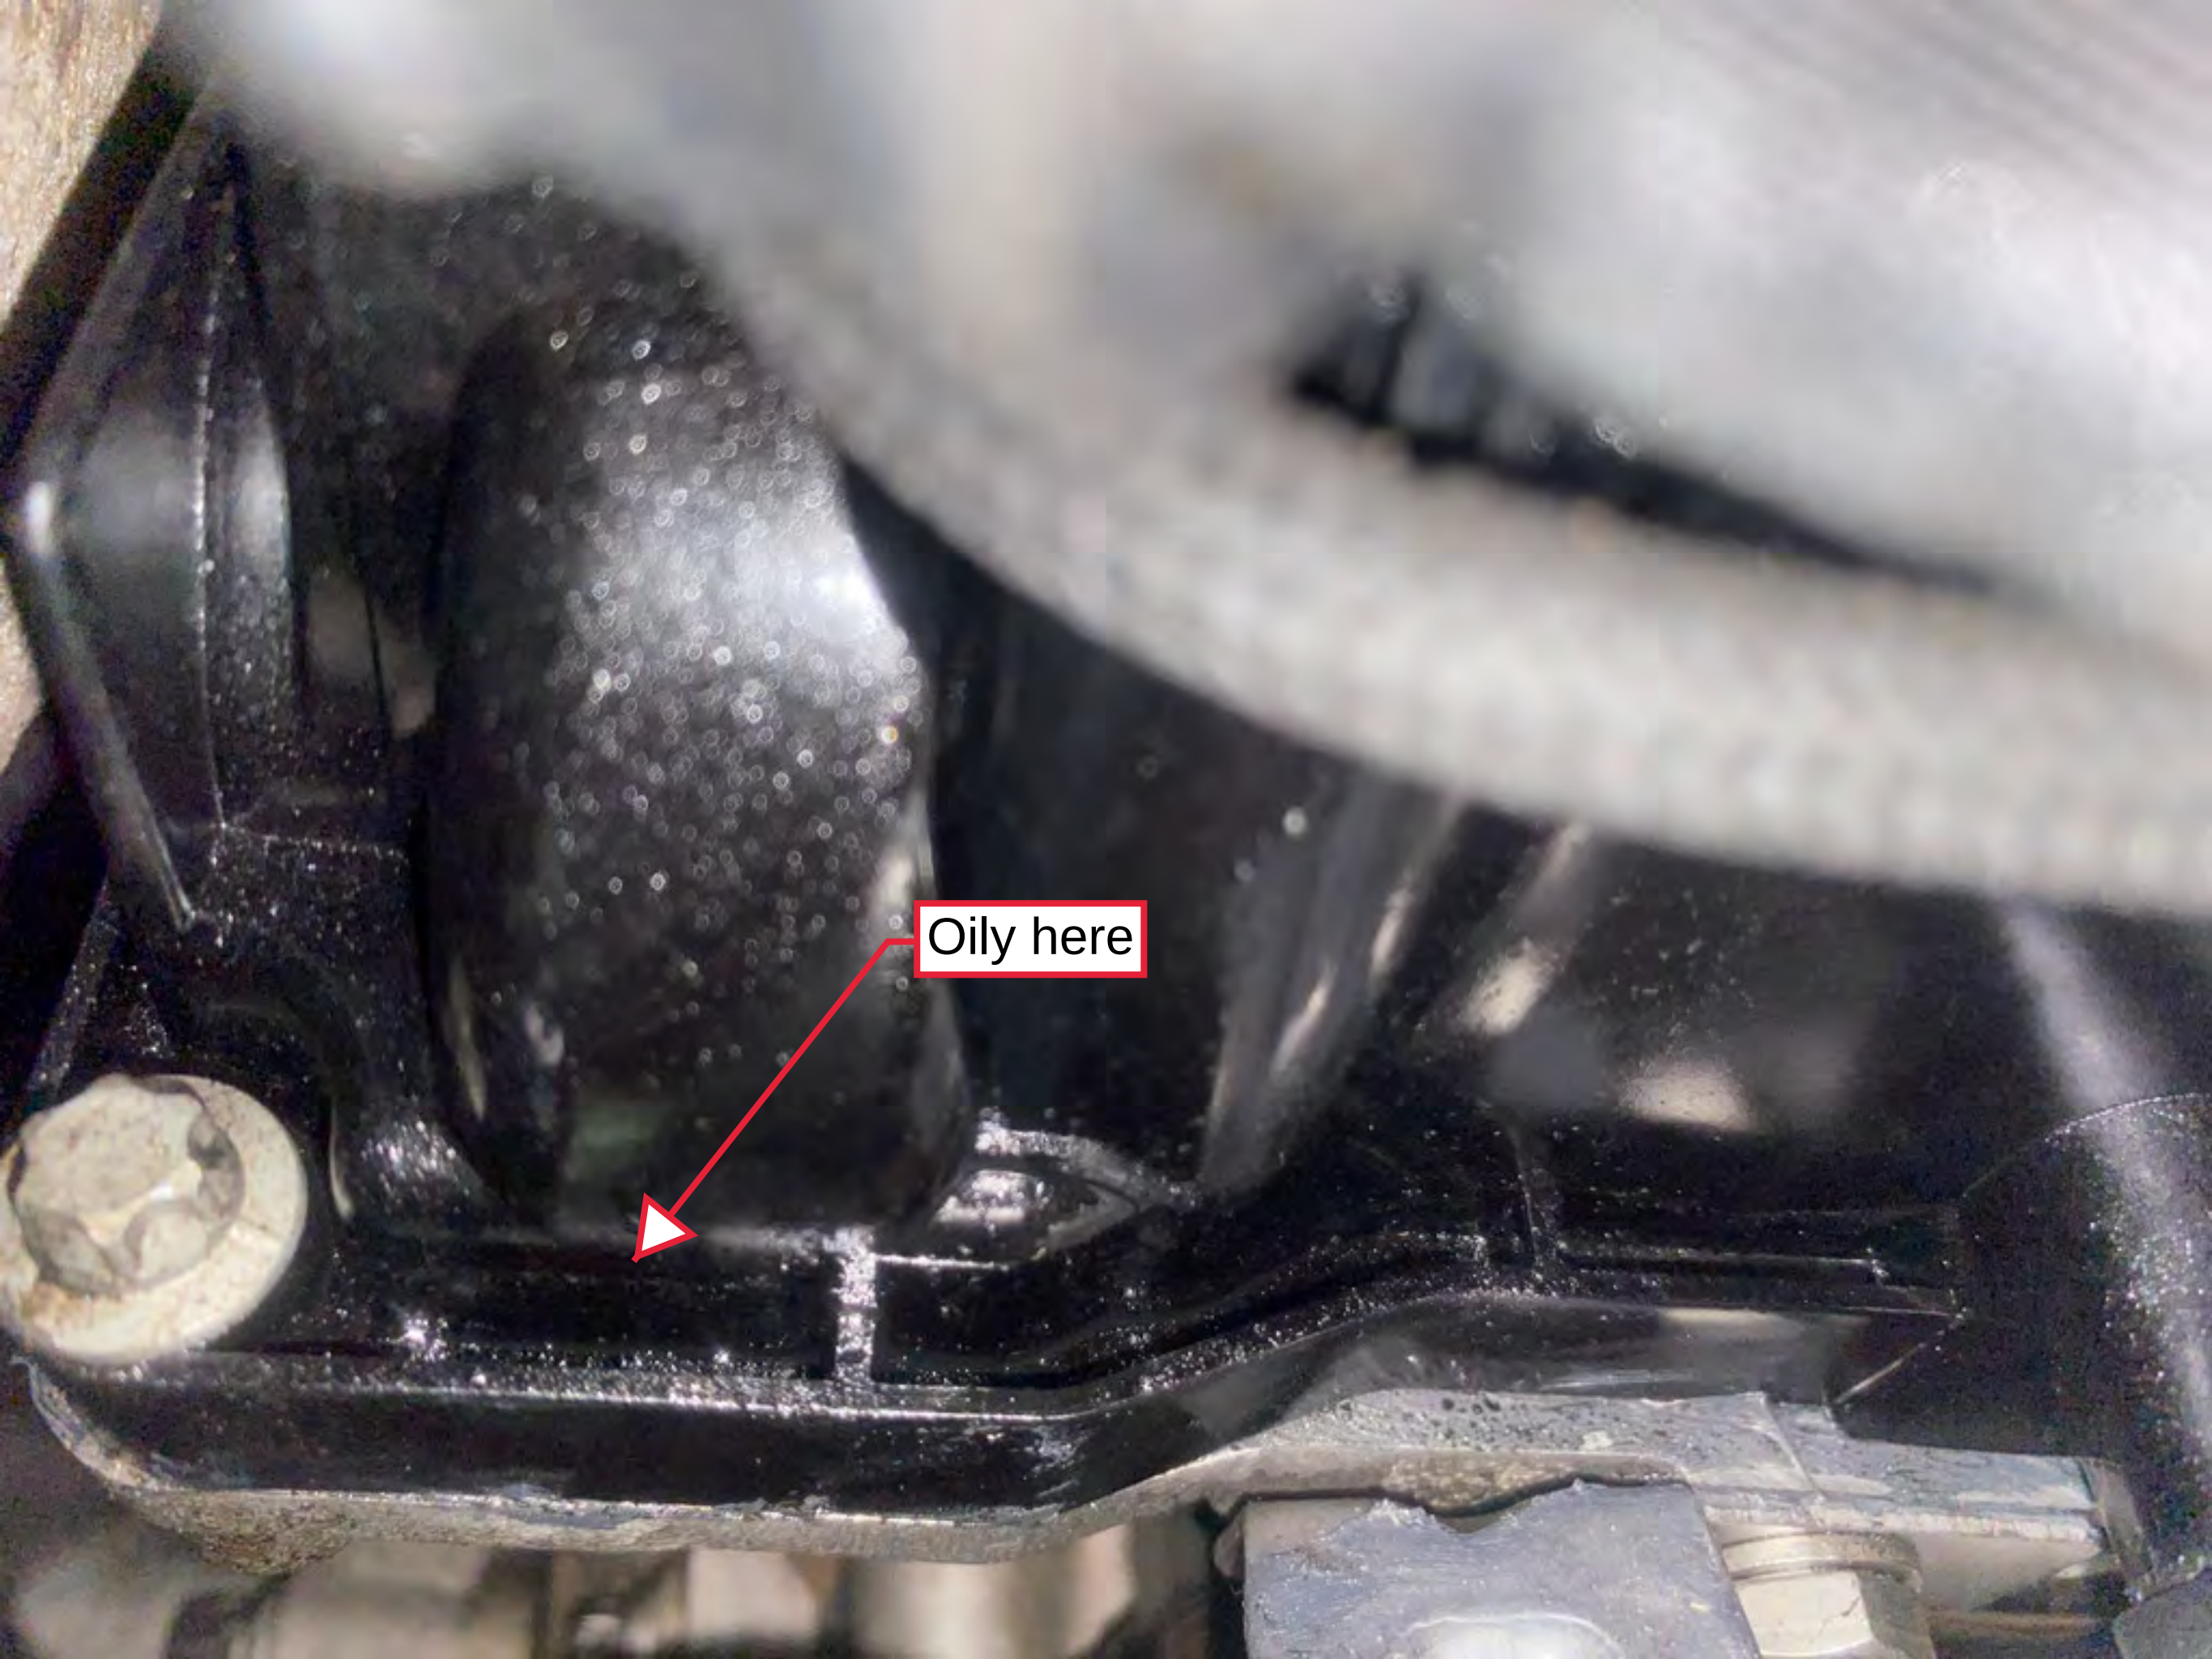
Oily here

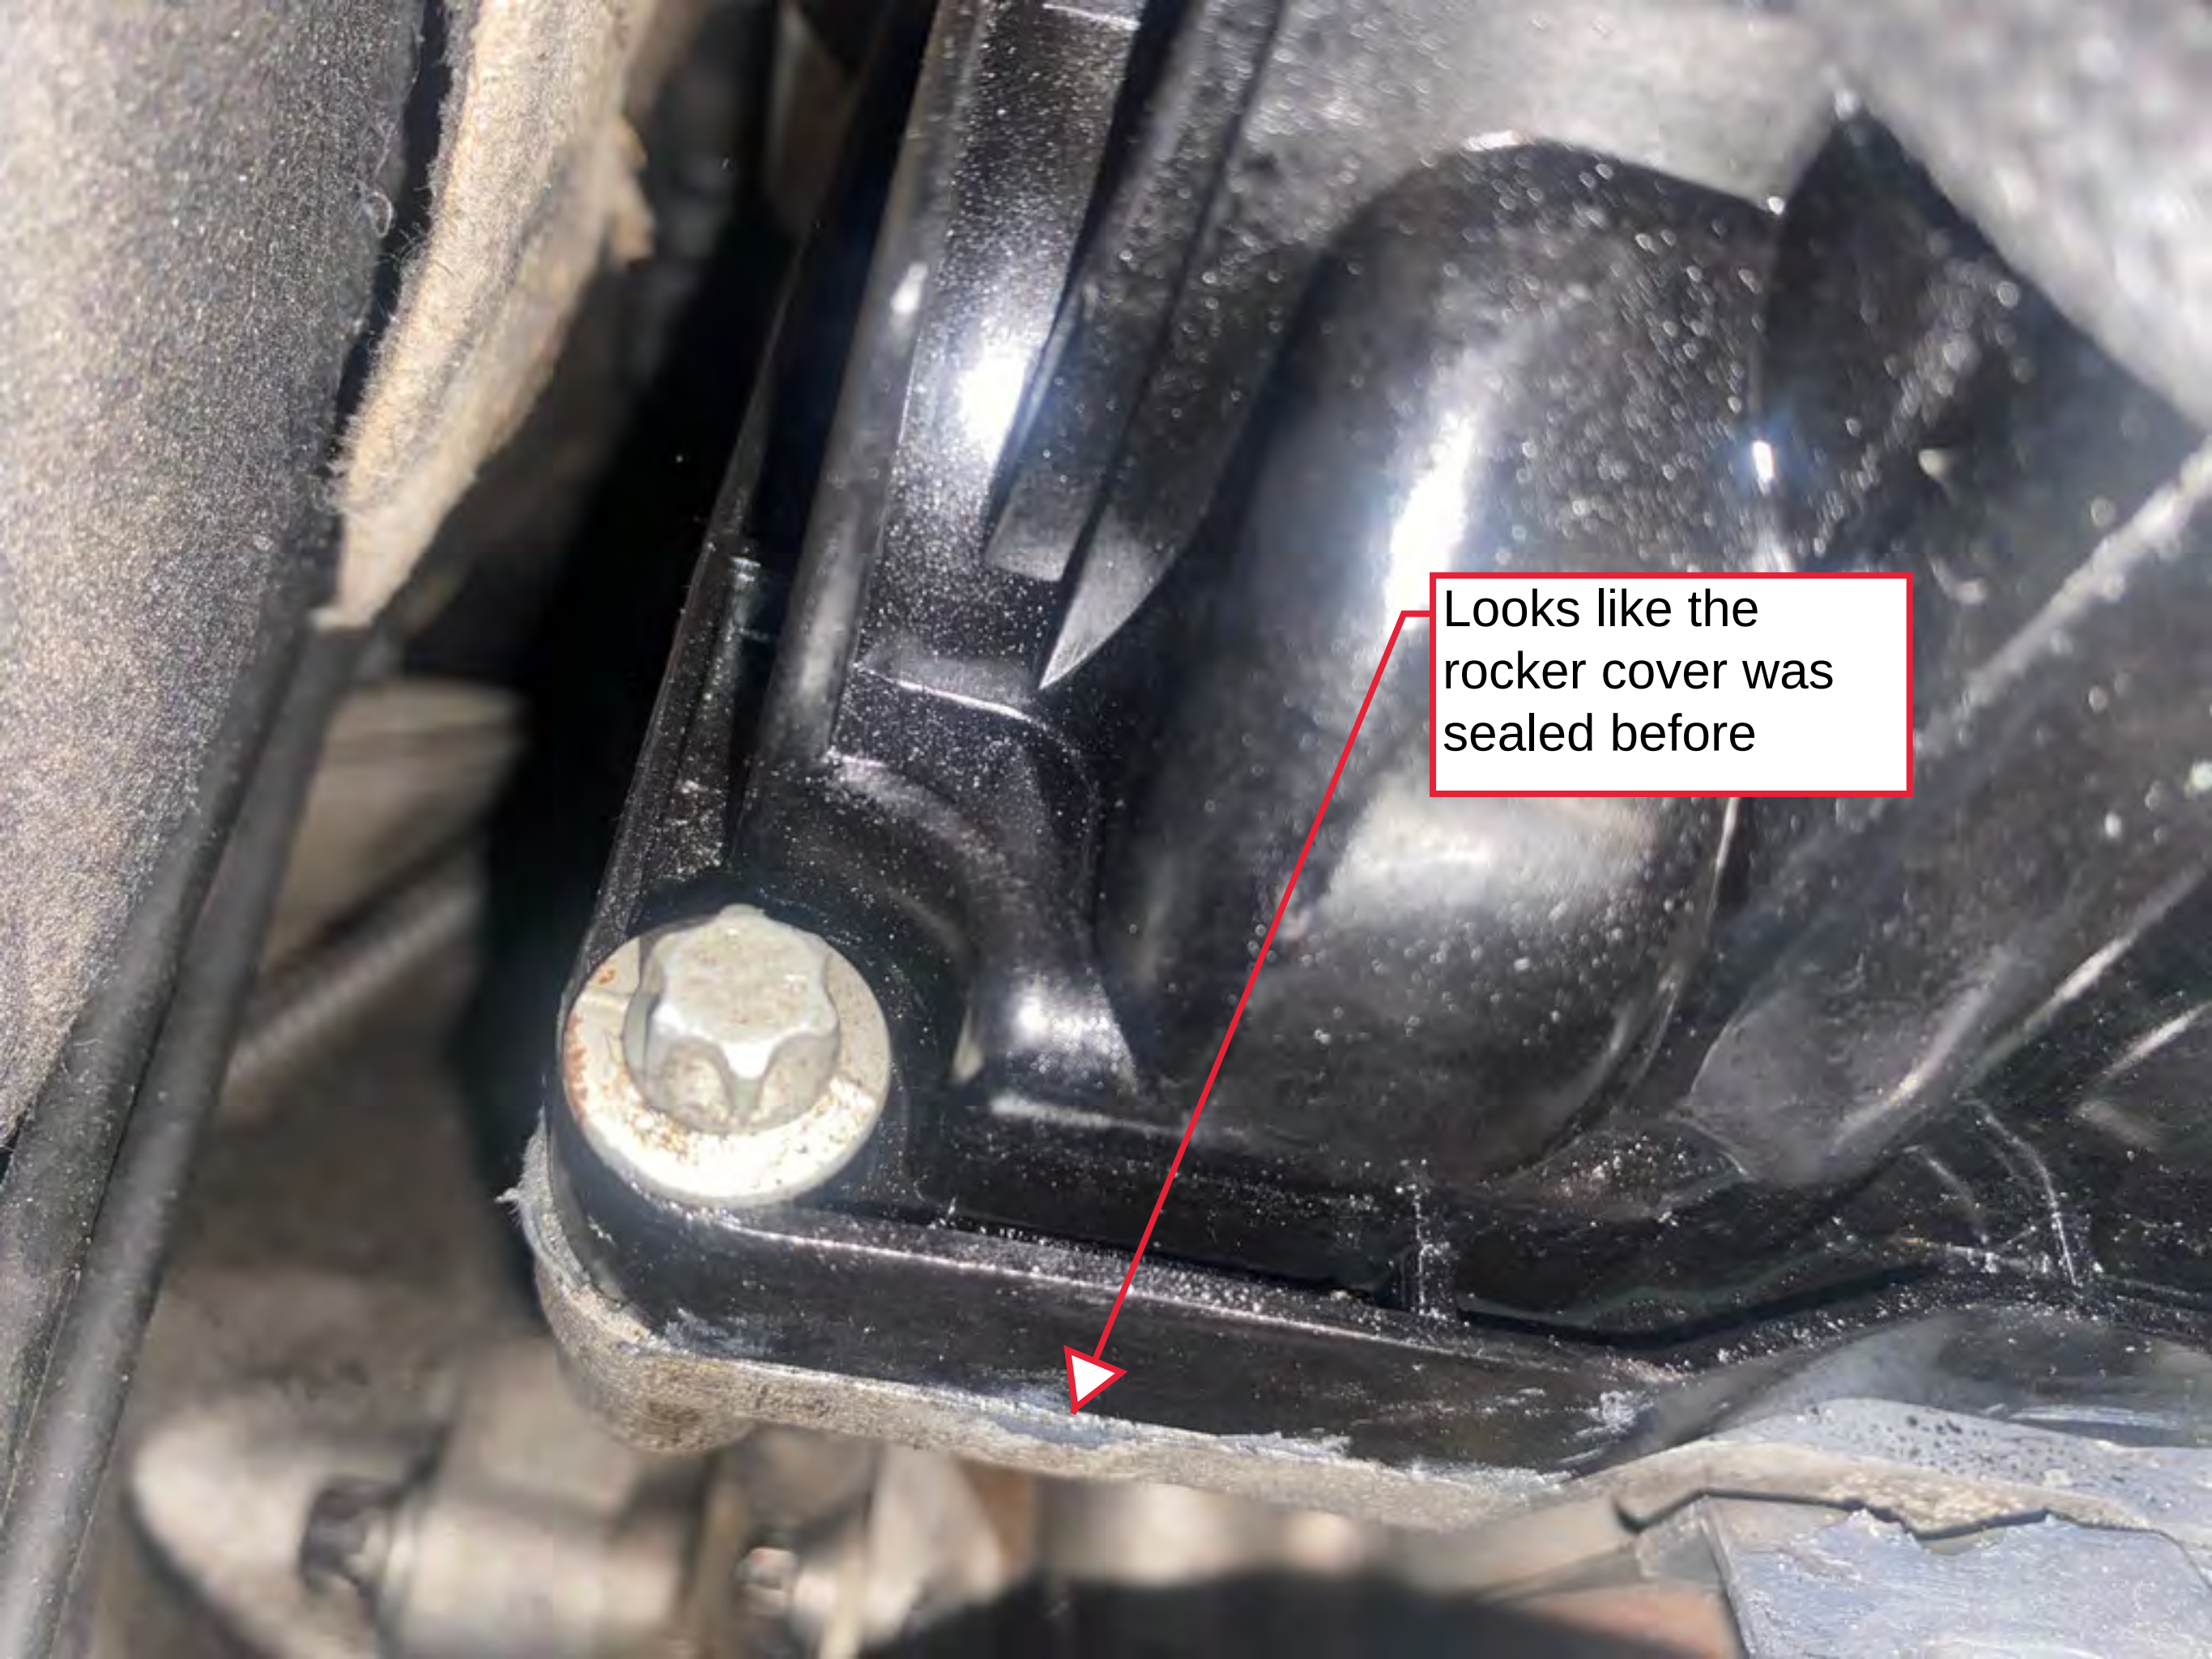
Looks like the  
rocker cover was  
sealed before

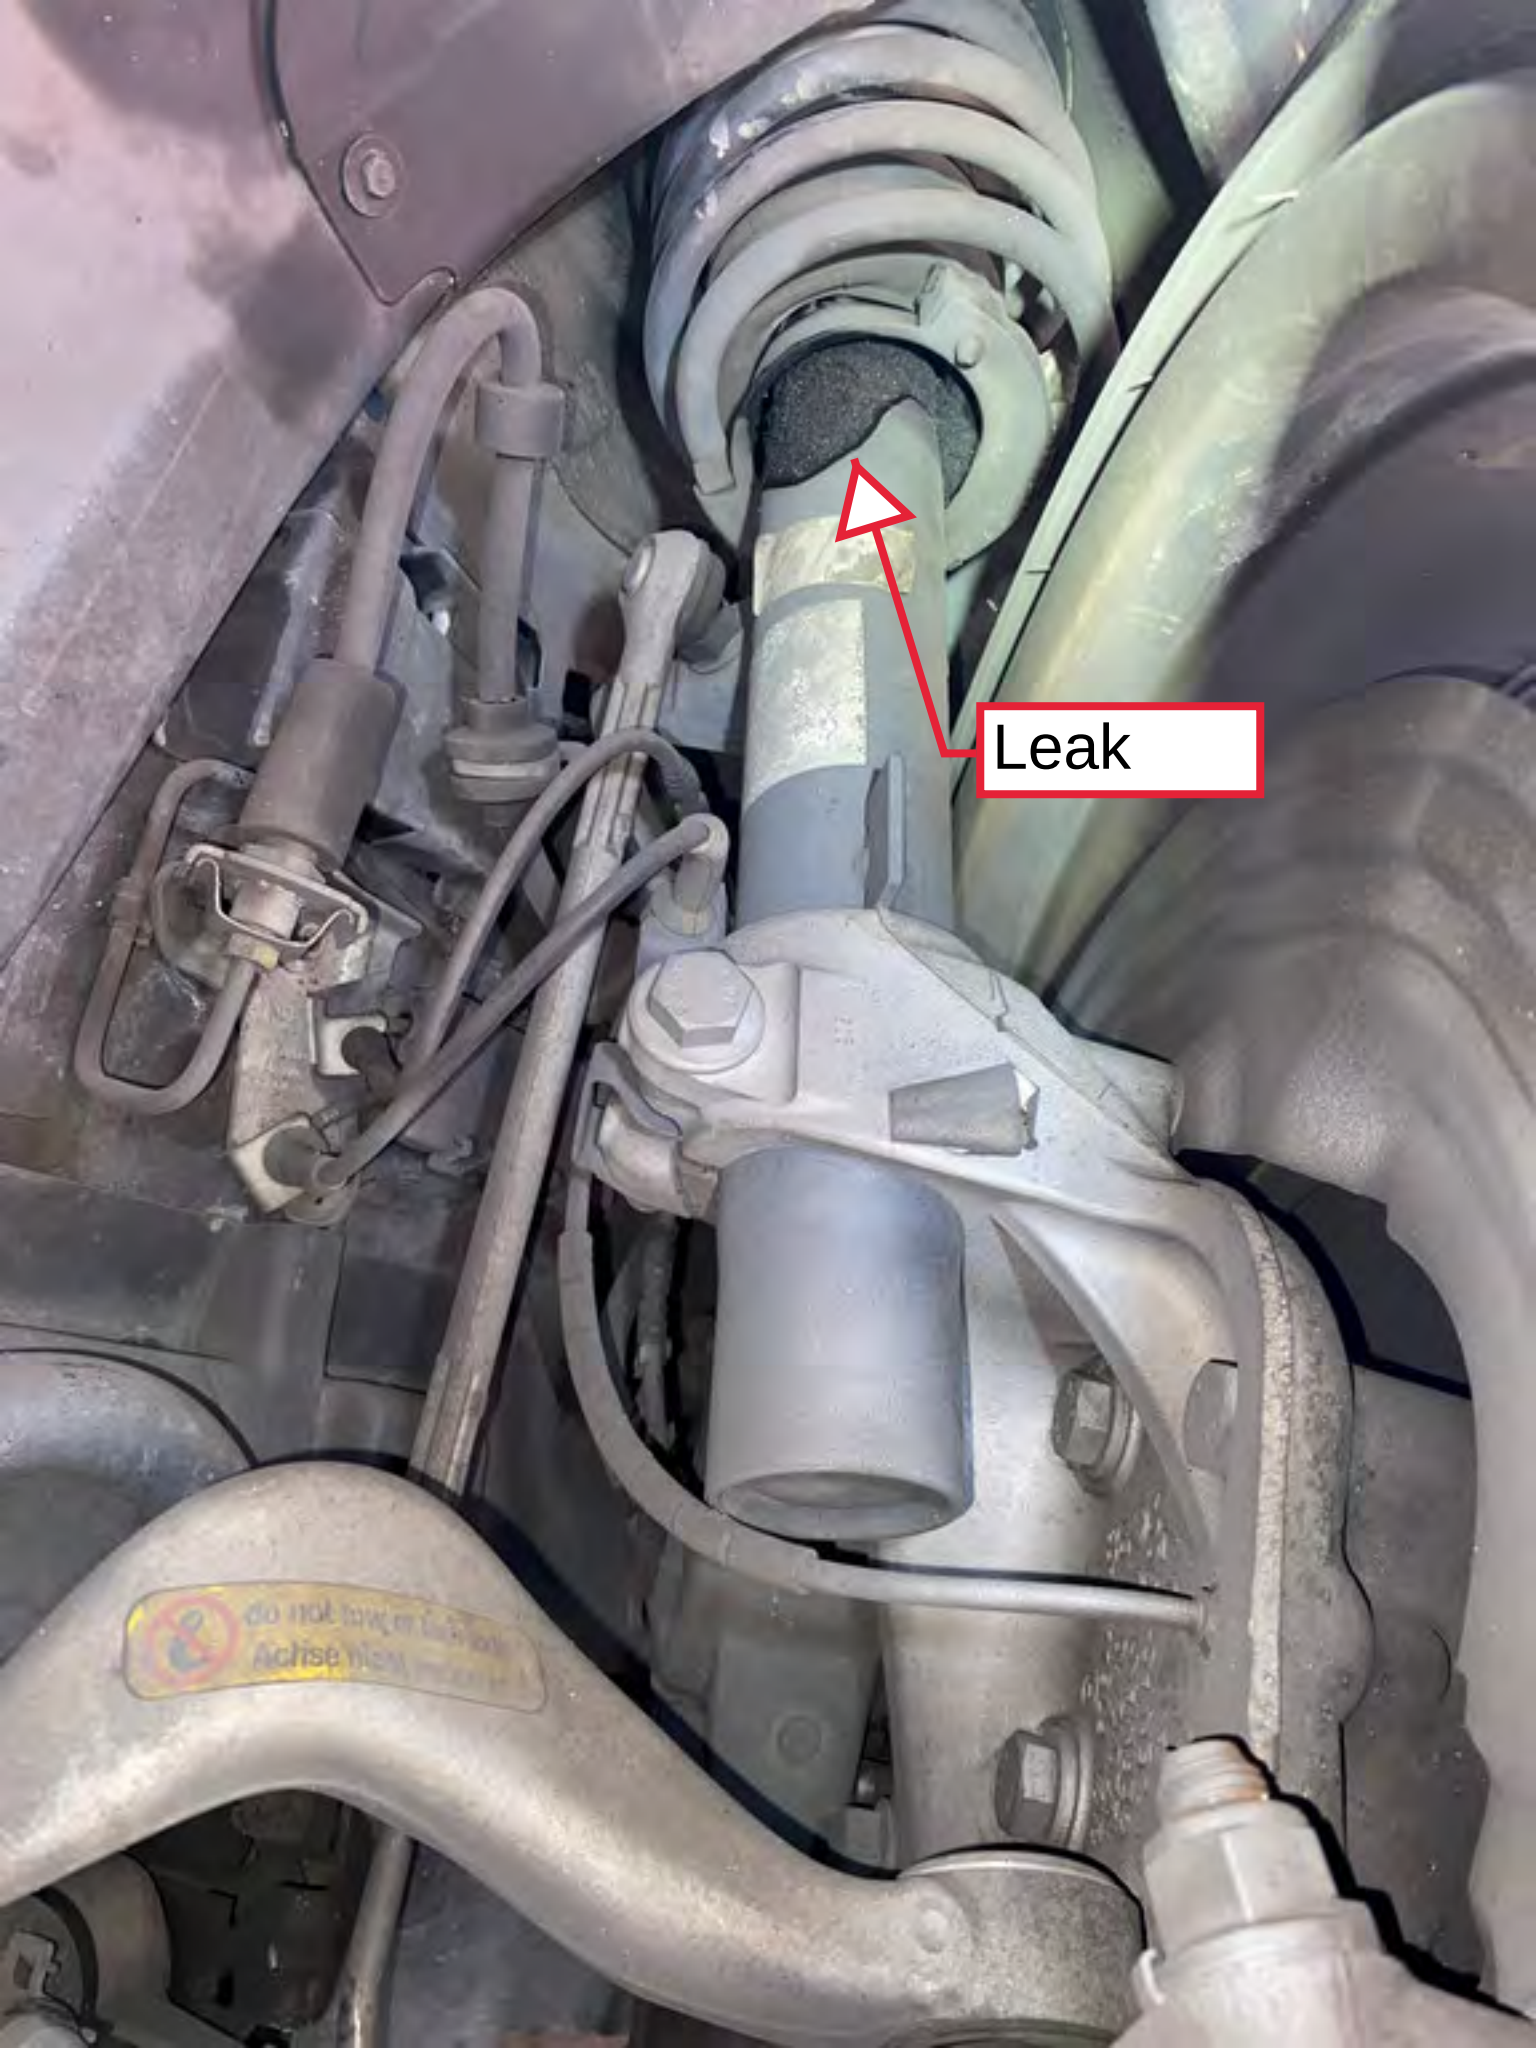
Leak
