BMW A.G.

3 Series - E90

# Engine & Servicing

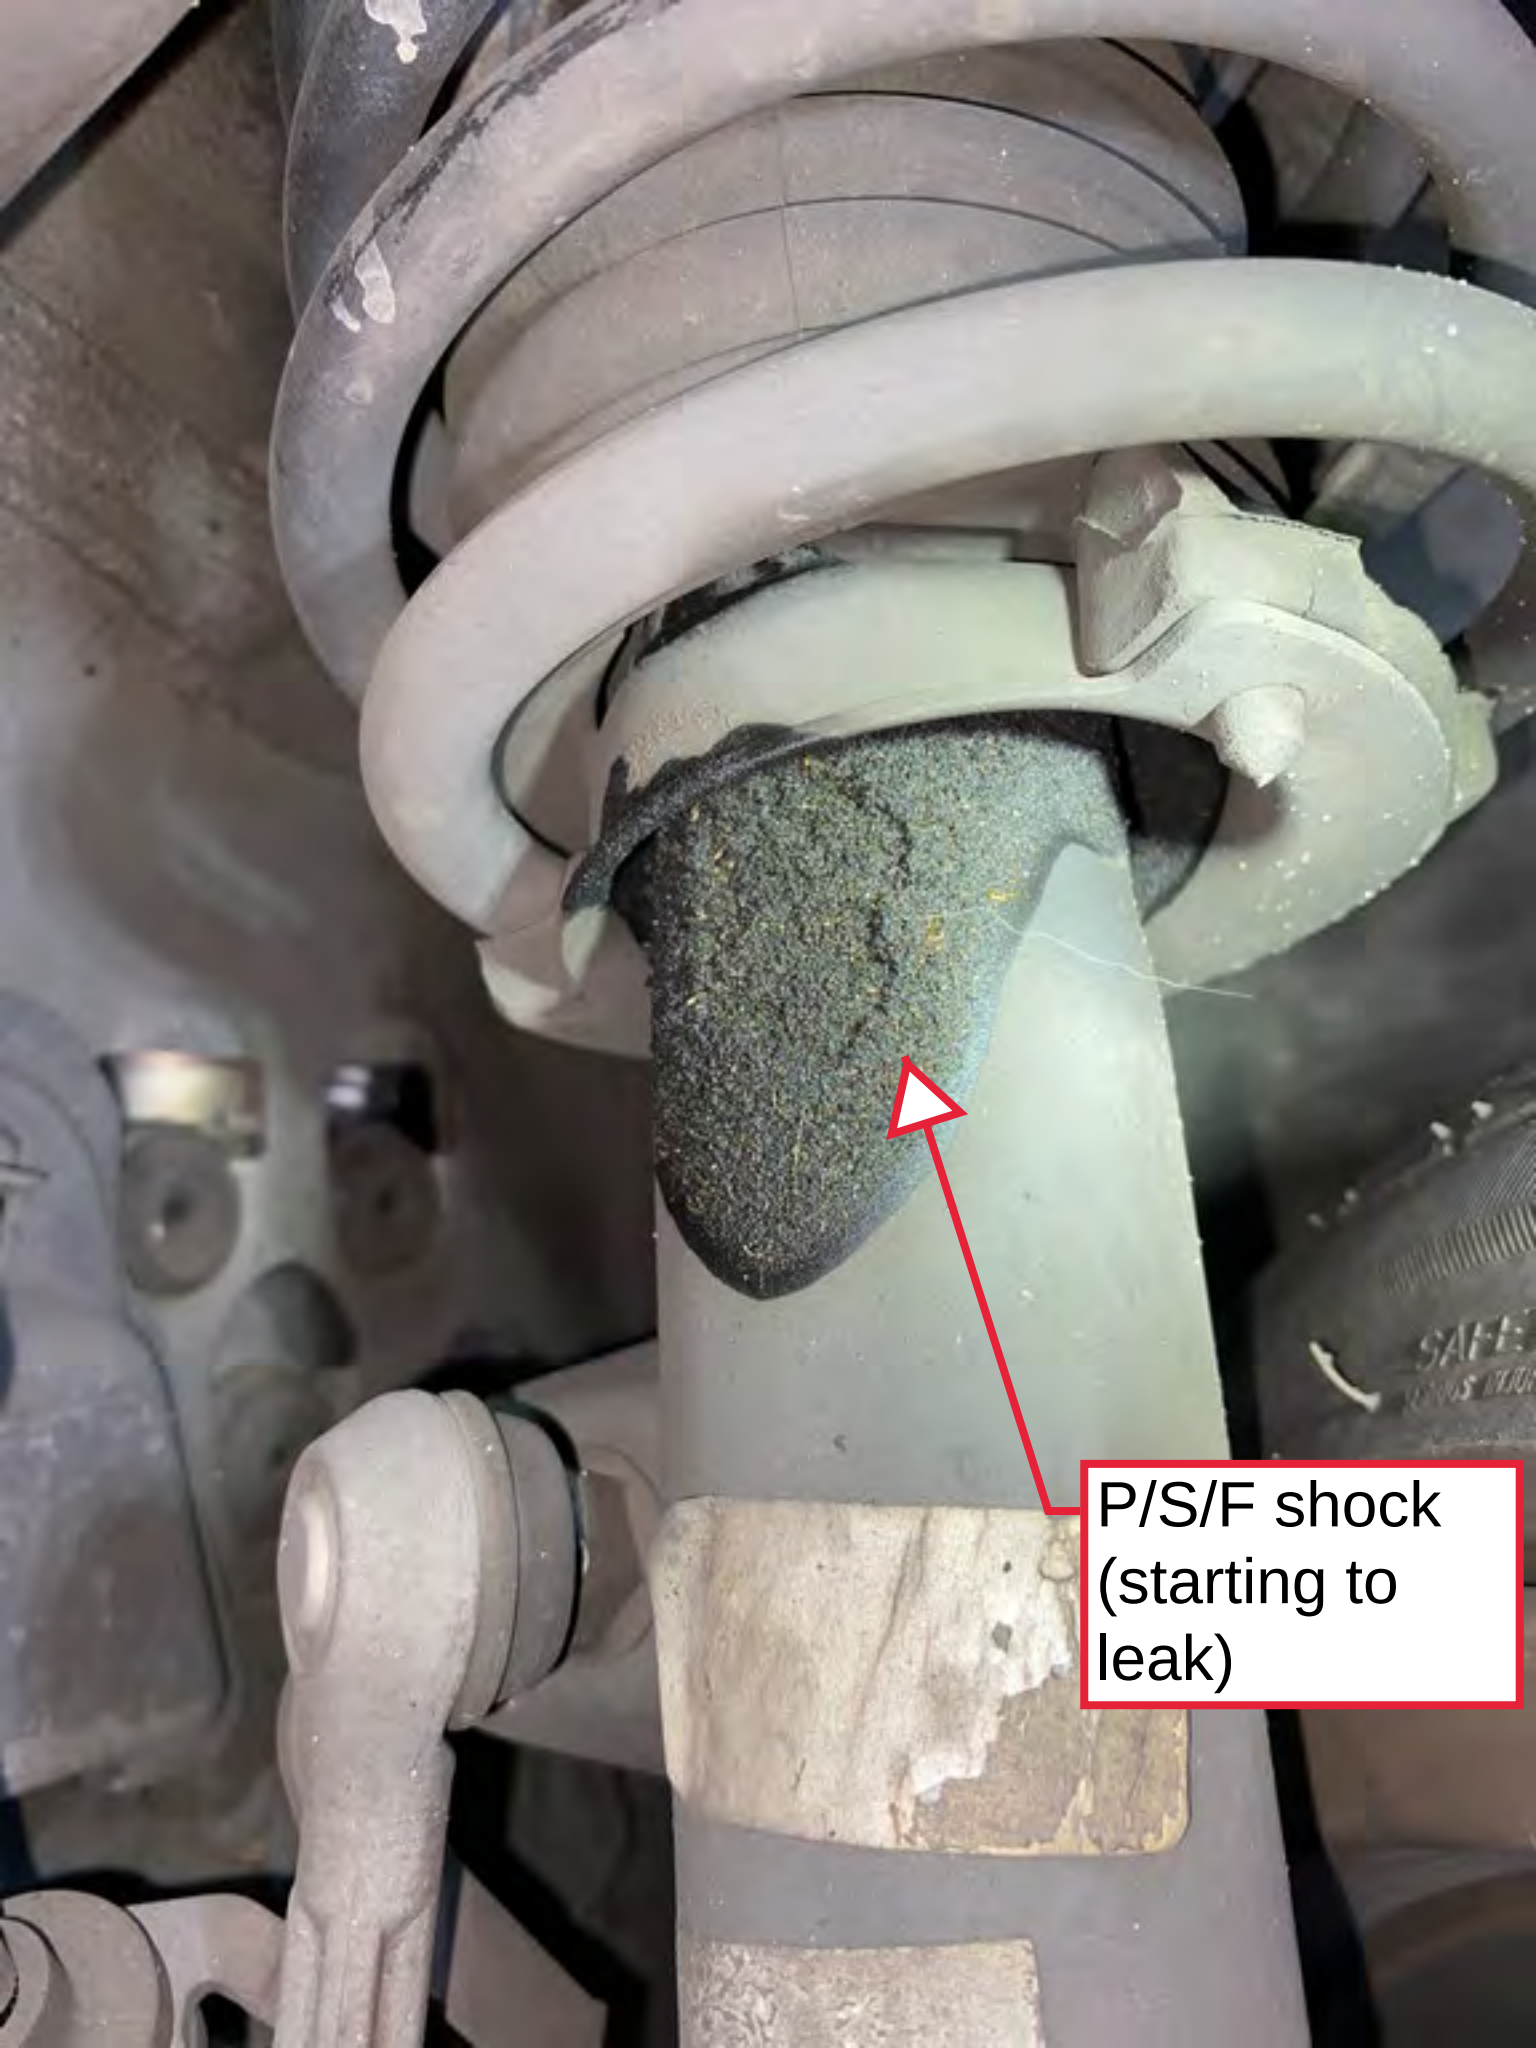
P/S/F shock  
(starting to  
leak)

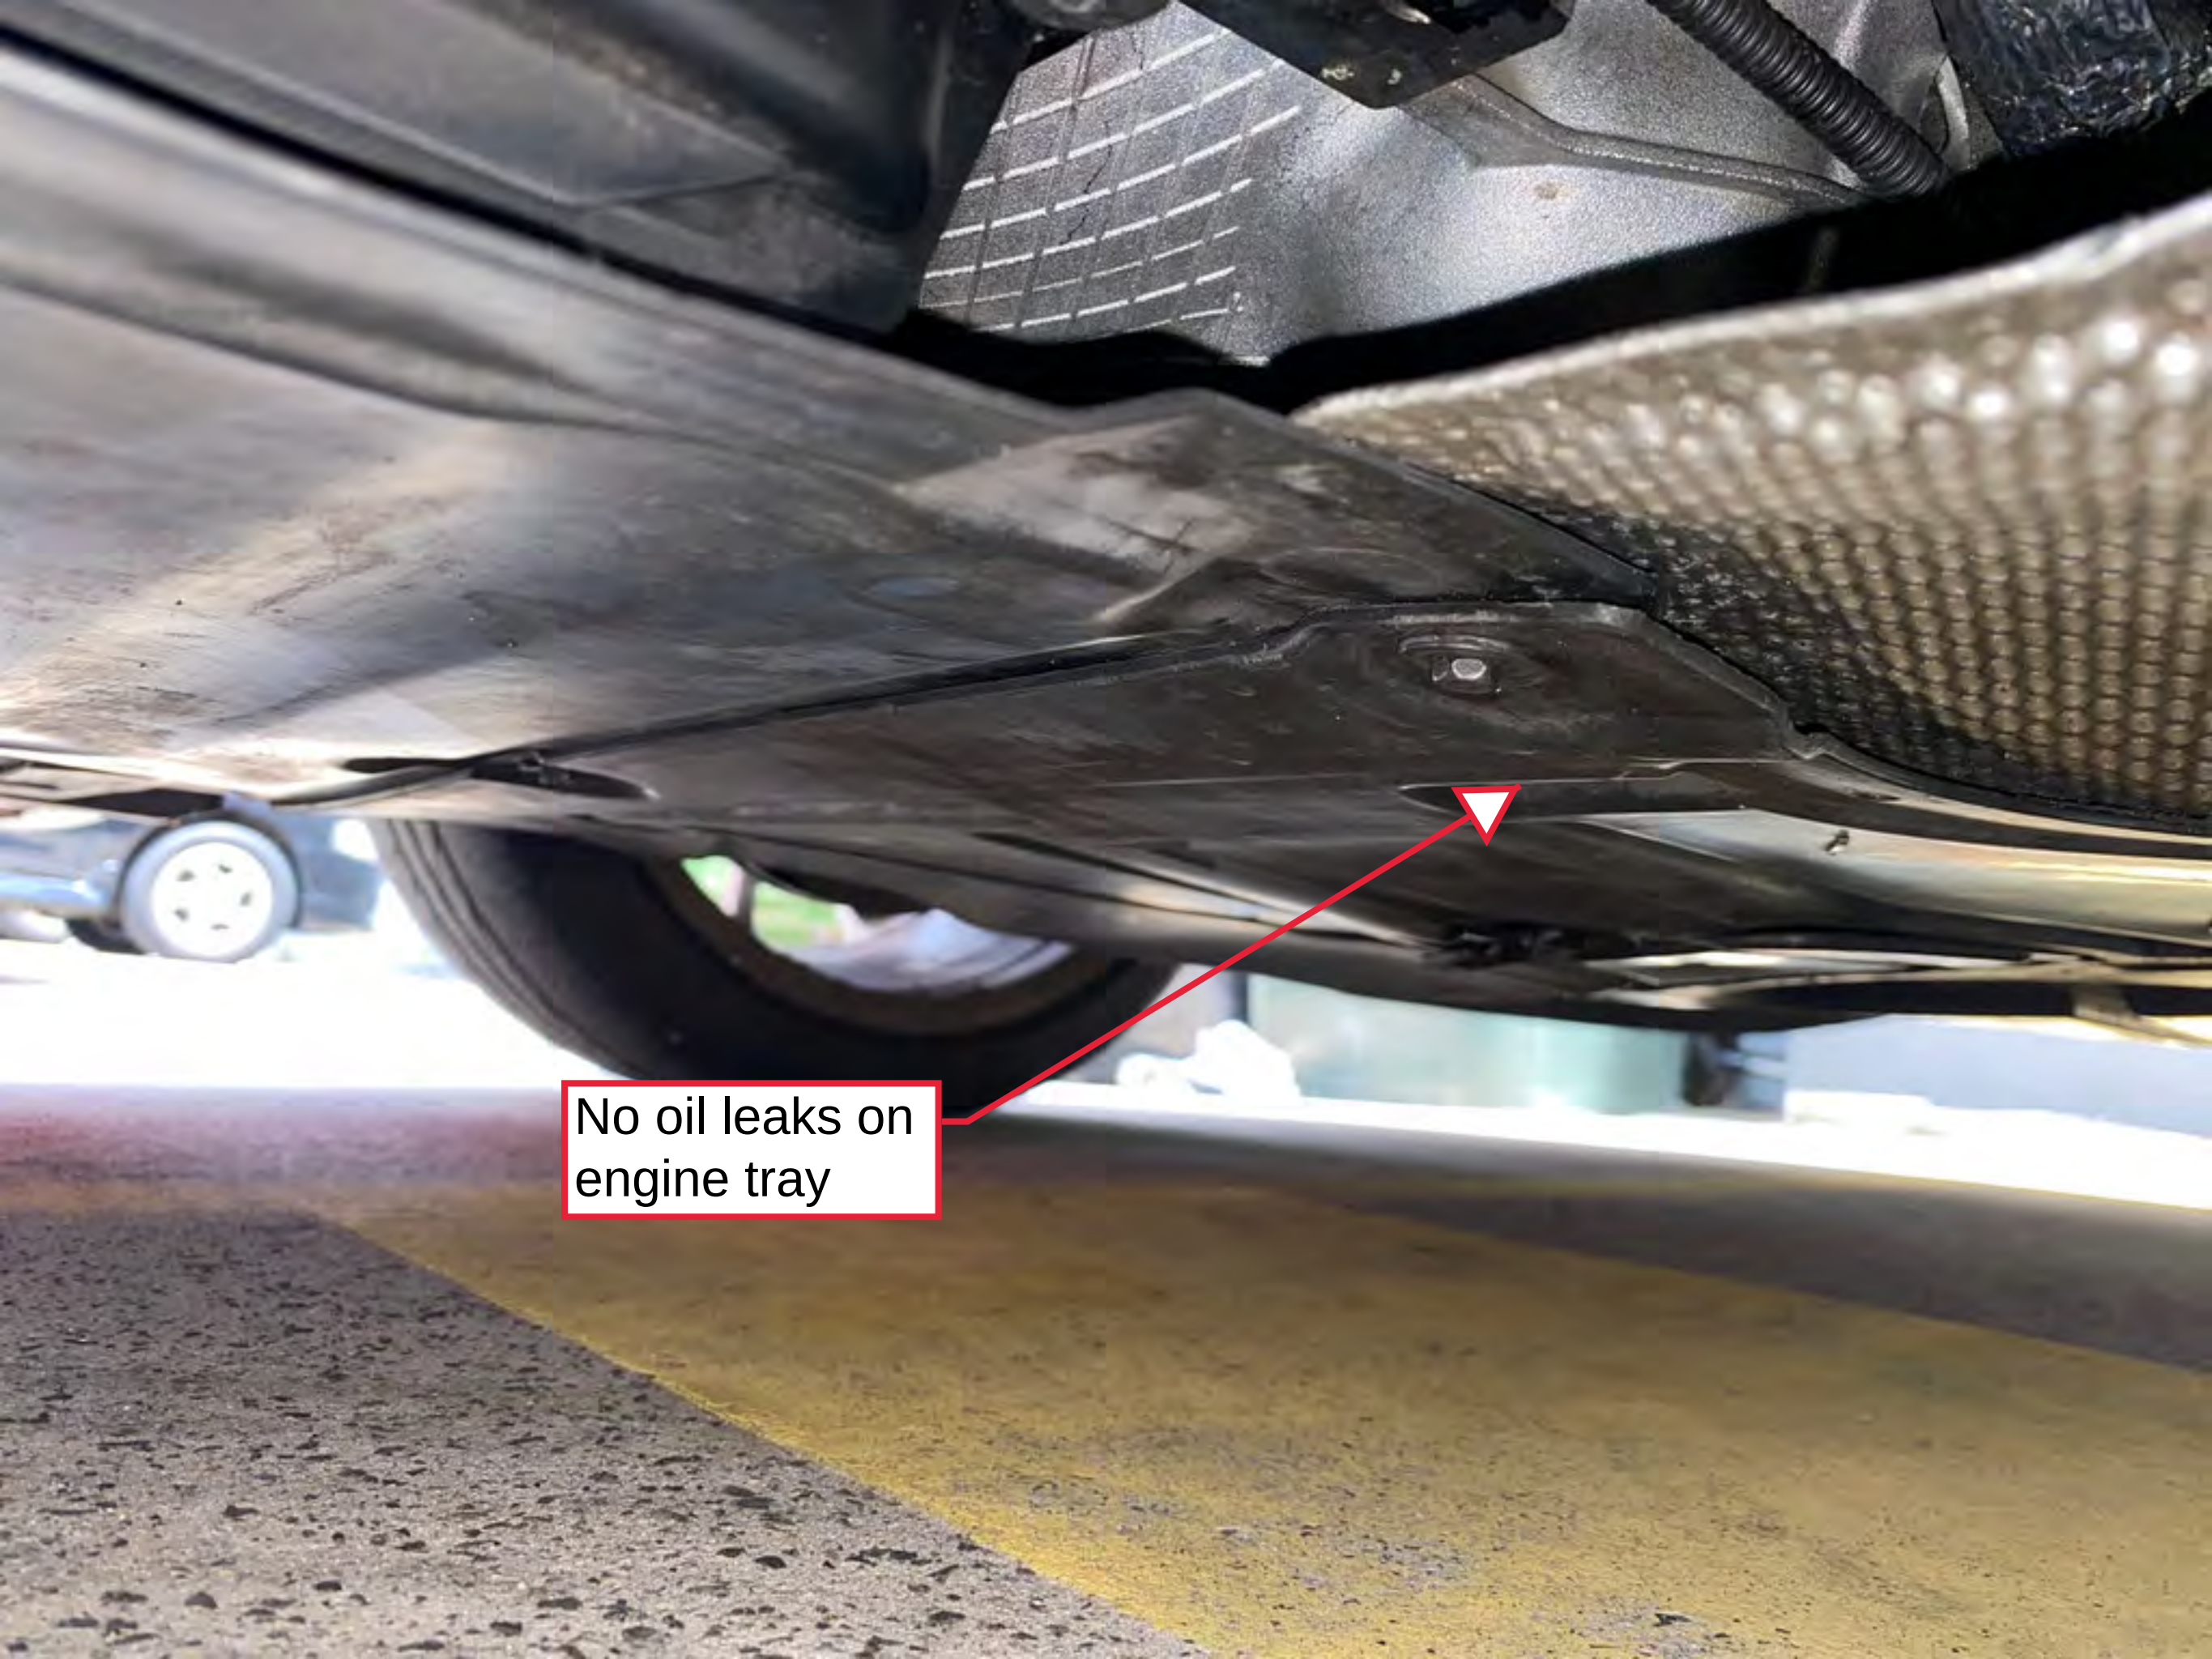
No oil leaks on  
engine tray

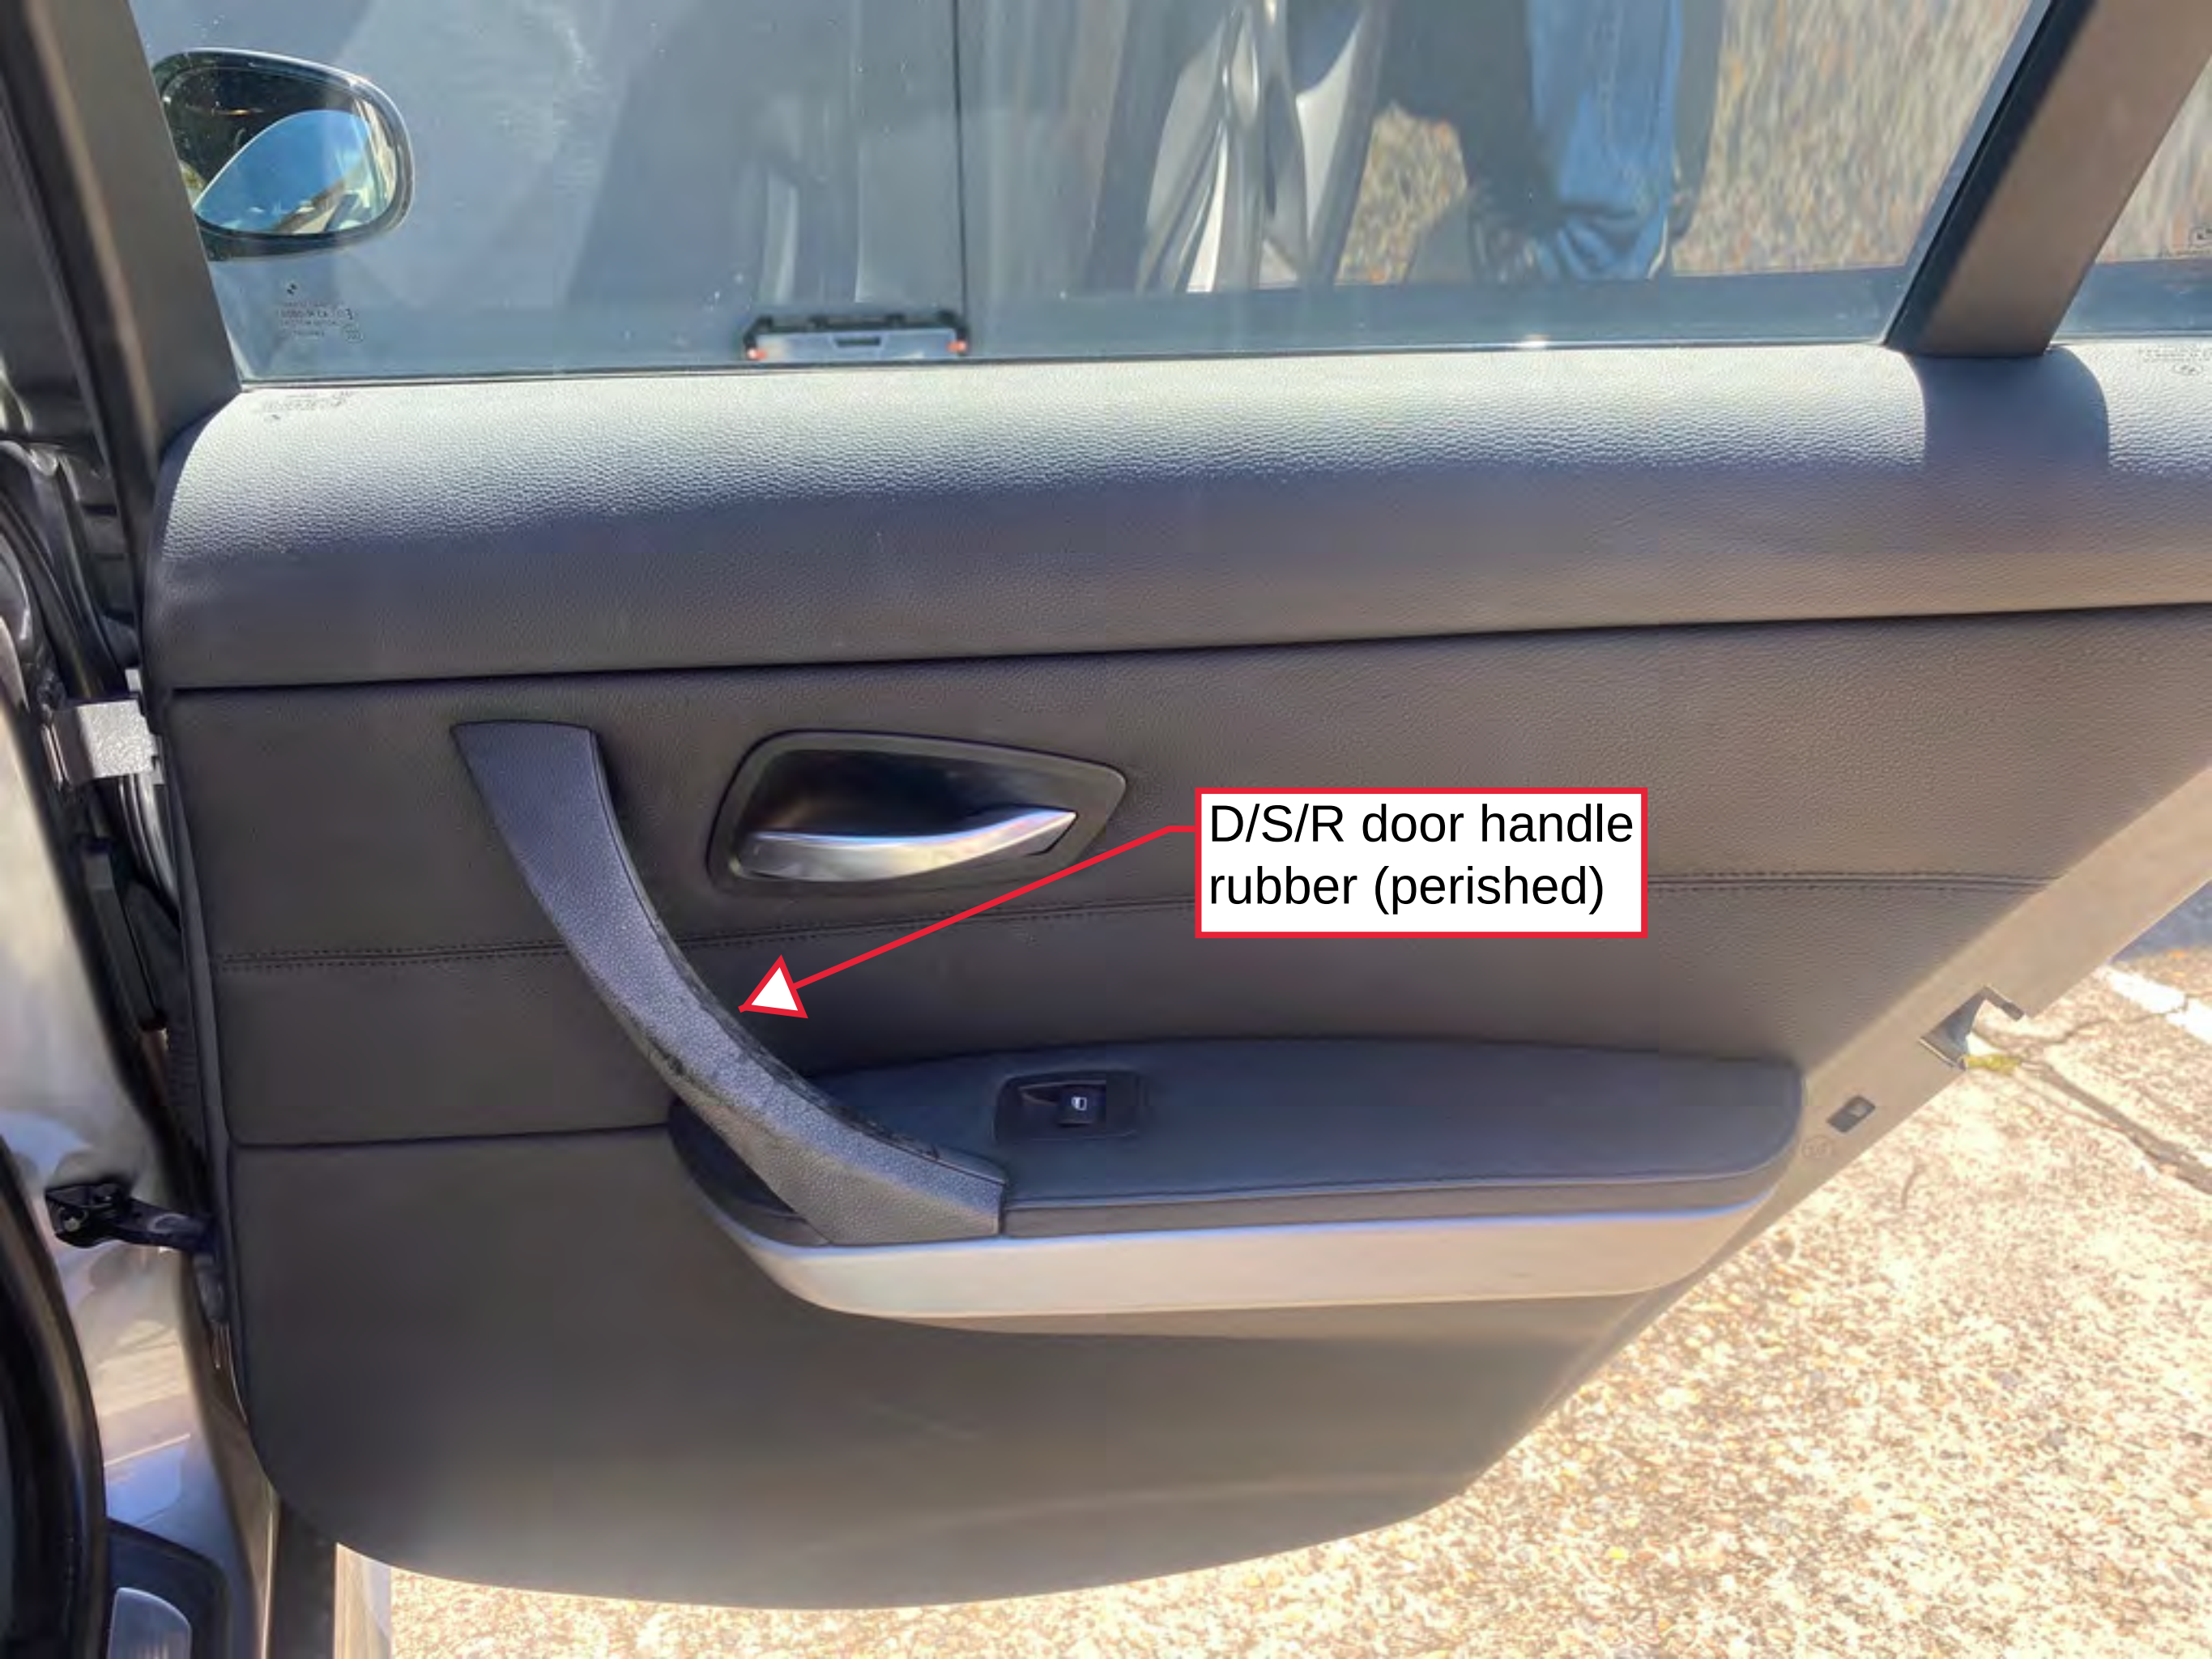
D/S/R door handle  
rubber (perished)

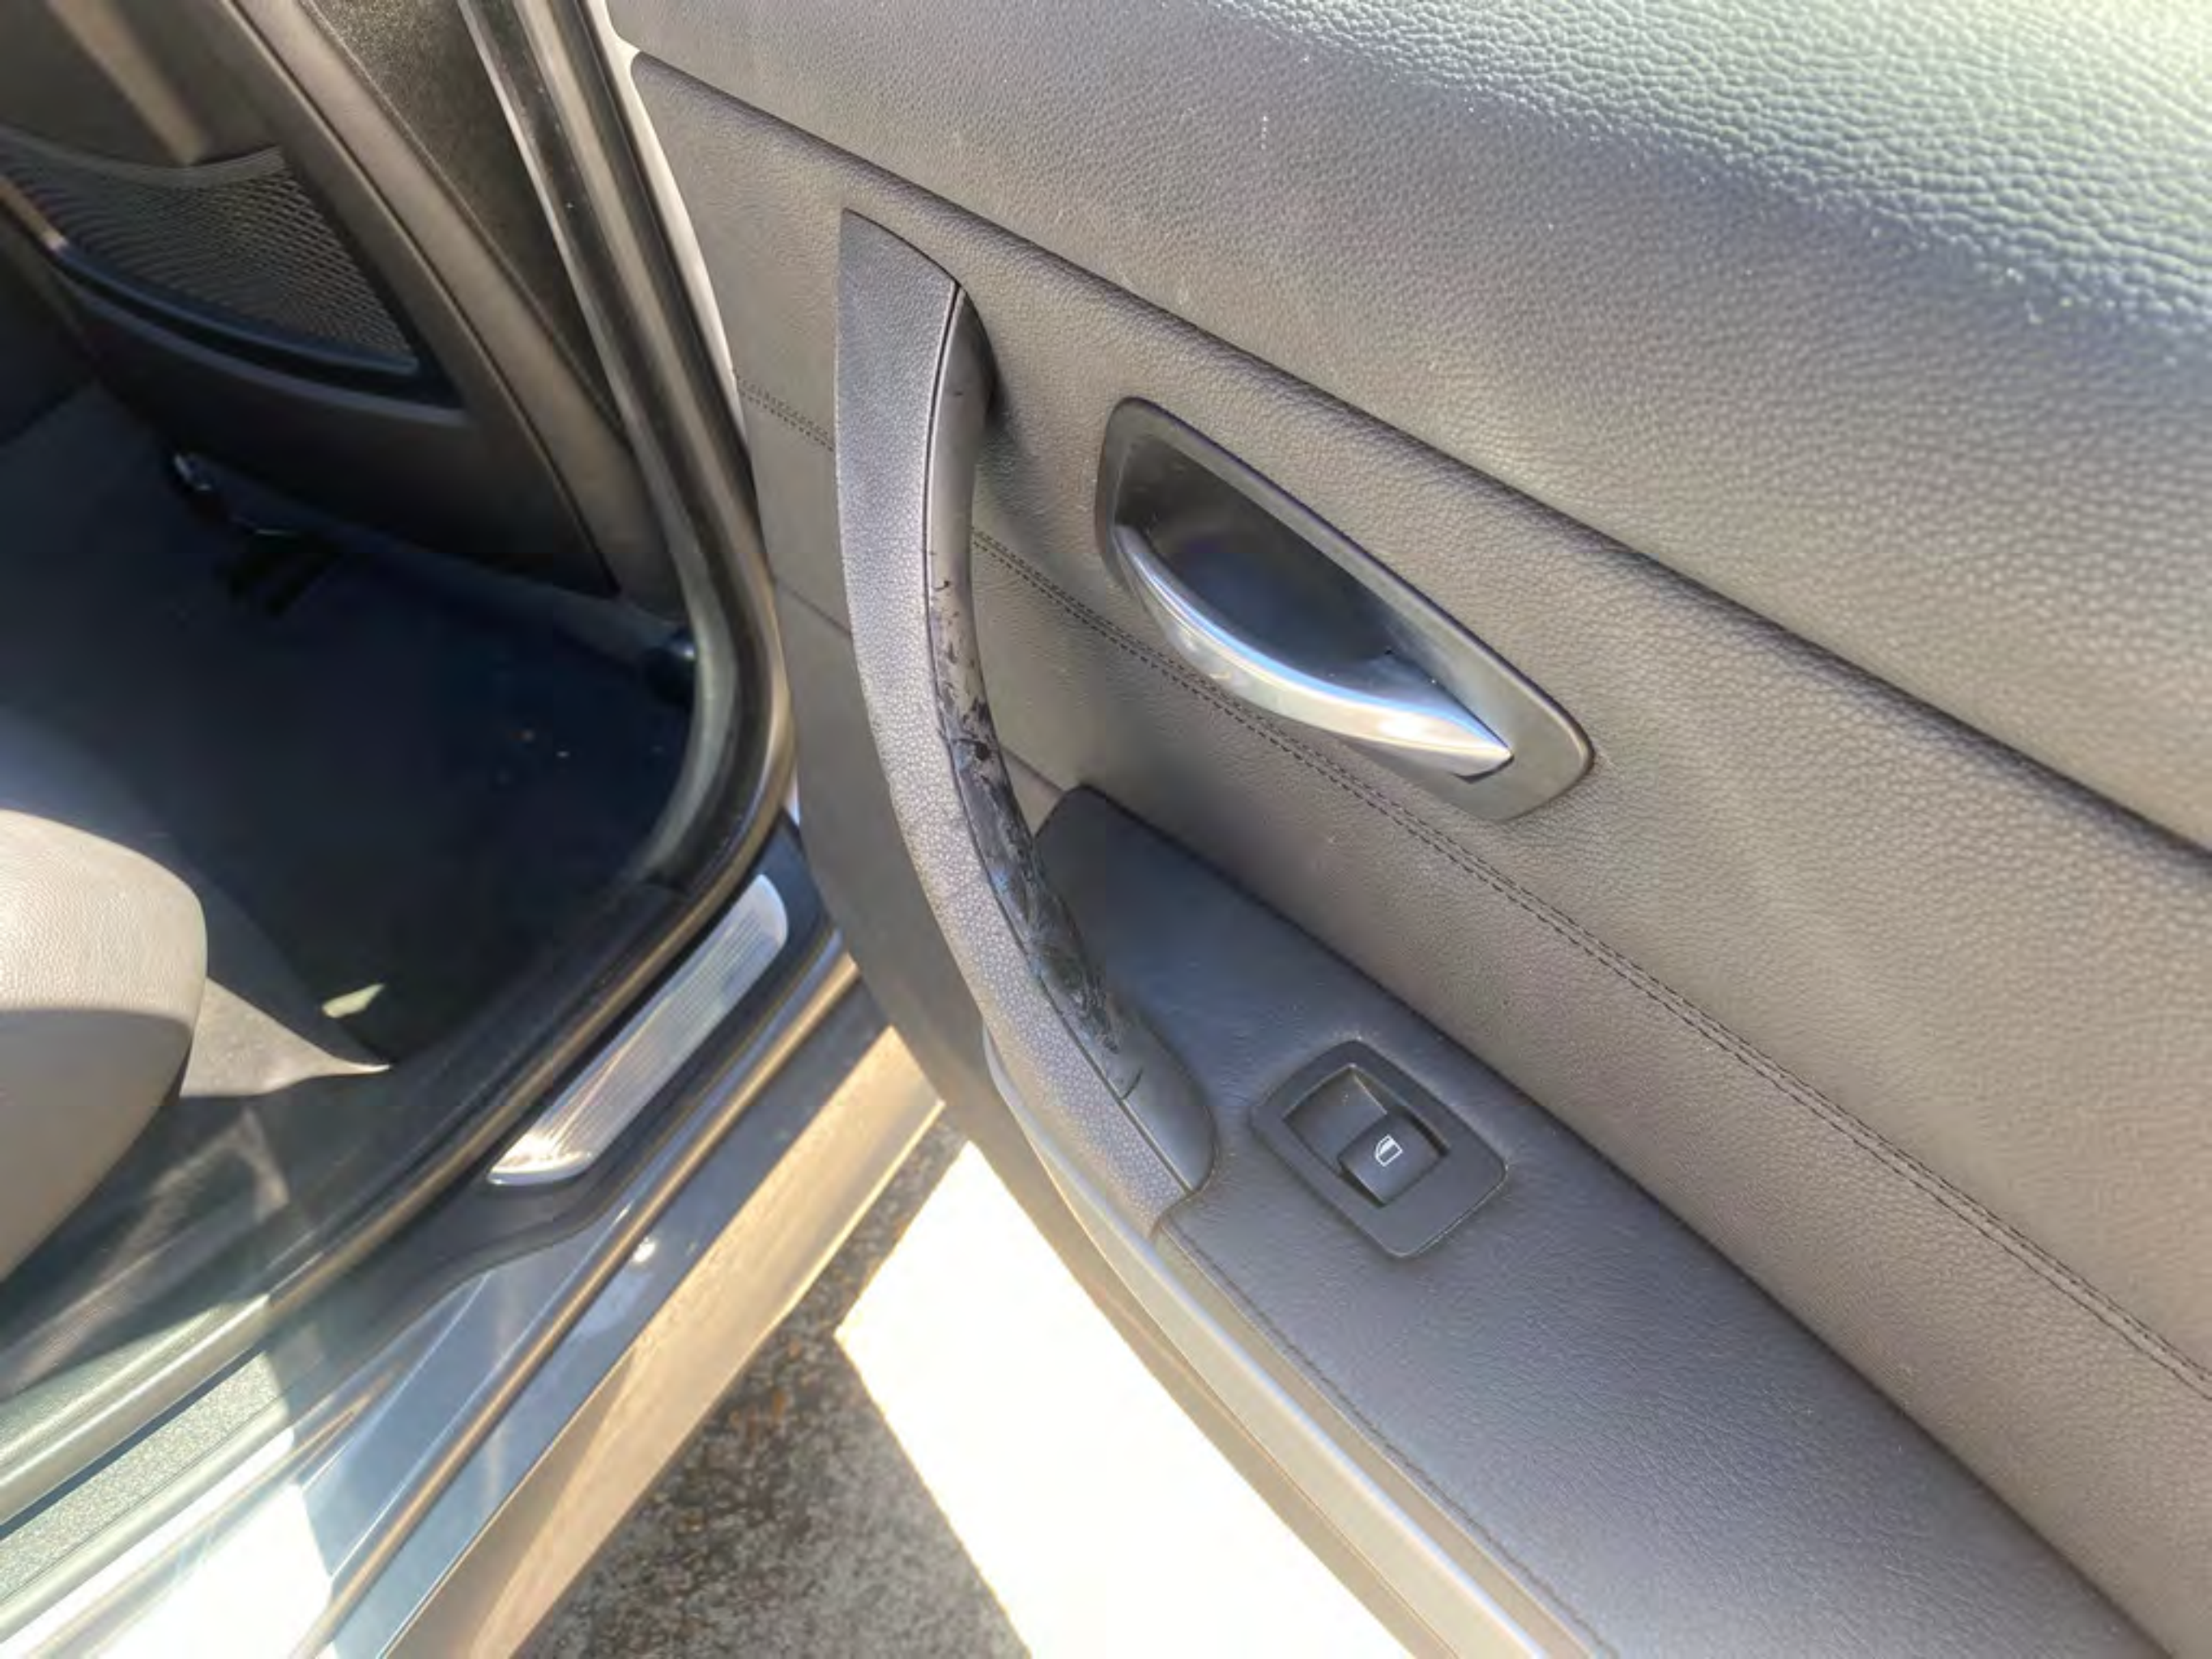
P/S/R door handle  
rubber (slightly  
perished)

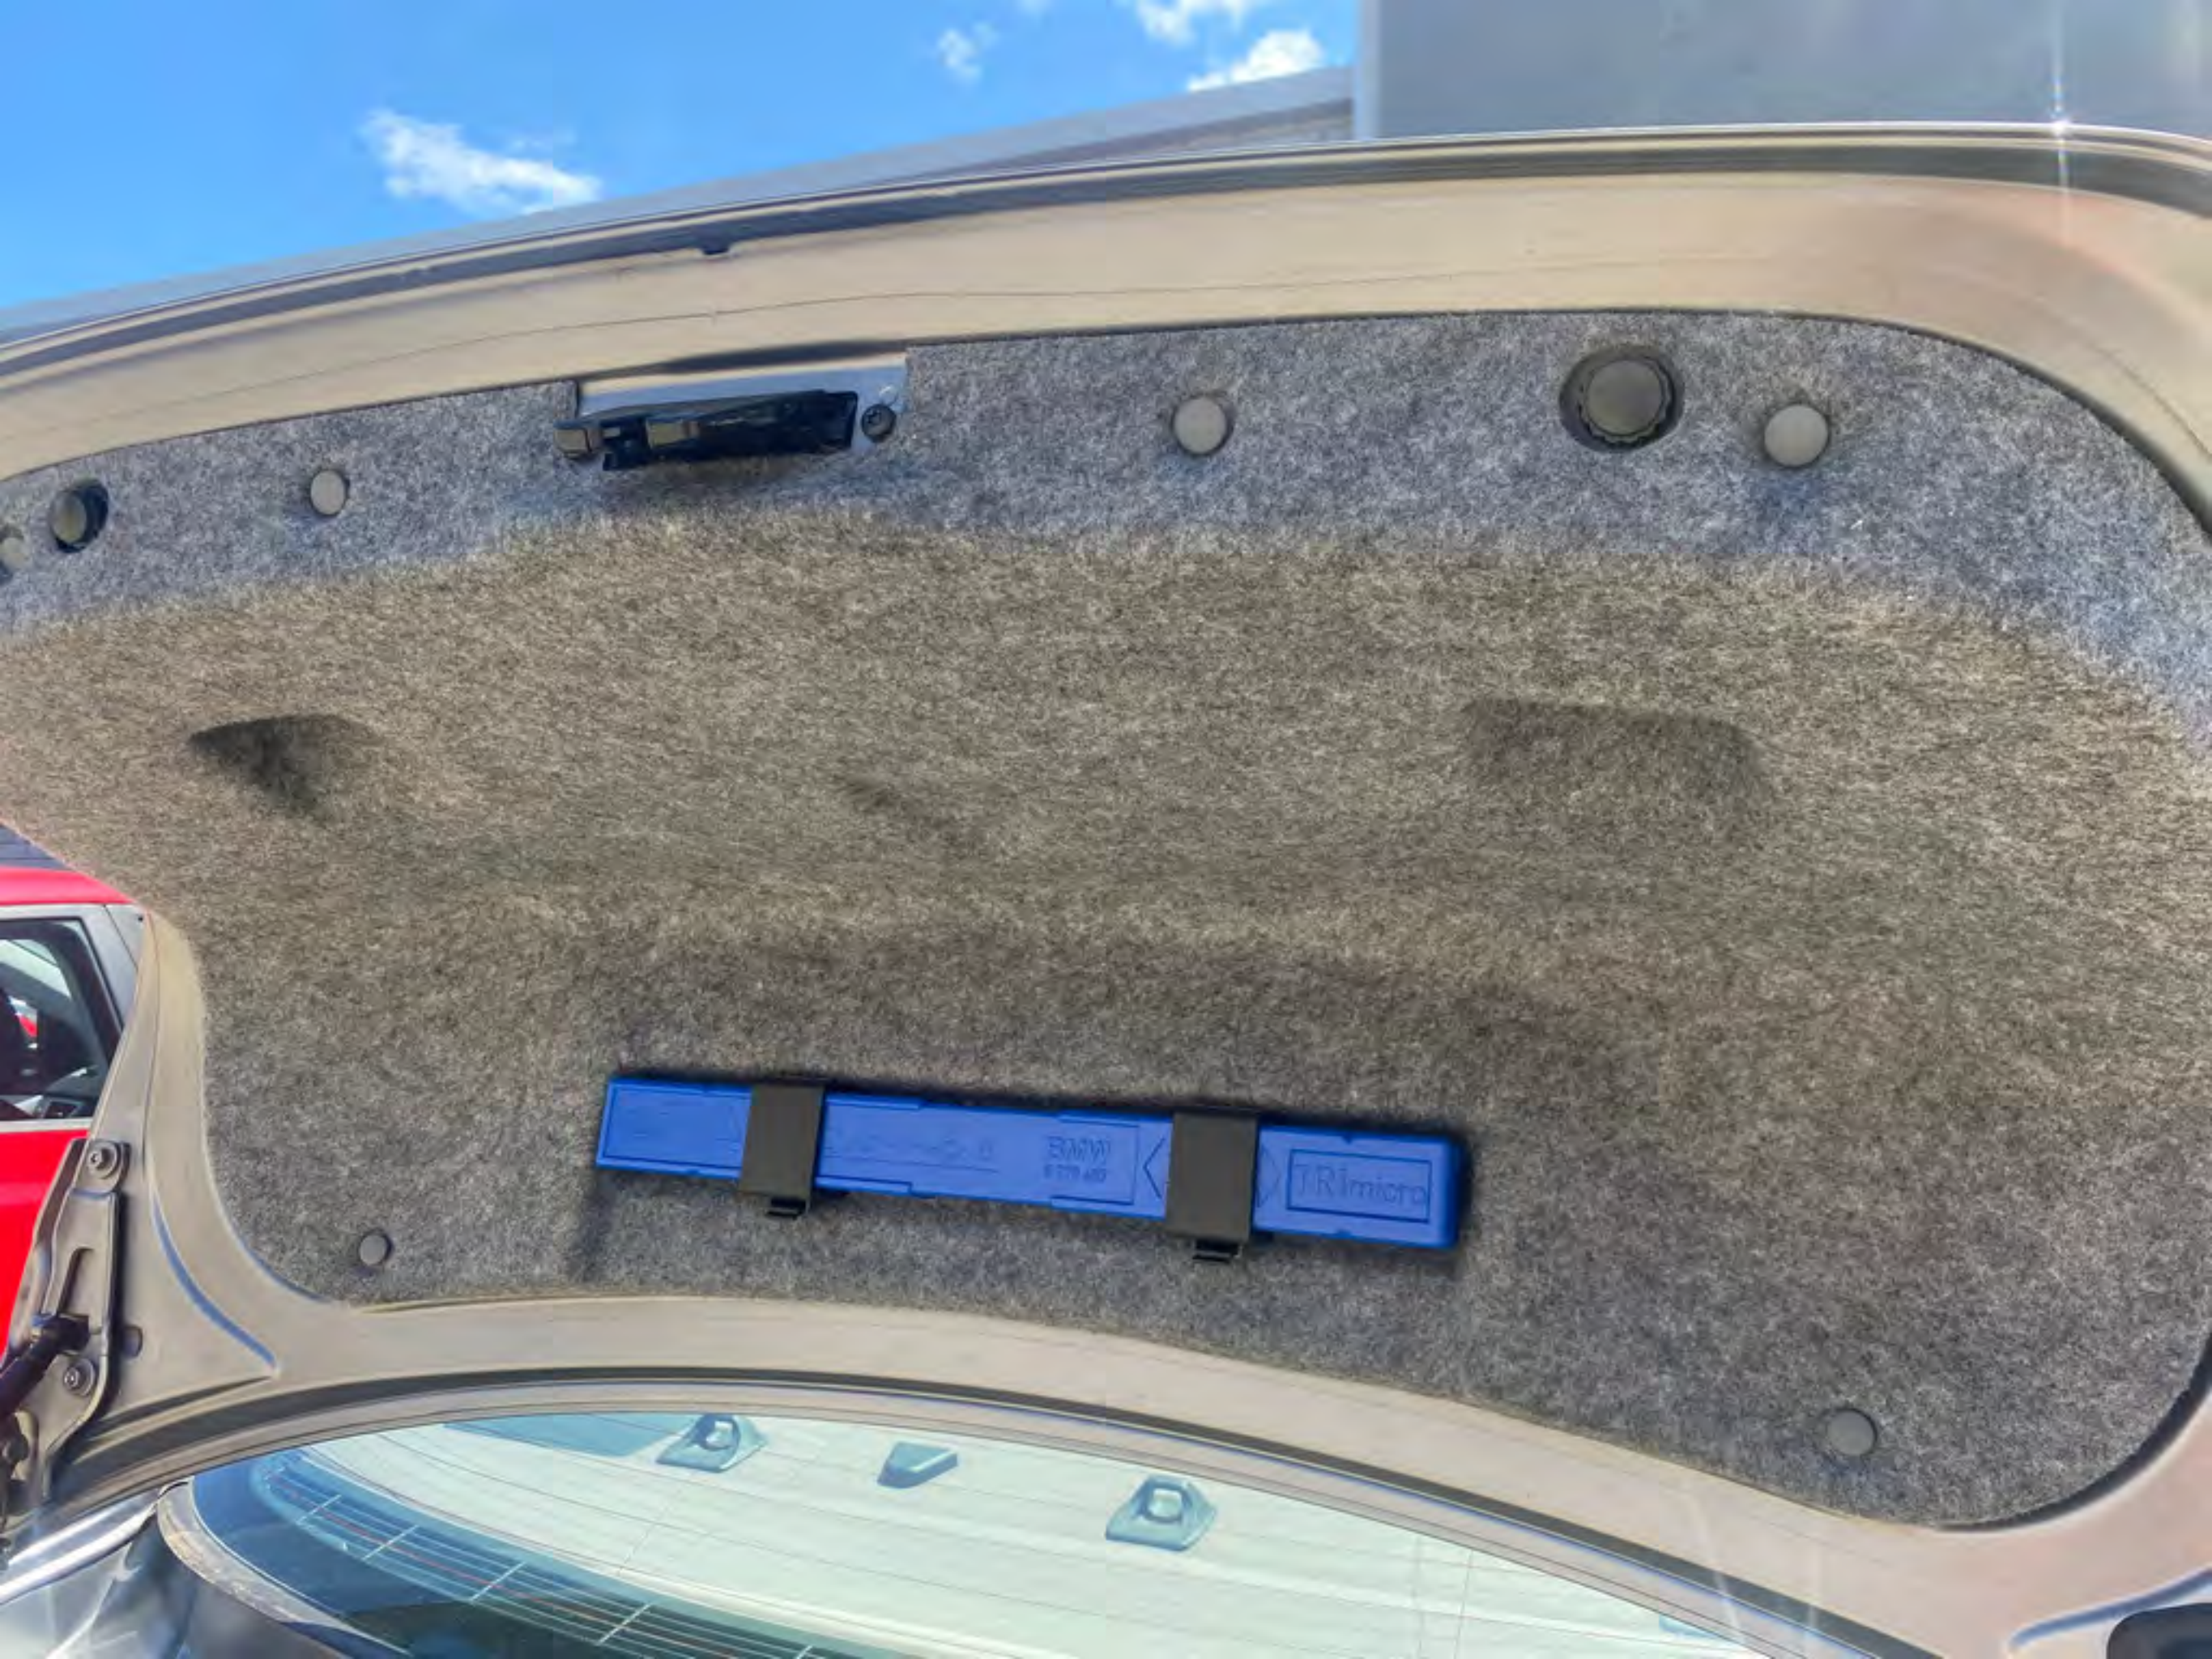
Wear on  
steering wheel

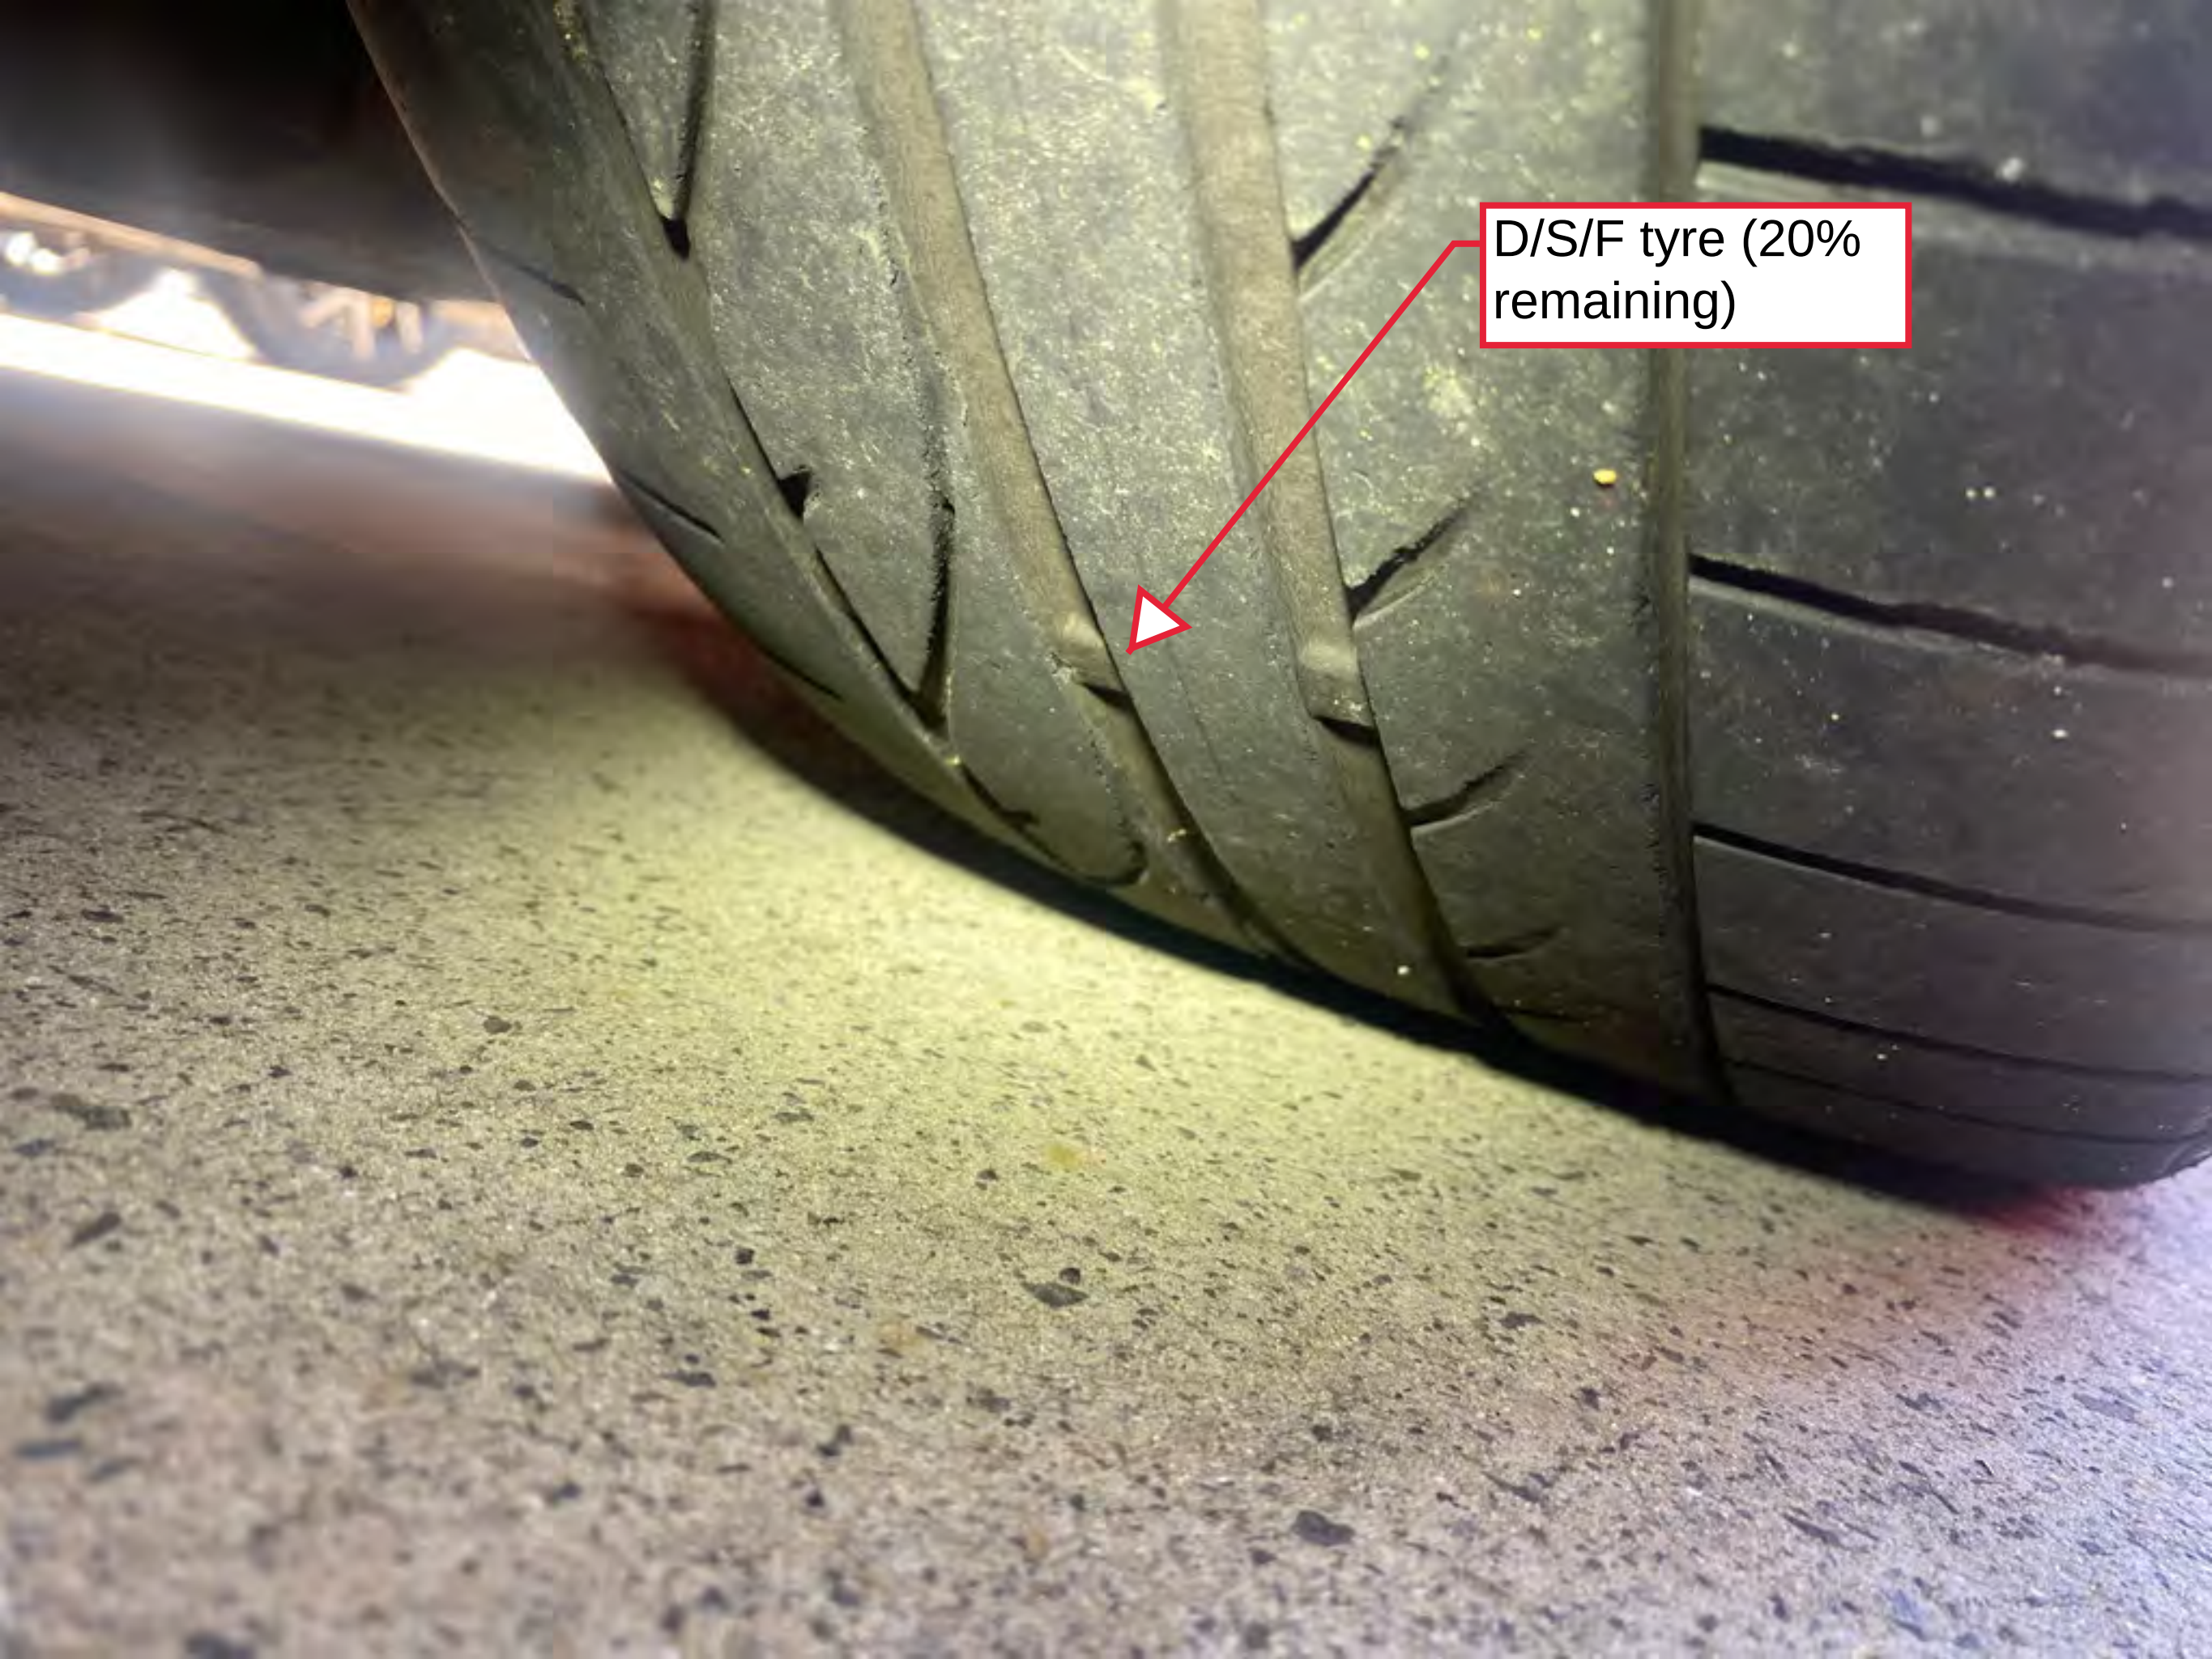
D/S/F tyre (20%  
remaining)
