BMW A.G.

3 Series - E90

# Engine & Servicing

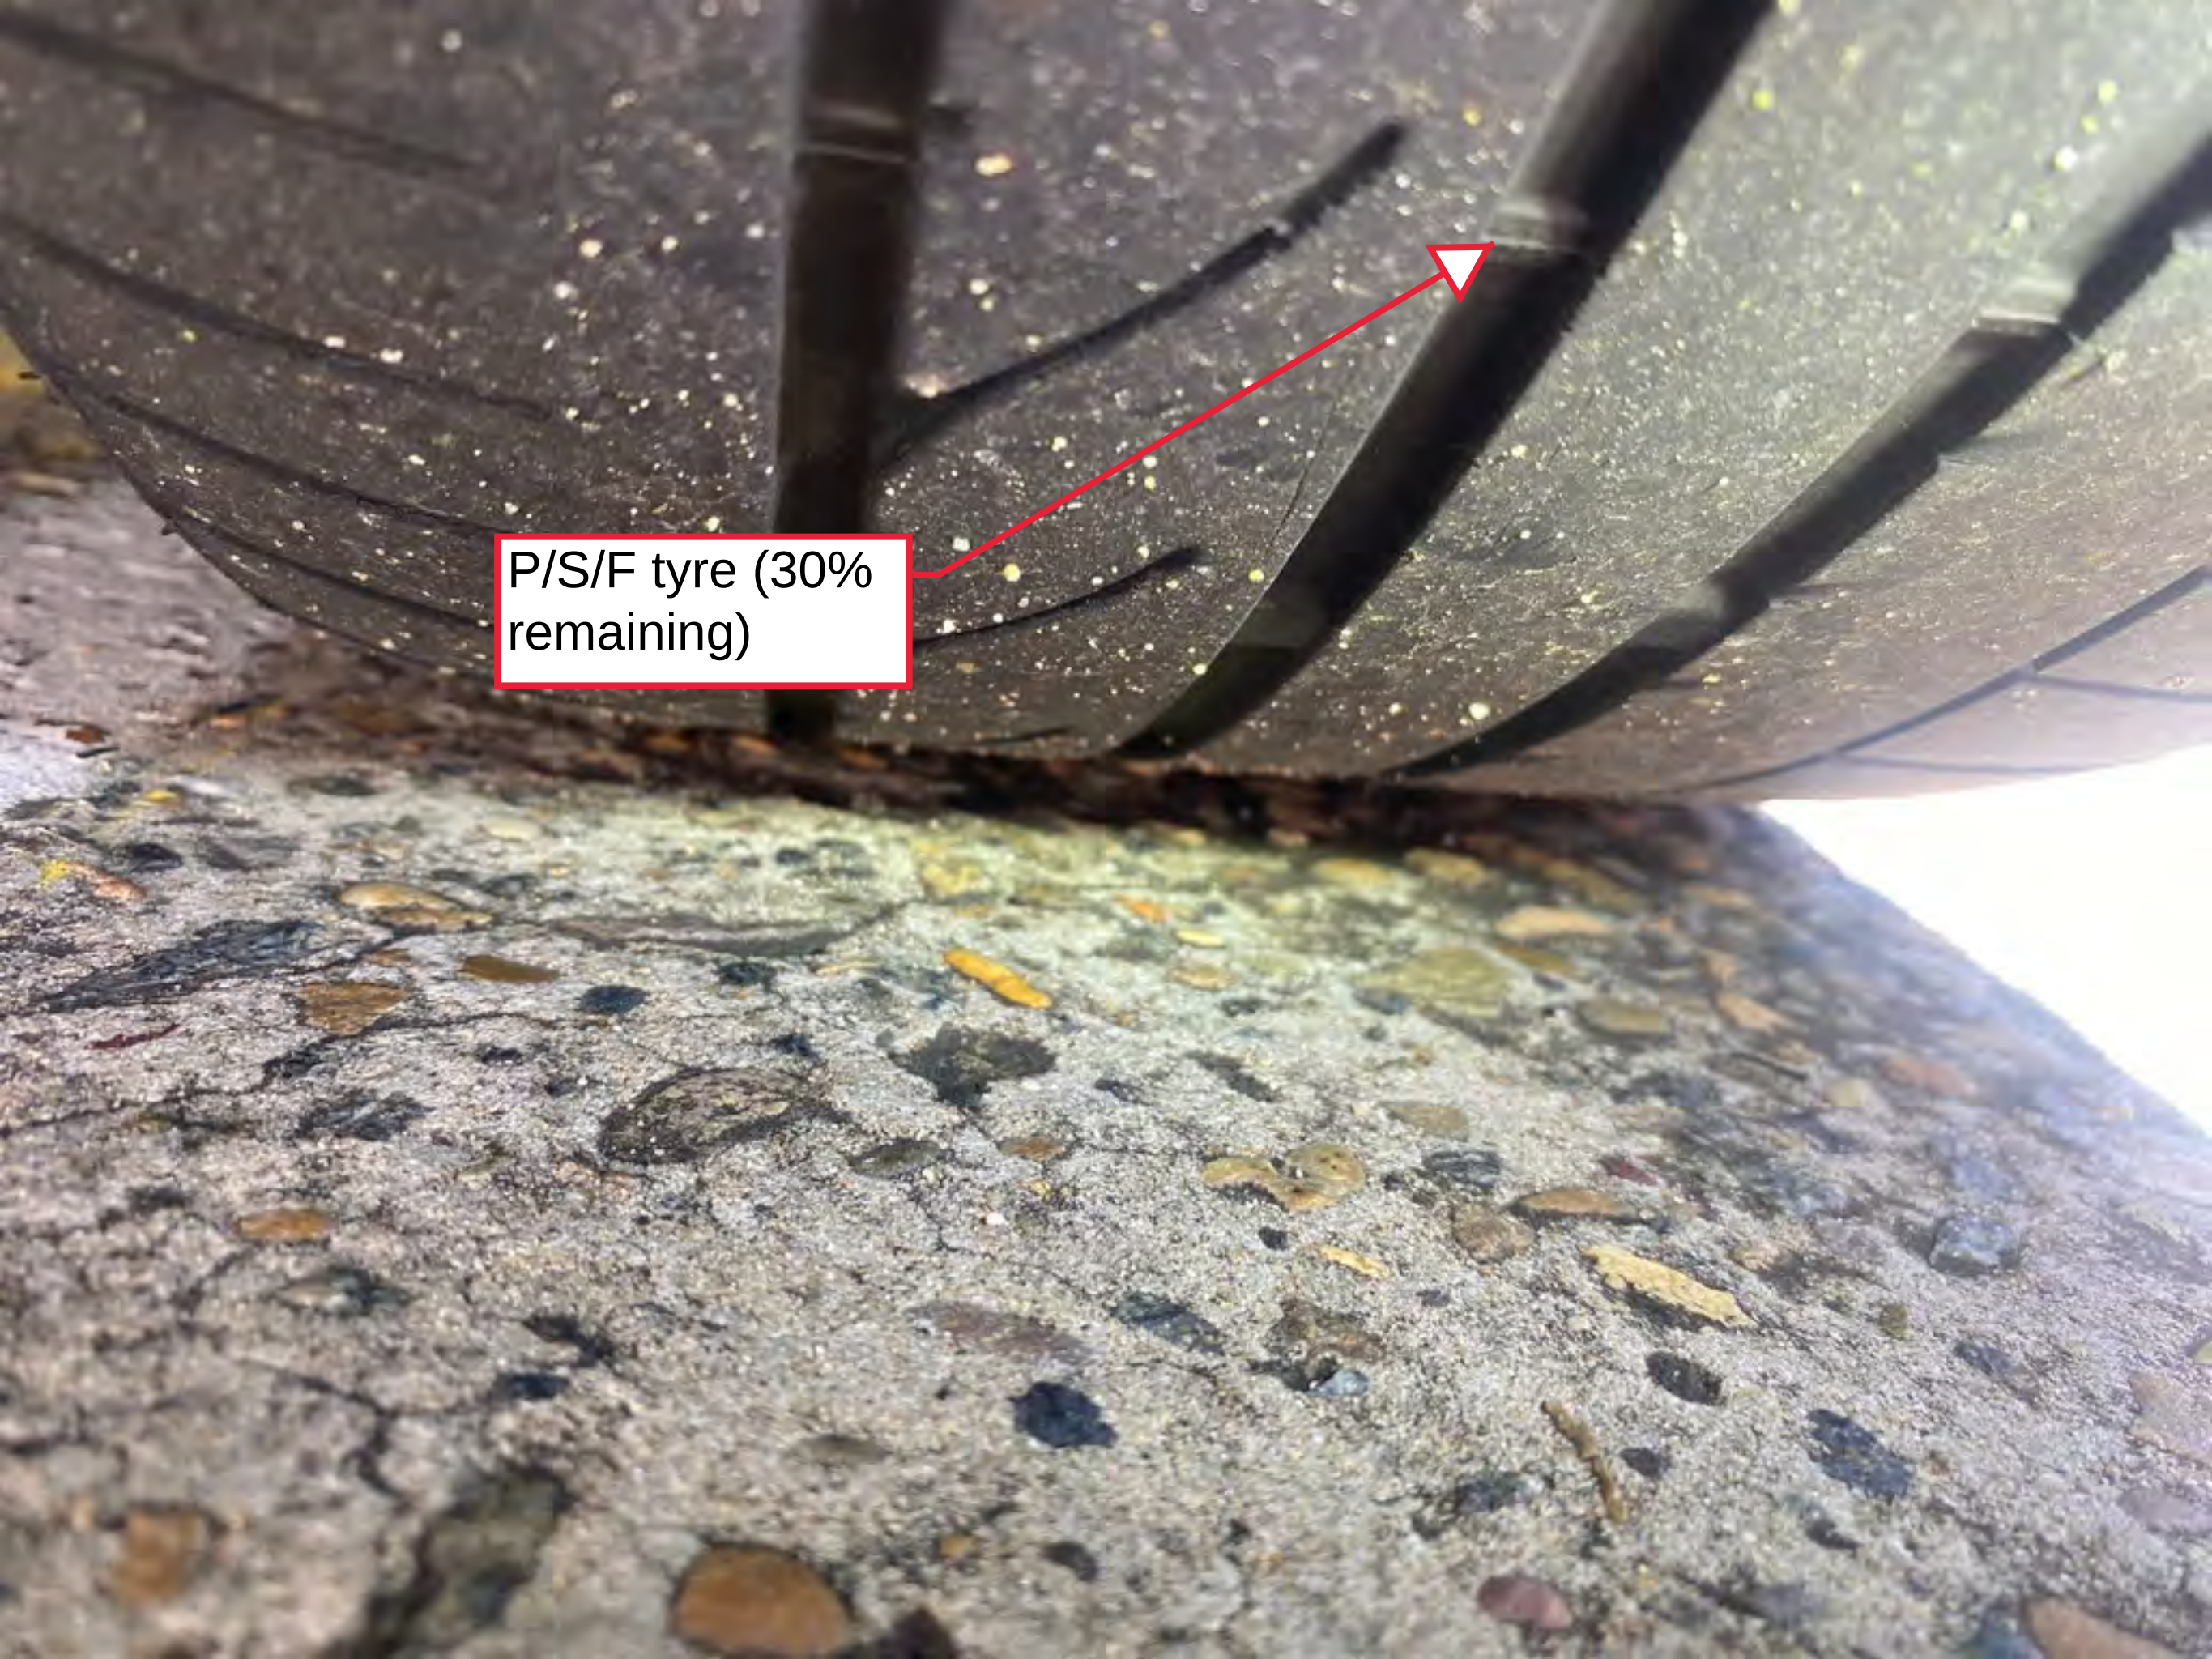
P/S/F tyre (30% remaining)

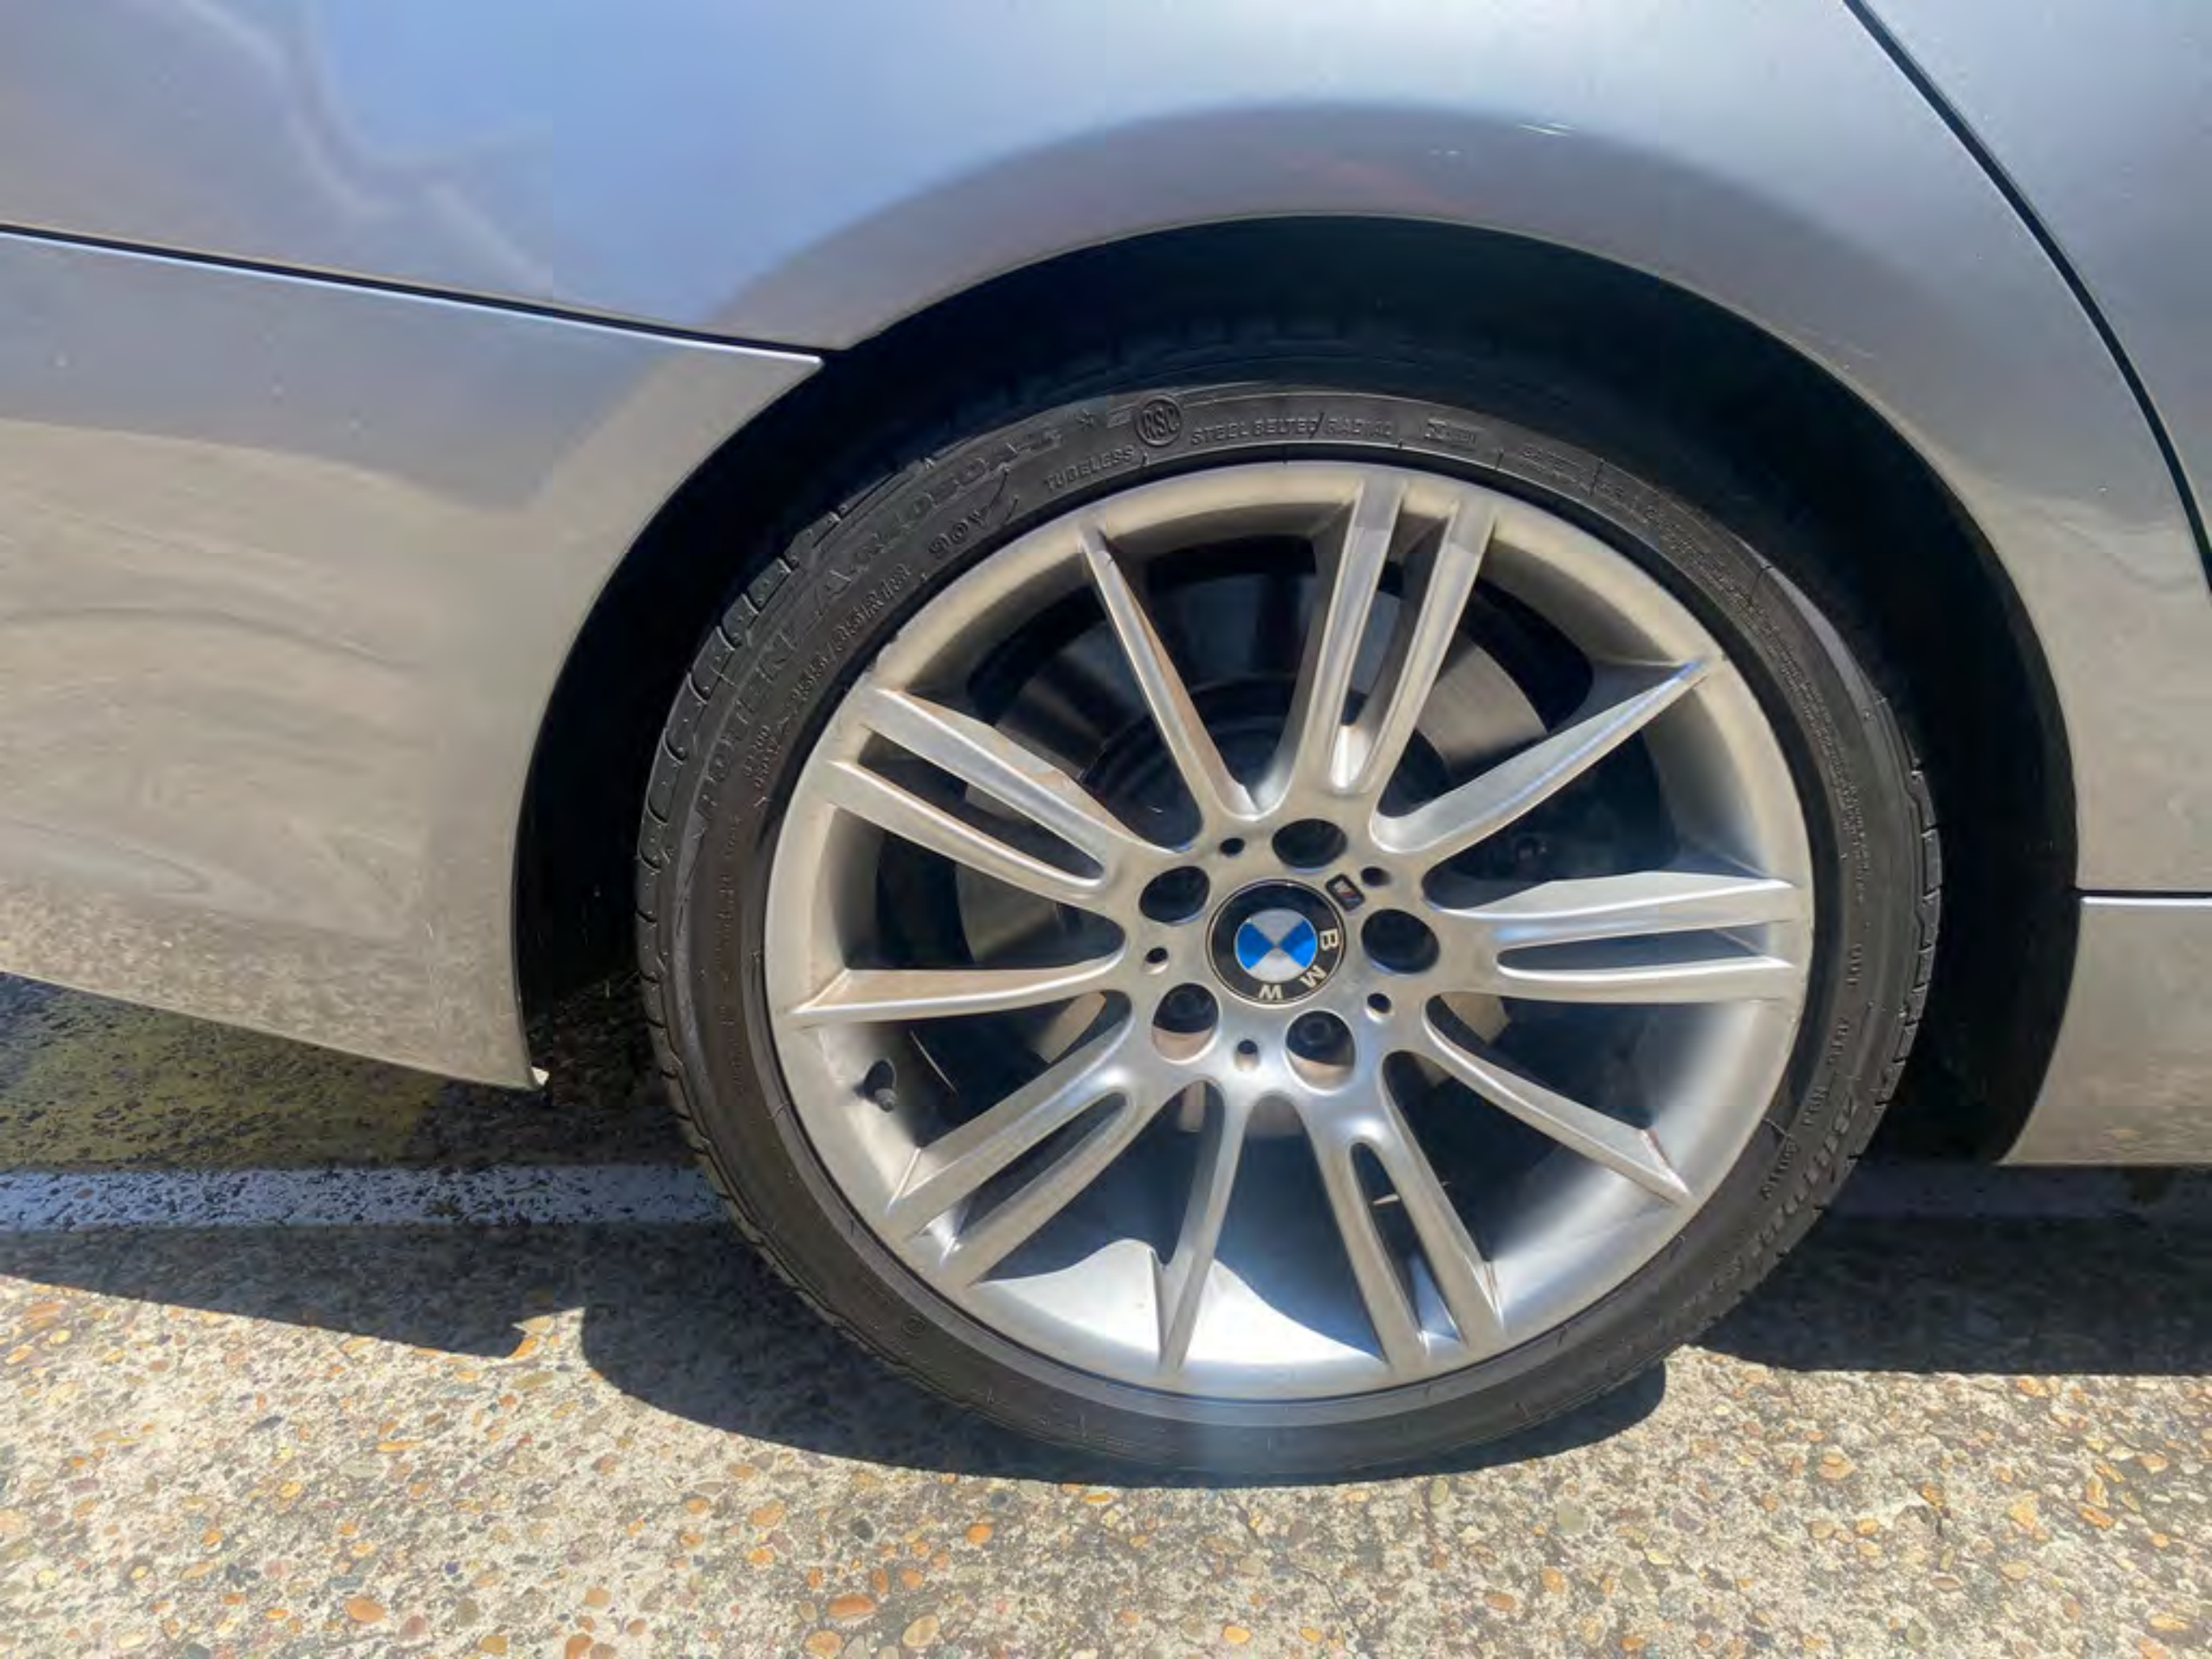
Rear tyres (0-10%  
remaining)
