Vehicle Inspection Report

Date	5/22/2018	
Buyer	George	
Phone	0402 444 888	
Seller	John	
Phone	0432 799 444	
Make	Ford	
Model	Territory	
Badge/ Series	GS	
Colour	Grey	
Comply/Build Date	Feb-09	Feb-09
Registration No	ABS 47P	
Registration Expiry	10/19/2018	
Kilometer Reading	175,517	
Vin/ Serial Number	6FPAAAJGER9U45674	
Engine Number

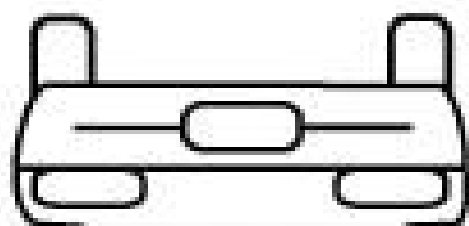
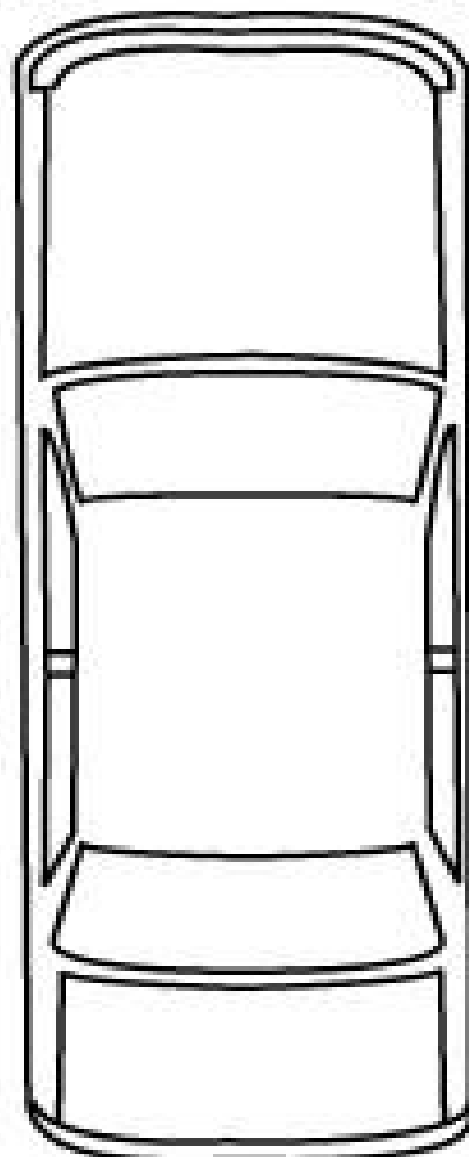
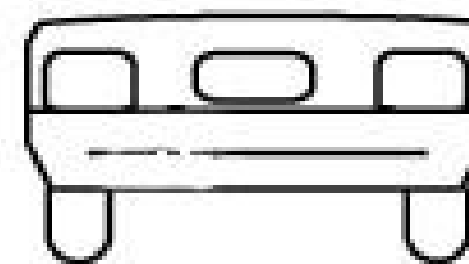
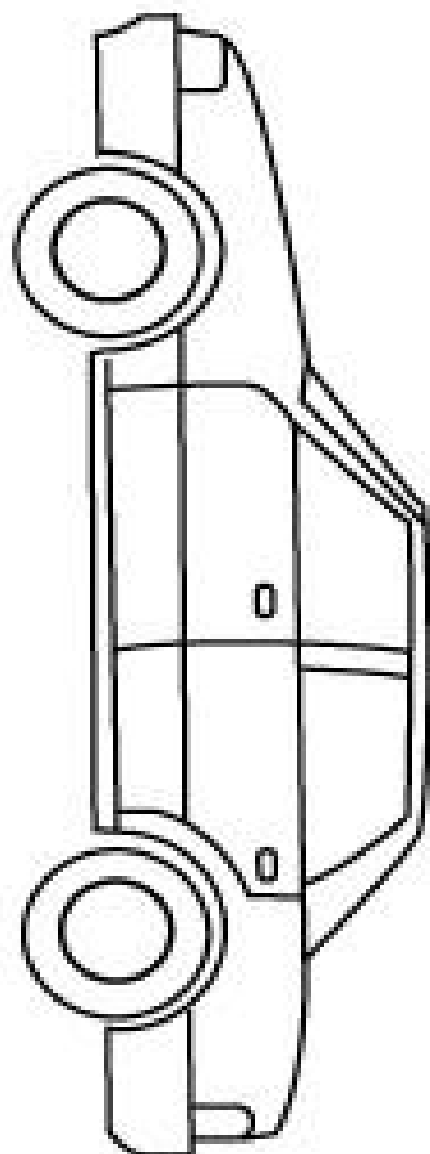
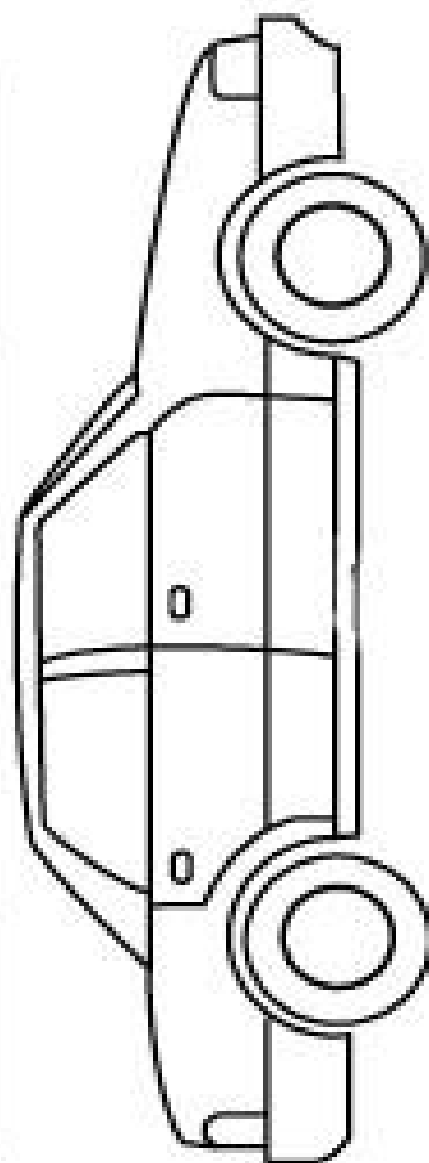
BODY PANEL & PAINTWORK DAMAGE

BODY CONDITION & PAINT THICKNESS			Ums	NO	Comments
159		D/S/F Guard	95		Previous respray
160		D/S/F Door	200		Previous respray
				☐	Ding on centre of door panel
161		D/S/R Door	190		Previous respray
				☐	Ding on front of door panel
162		D/S/R ¼ Panel	160		
163		Rear bumper bar			Light scratches & marks
164		Rear Boot/hatch	170		
165		P/S/R ¼ Panel	150		
166		P/S/R Door	180		Previous respray
167		P/S/F Door	200		Previous respray
					Small ding/marks on centre of panel
168		P/S/F Guard	250		Previous respray
169		Front bumper bar			
170		Front bonnet	180		Previous respray
171		F & R Spoilers			
172		Lower Side skirts			
173		Roof	150

P/S/F wiper arm (paint peeling)

Minor Repairs (after 12 months but monitor at each service)	
7	Rear main seal (slight leak) - degrease/ check/ replace if necessary
8	P/S/F engine block (minor leak) under thermostat housing- degrease/ check for leak/ replace
9	Minor leak under Power Steering reservoir - degrease/ check for source of leak/ replace
10	Buff marks & scratches
11	Detail interior
12	Remove dings on D/S/F & D/S/R door panels
13	Re-paint wiper arms
