Vehicle Inspection Report

Date	5/22/2018	
Buyer	George	
Phone	0402 444 888	
Seller	John	
Phone	0432 799 444	
Make	Ford	
Model	Territory	
Badge/ Series	GS	
Colour	Grey	
Comply/Build Date	Feb-09	Feb-09
Registration No	ABS 47P	
Registration Expiry	10/19/2018	
Kilometer Reading	175,517	
Vin/ Serial Number	6FPAAAJGER9U45674	
Engine Number

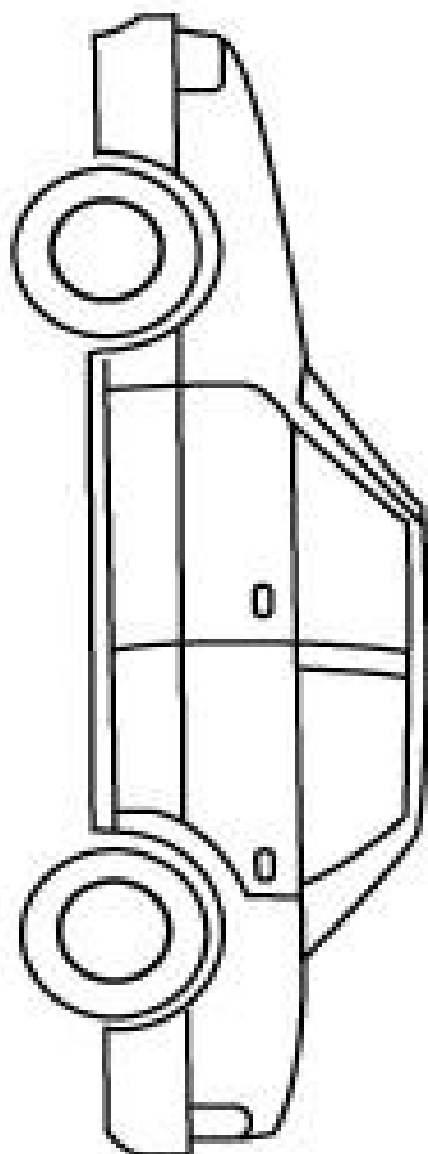
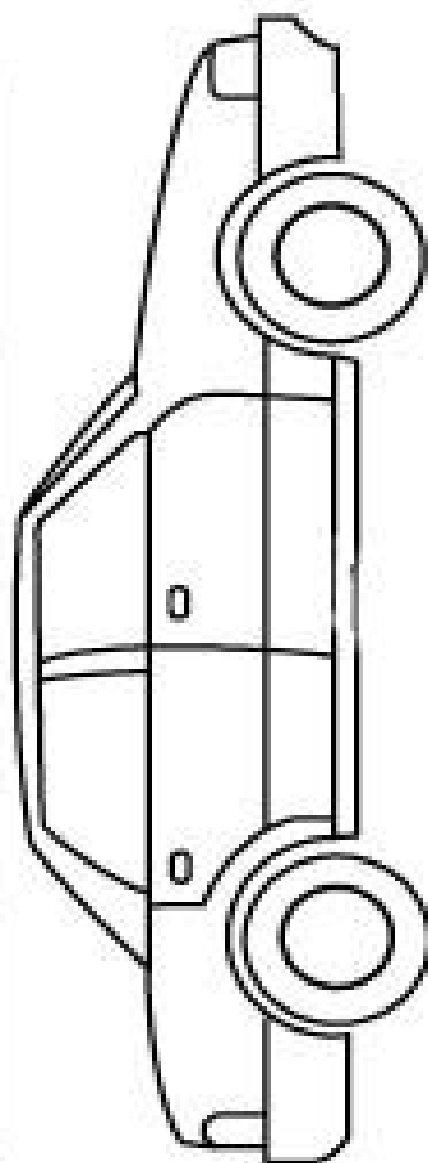
BODY PANEL & PAINTWORK DAMAGE

BODY CONDITION & PAINT THICKNESS			Ums	NO	Comments
159		D/S/F Guard	95		Previous respray
160		D/S/F Door	200		Previous respray
				☐	Ding on centre of door panel
161		D/S/R Door	190		Previous respray
				☐	Ding on front of door panel
162		D/S/R ¼ Panel	160		
163		Rear bumper bar			Light scratches & marks
164		Rear Boot/hatch	170		
165		P/S/R ¼ Panel	150		
166		P/S/R Door	180		Previous respray
167		P/S/F Door	200		Previous respray
					Small ding/marks on centre of panel
168		P/S/F Guard	250		Previous respray
169		Front bumper bar			
170		Front bonnet	180		Previous respray
171		F & R Spoilers			
172		Lower Side skirts			
173		Roof	150

P/S/F wiper arm (paint peeling)

Minor Repairs (after 12 months but monitor at each service)	
7	Rear main seal (slight leak) - degrease/ check/ replace if necessary
8	P/S/F engine block (minor leak) under thermostat housing- degrease/ check for leak/ replace
9	Minor leak under Power Steering reservoir - degrease/ check for source of leak/ replace
10	Buff marks & scratches
11	Detail interior
12	Remove dings on D/S/F & D/S/R door panels
13	Re-paint wiper arms
