# Vehicle Inspection Report

Date	5/22/2018	
Buyer	George	
Phone	0402 444 888	
Seller	John	
Phone	0432 799 444	
Make	Ford	
Model	Territory	
Badge/ Series	GS	
Colour	Grey	
Comply/Build Date	Feb-09	Feb-09
Registration No	ABS 47P	
Registration Expiry	10/19/2018	
Kilometer Reading	175,517	
Vin/ Serial Number	6FPAAAJGER9U45674	
Engine Number

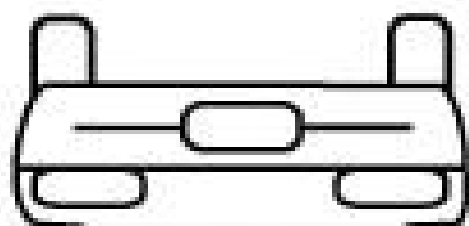
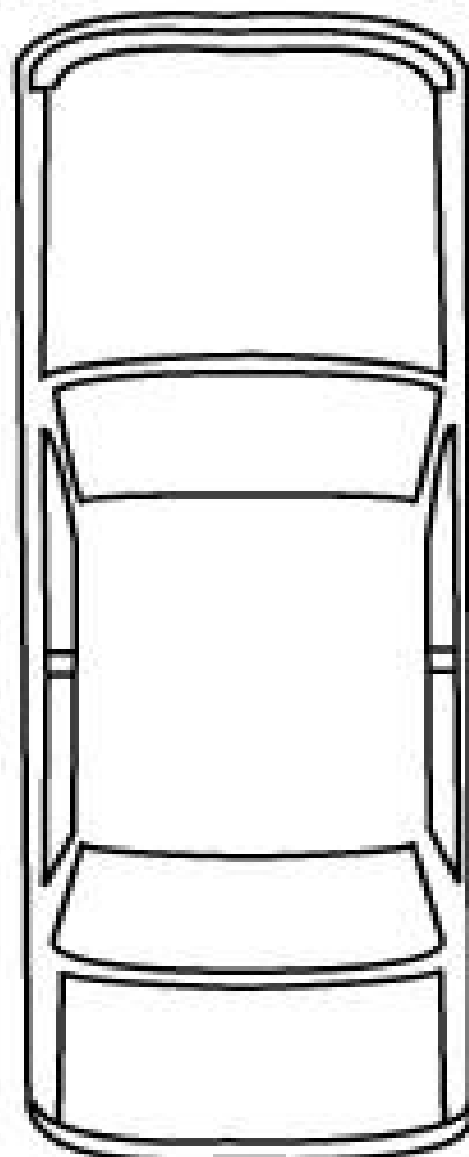
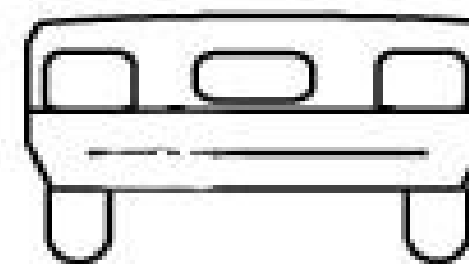
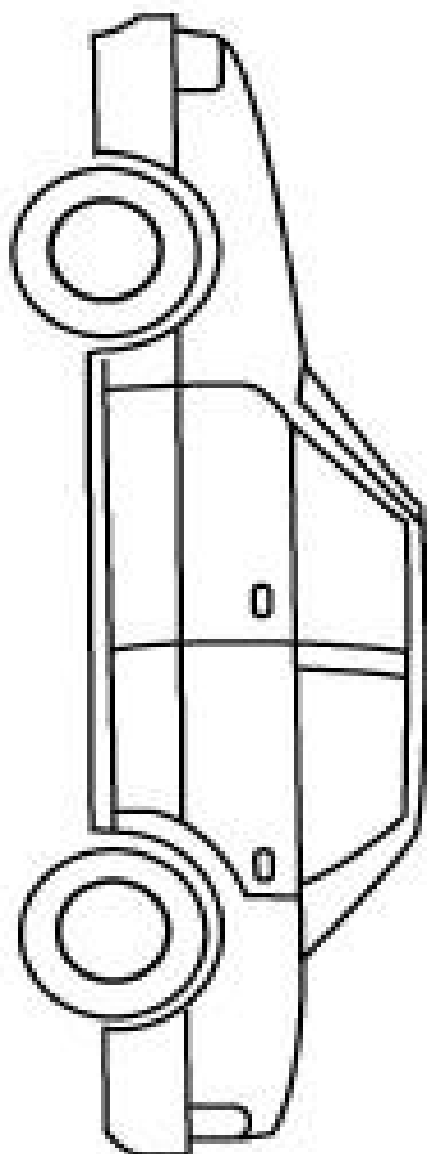
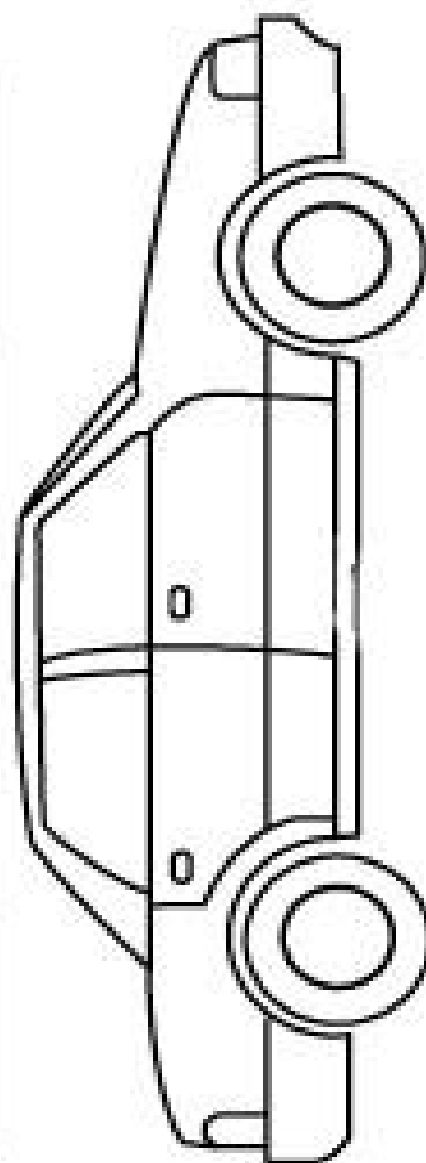
**BODY PANEL & PAINTWORK DAMAGE**

BODY CONDITION & PAINT THICKNESS			Ums	NO	Comments
159		D/S/F Guard	95		Previous respray
160		D/S/F Door	200		Previous respray
				☐	Ding on centre of door panel
161		D/S/R Door	190		Previous respray
				☐	Ding on front of door panel
162		D/S/R ¼ Panel	160		
163		Rear bumper bar			Light scratches & marks
164		Rear Boot/hatch	170		
165		P/S/R ¼ Panel	150		
166		P/S/R Door	180		Previous respray
167		P/S/F Door	200		Previous respray
					Small ding/marks on centre of panel
168		P/S/F Guard	250		Previous respray
169		Front bumper bar			
170		Front bonnet	180		Previous respray
171		F & R Spoilers			
172		Lower Side skirts			
173		Roof	150

P/S/F wiper arm (paint peeling)
