BMW A.G.

3 Series - E90

# Engine & Servicing

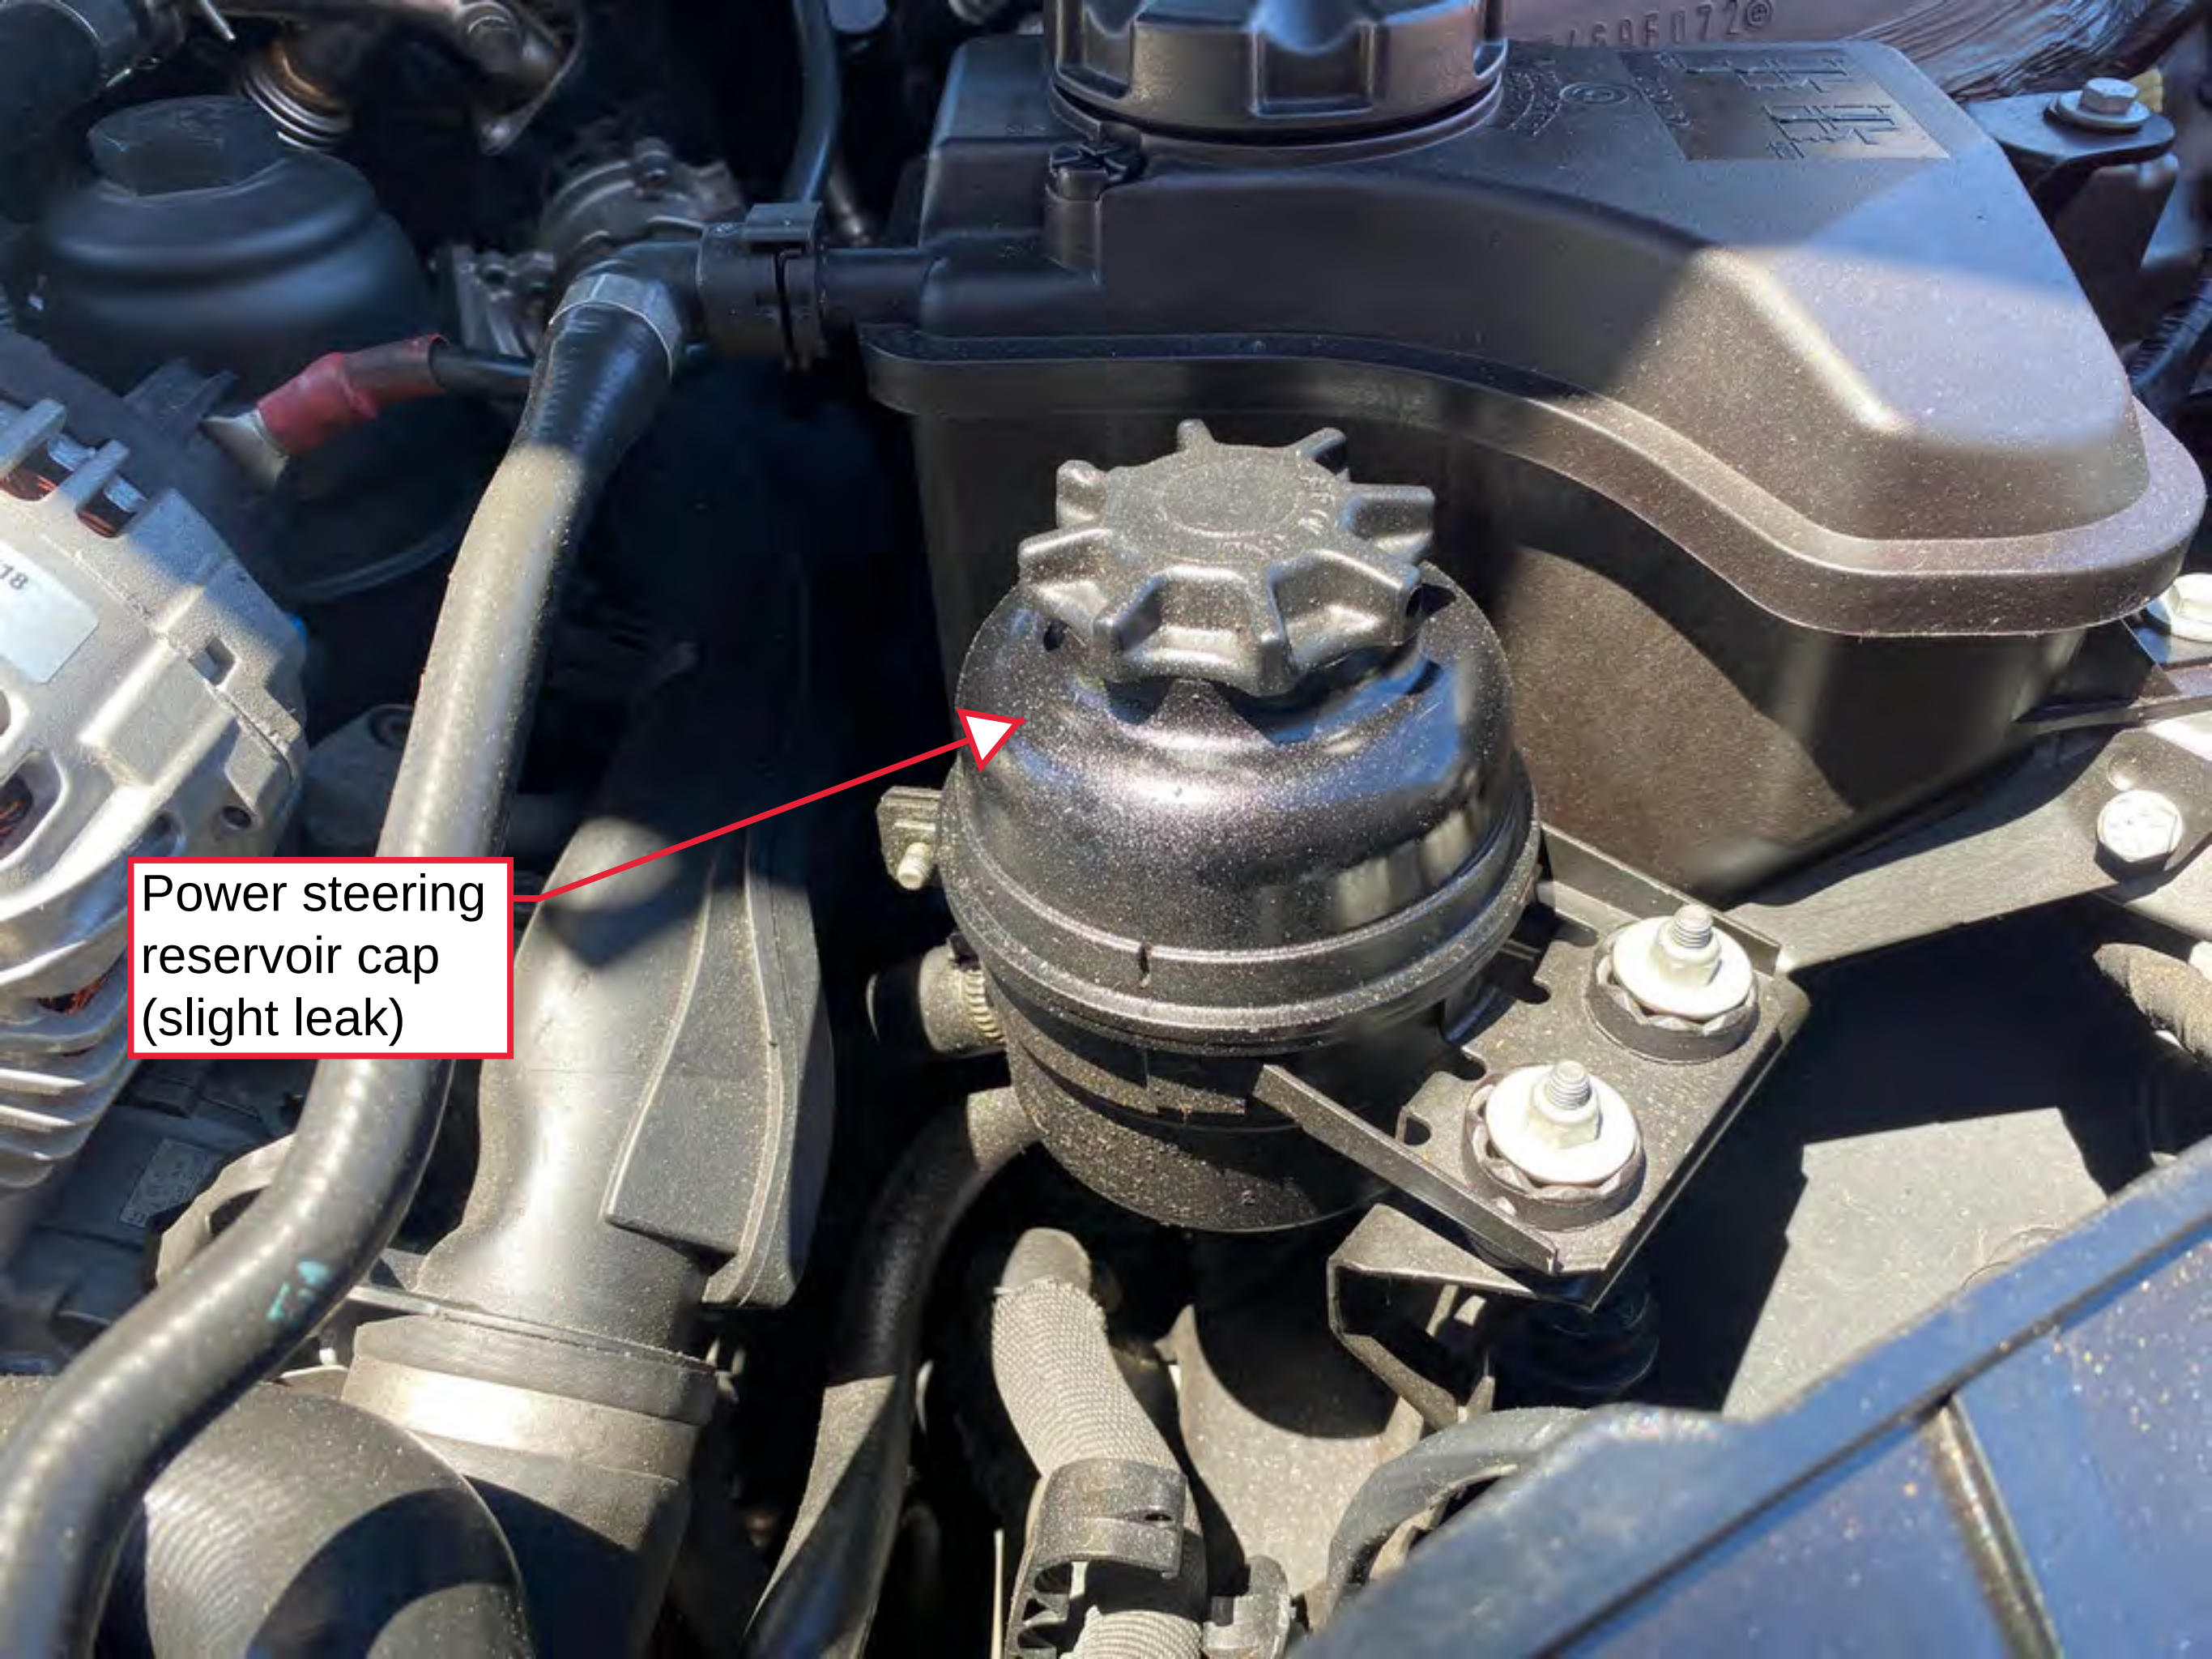
Power steering  
reservoir cap  
(slight leak)

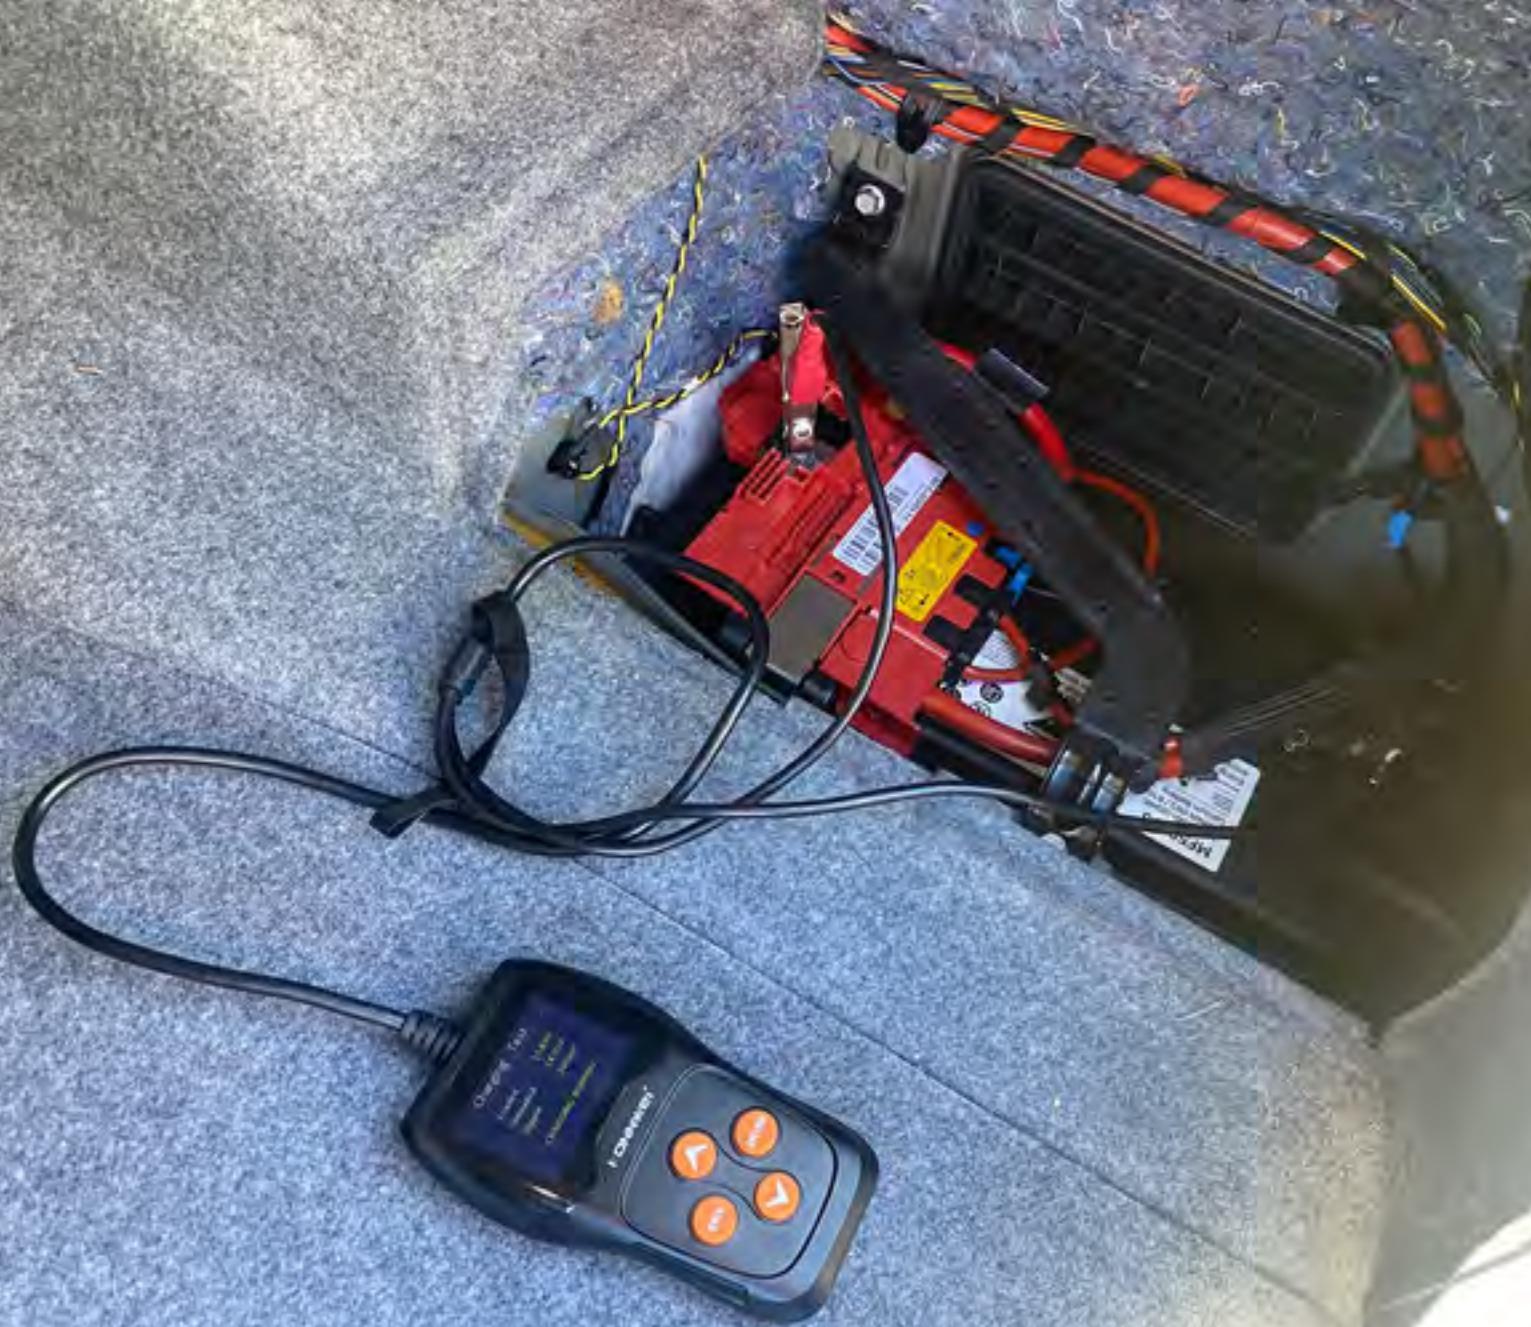
SOH **67%**

GOOD-RECHARGE

CCA: **546A** ←

STD: **810A**

VOL: **12.10V**

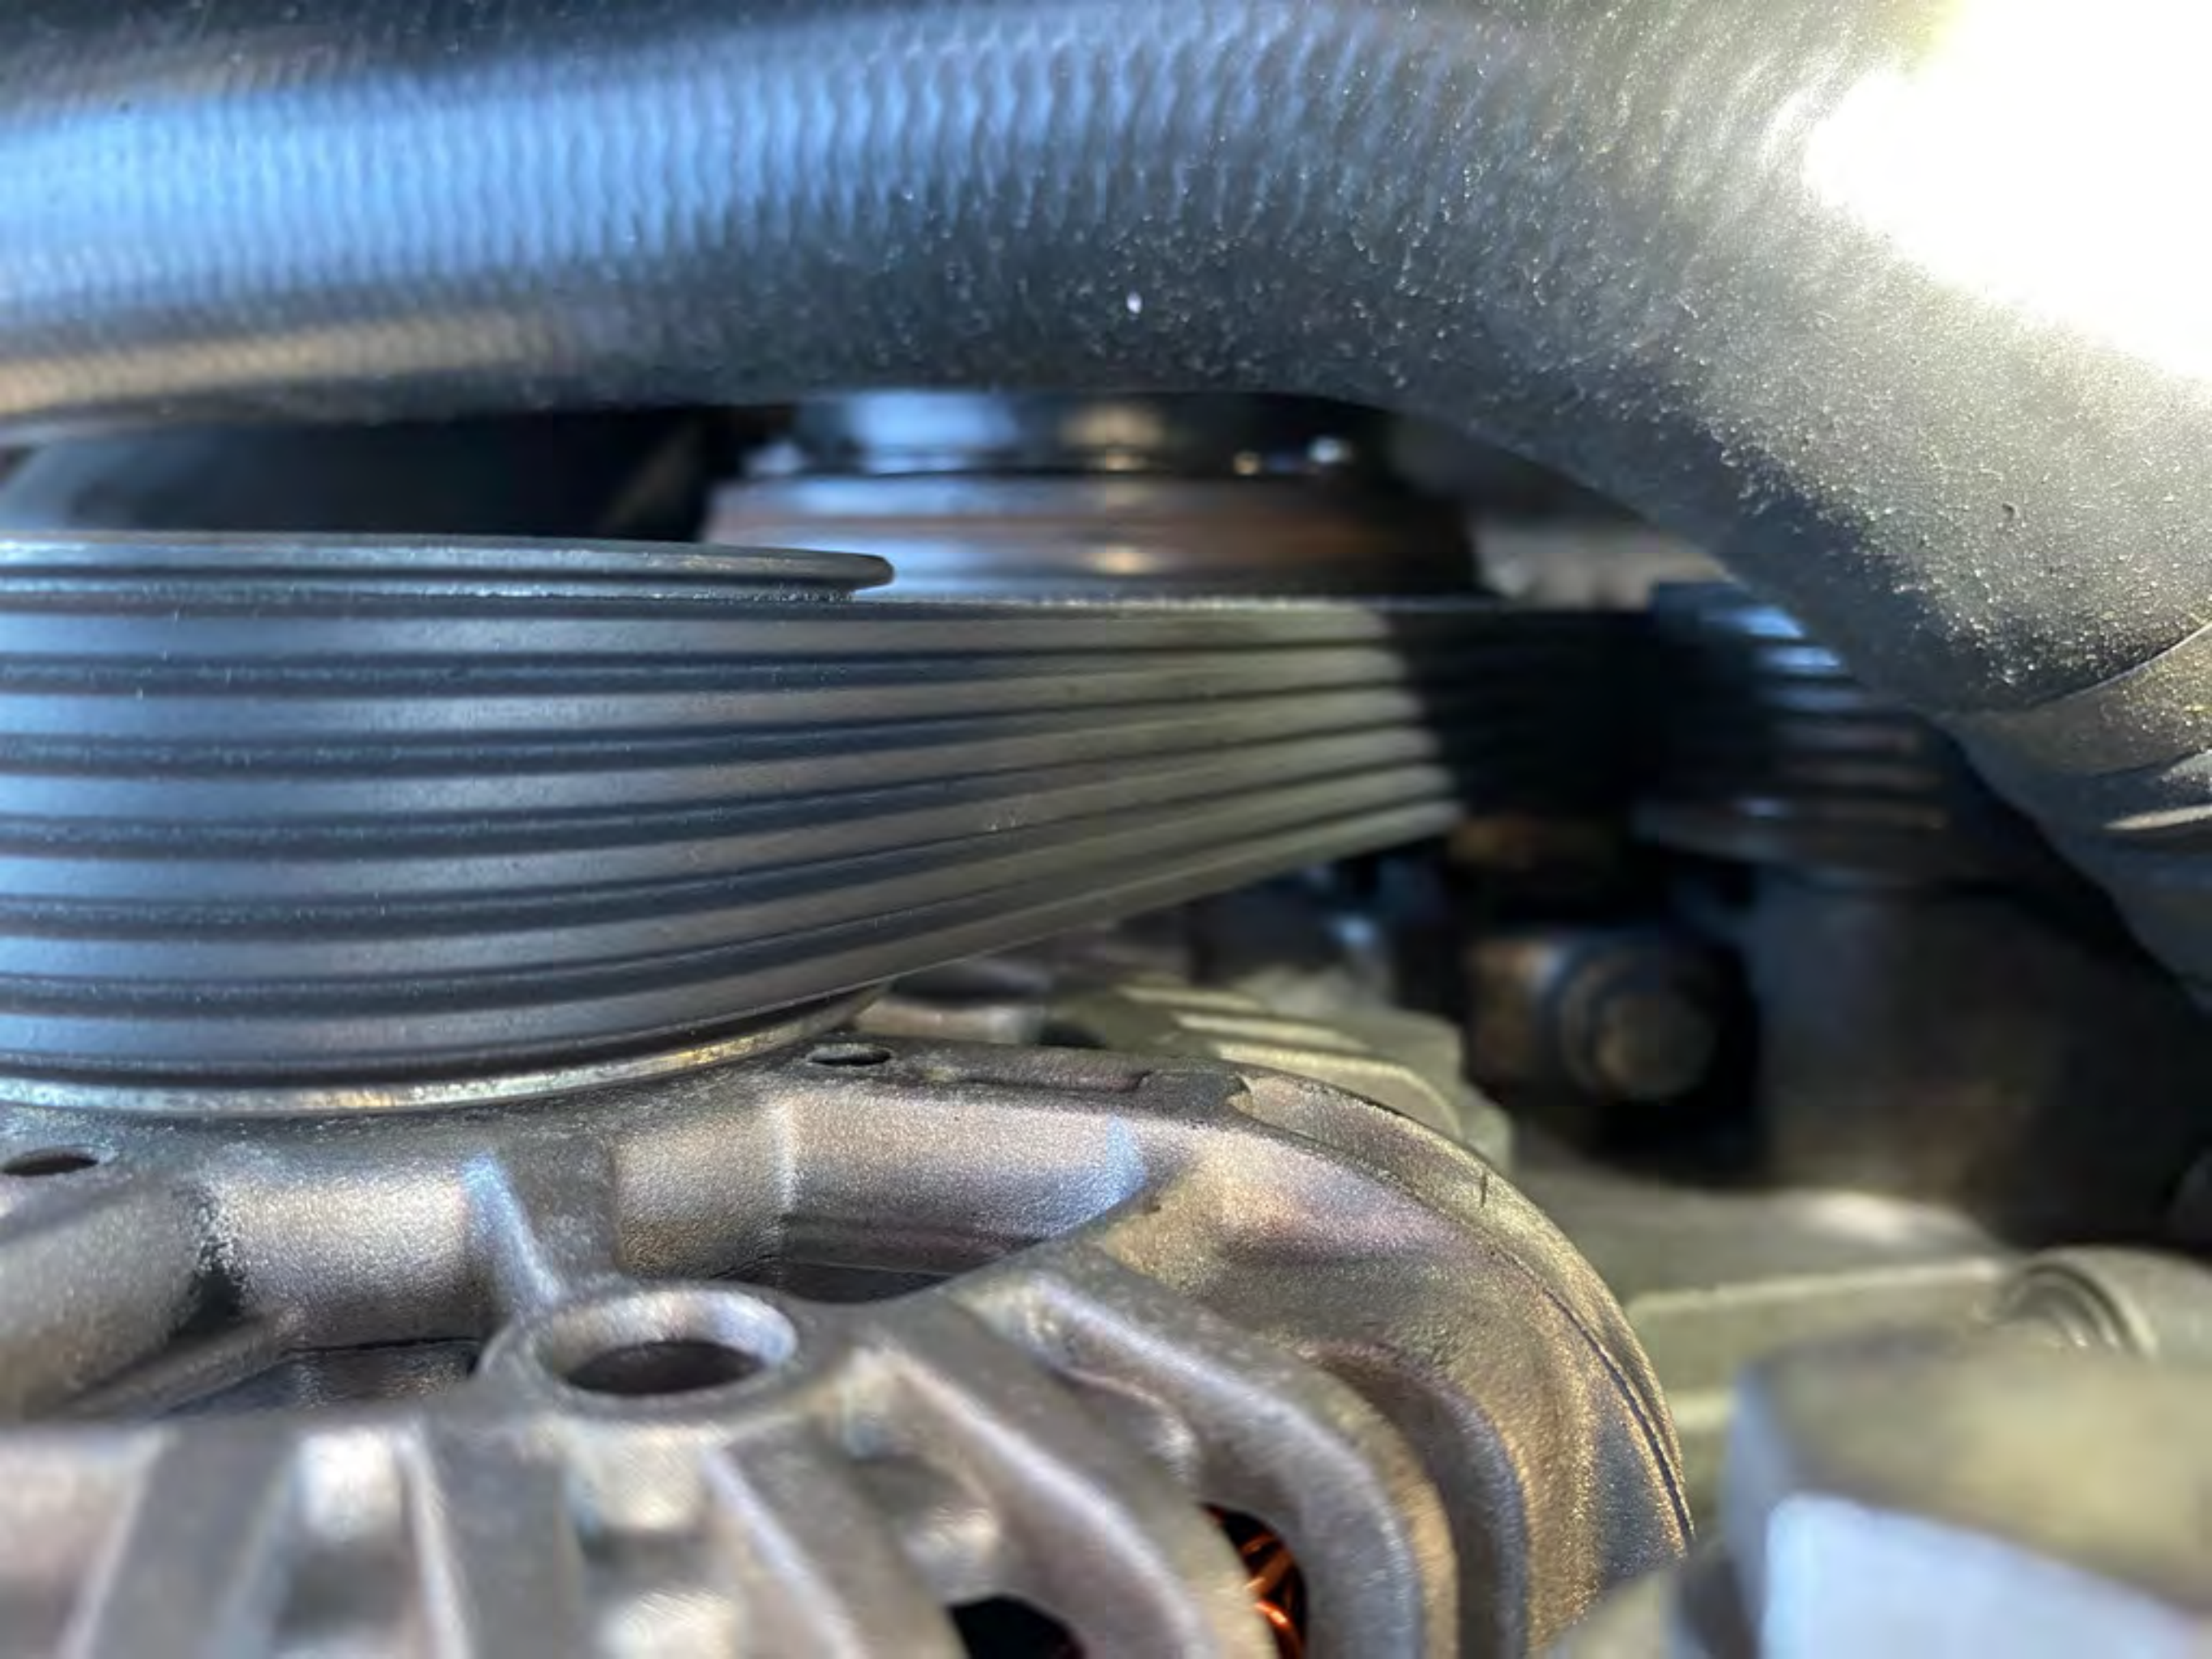
Slight leak on  
front lower turbo  
hose

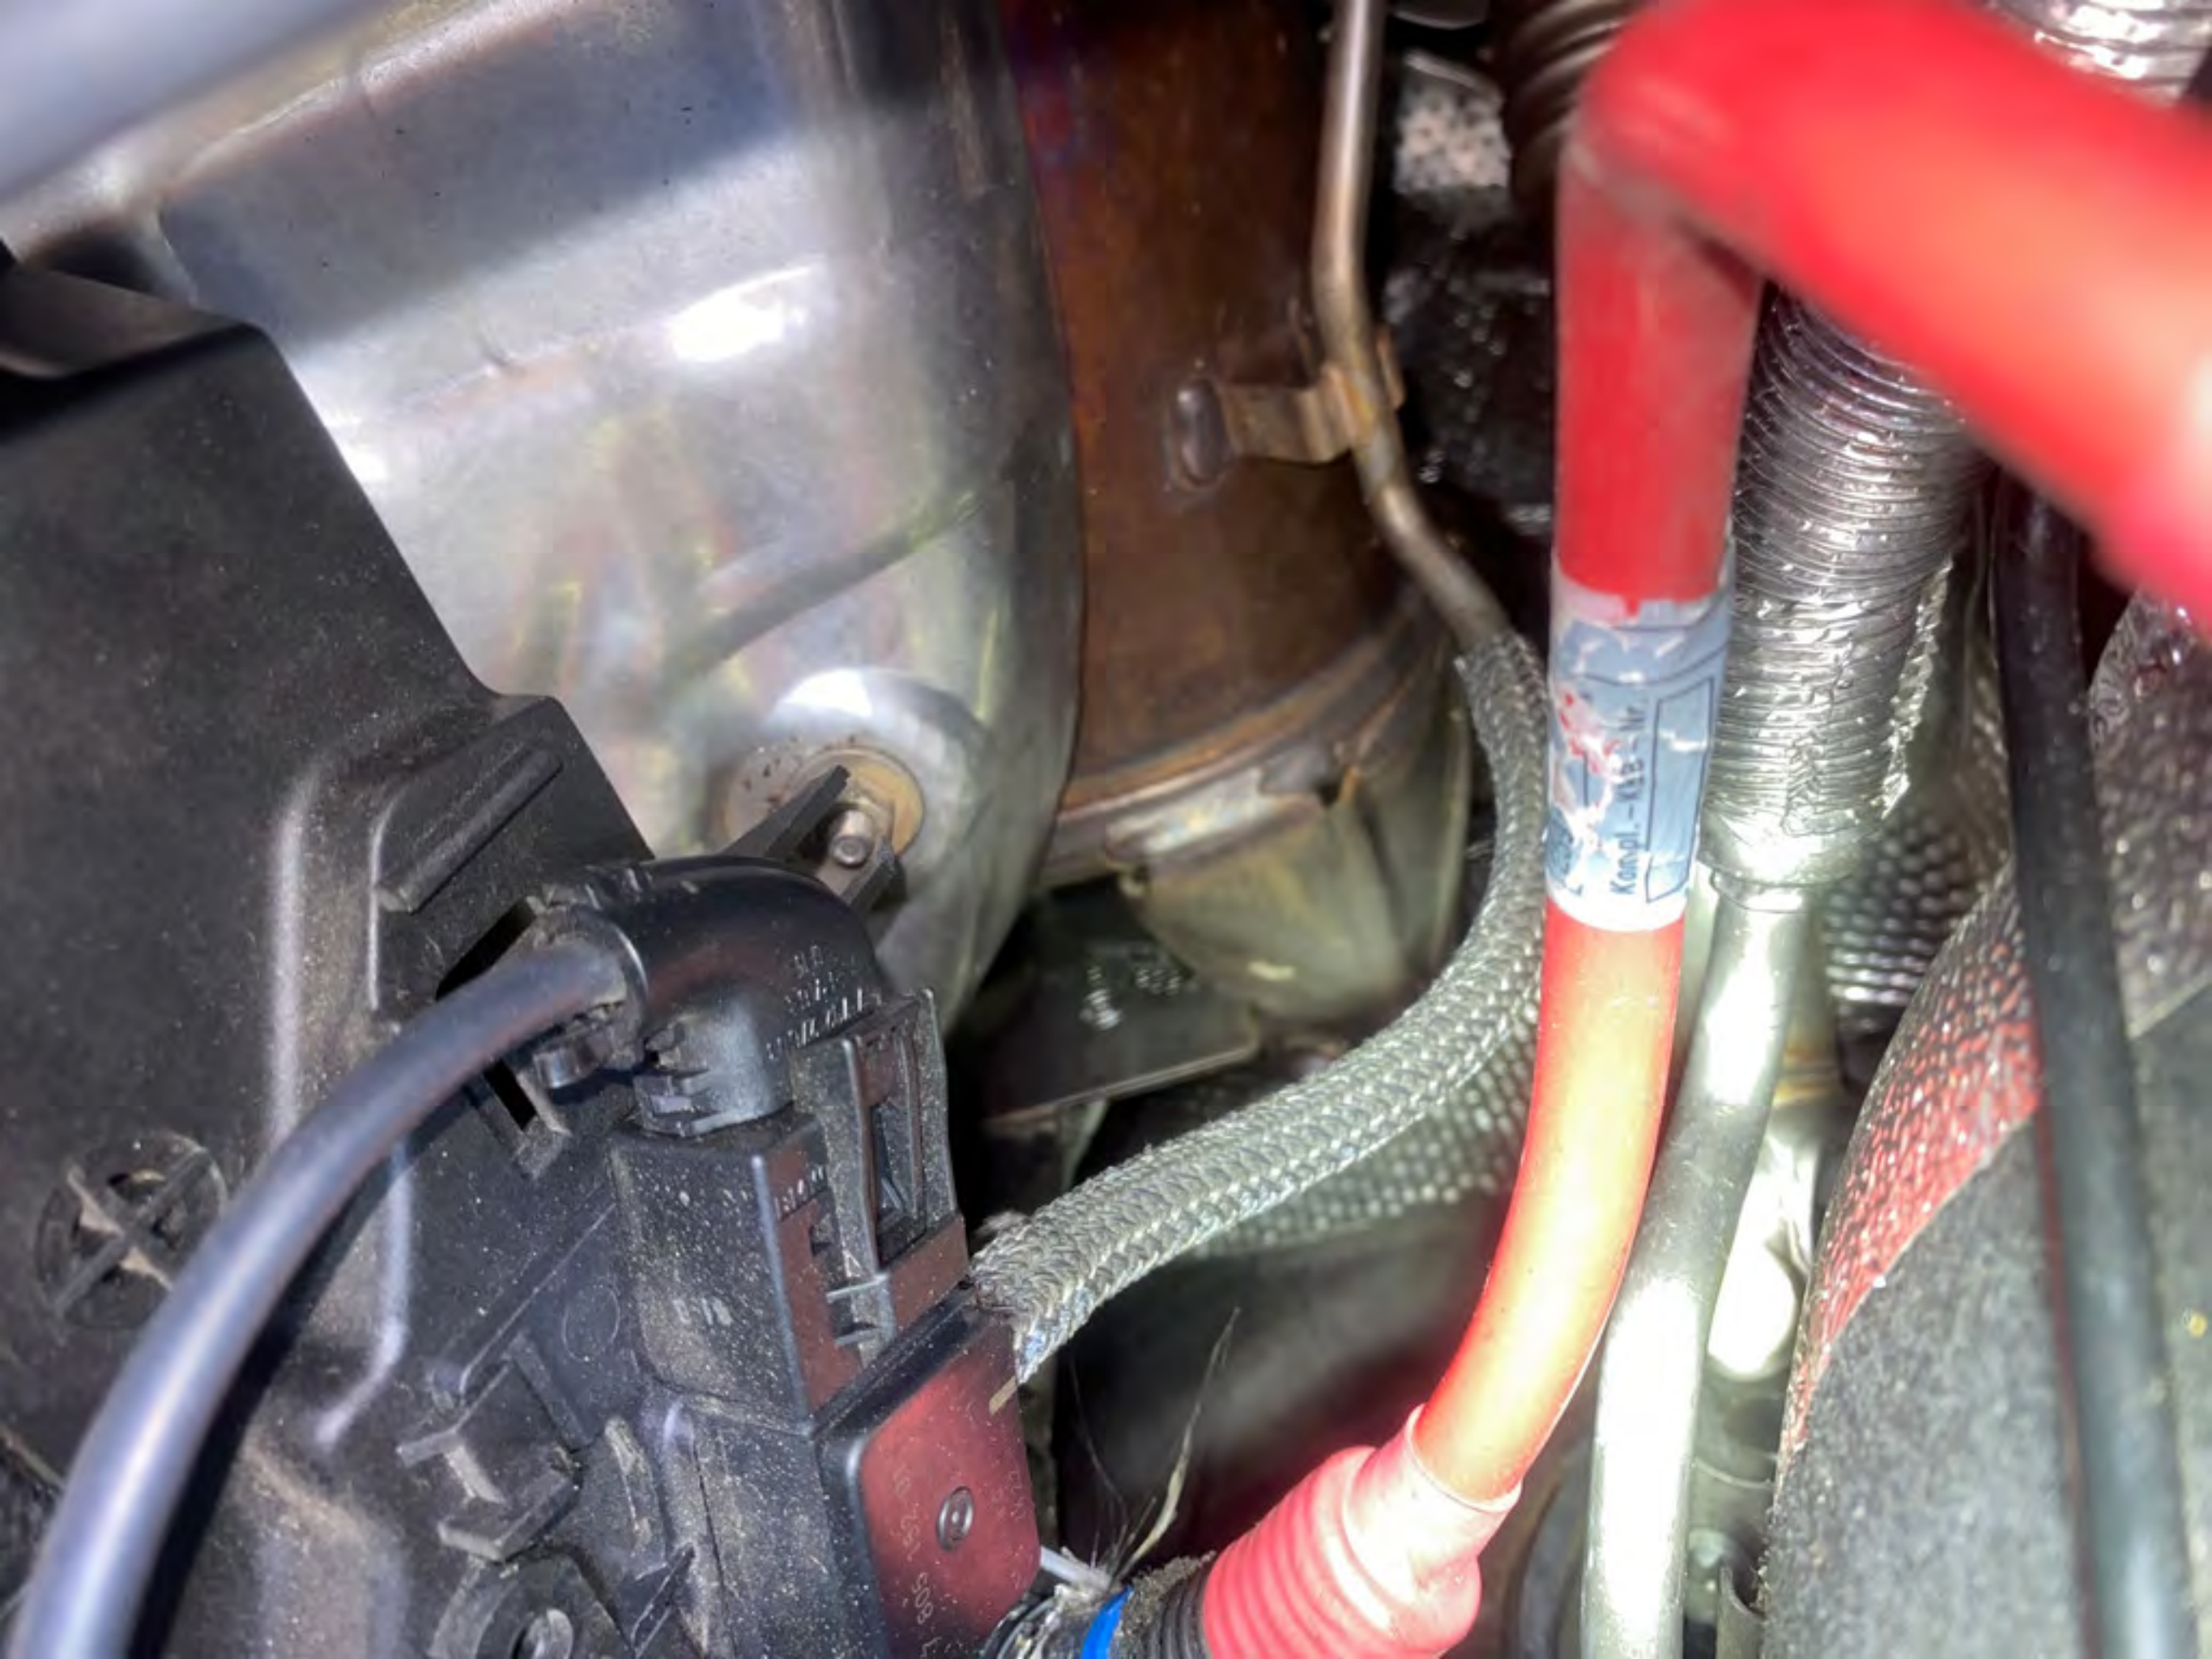
Oil leak on rear of  
rocker cover

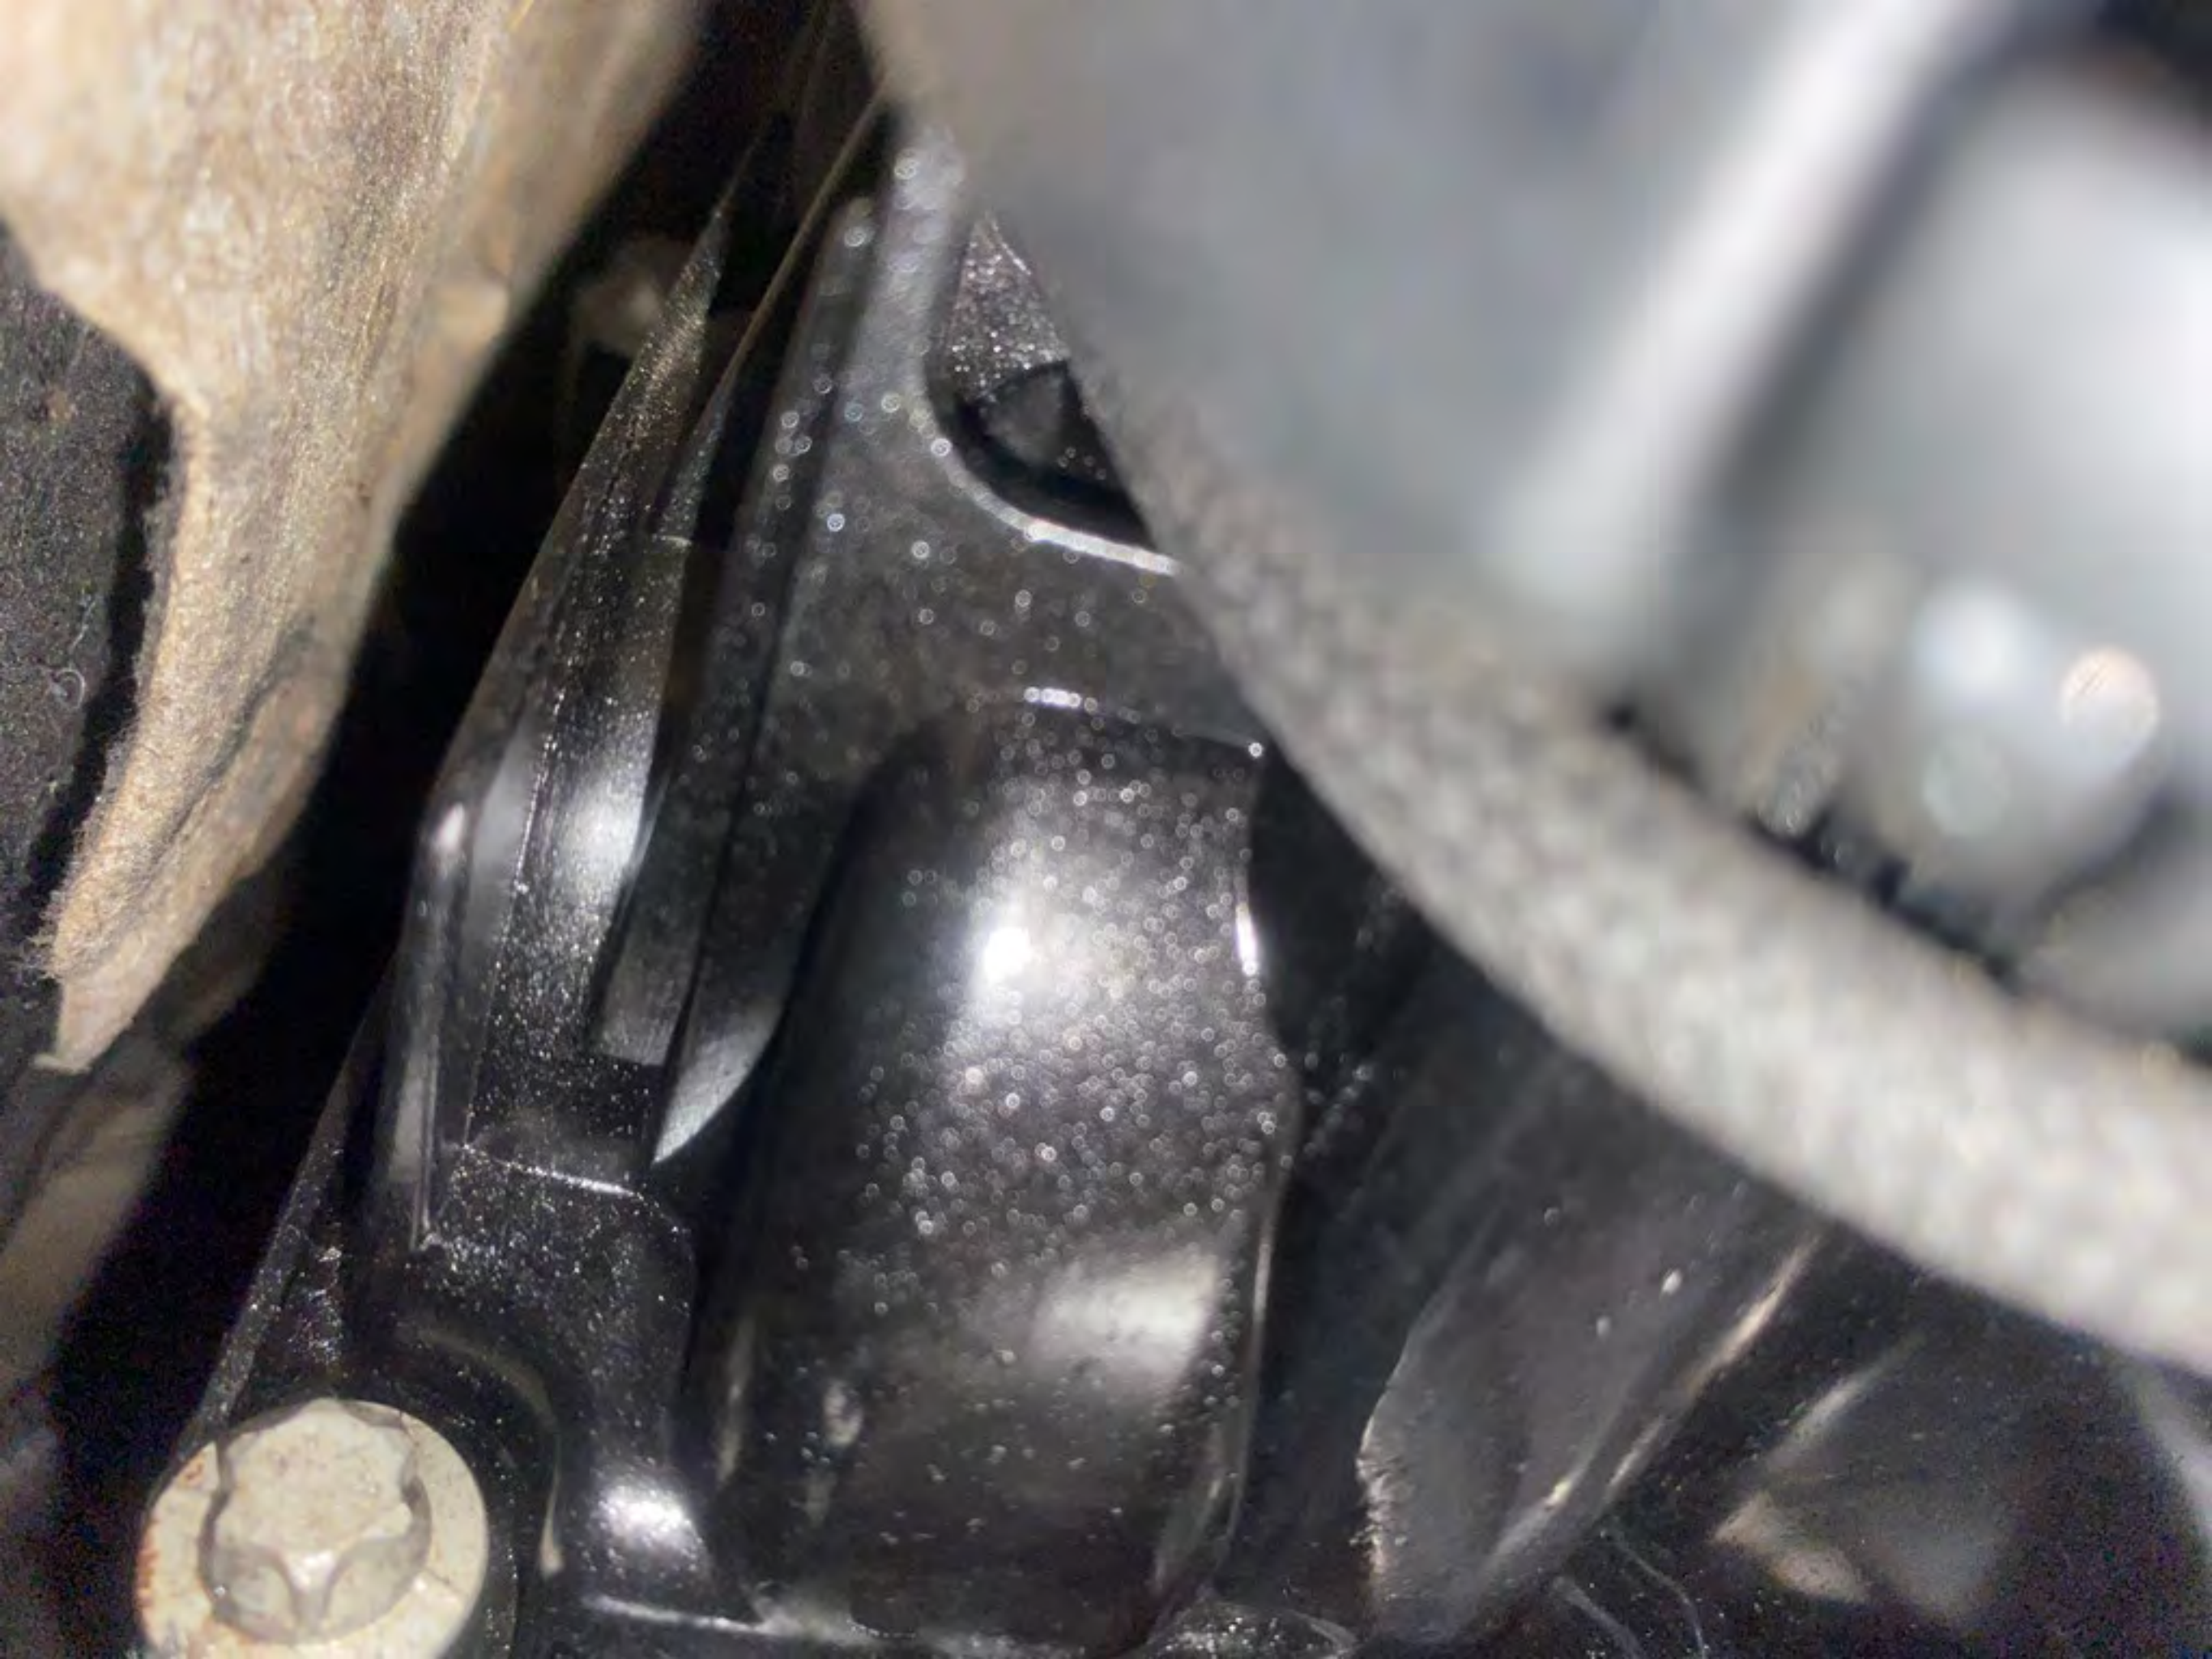
Oily here
