BMW A.G.

3 Series - E90

# Engine & Servicing

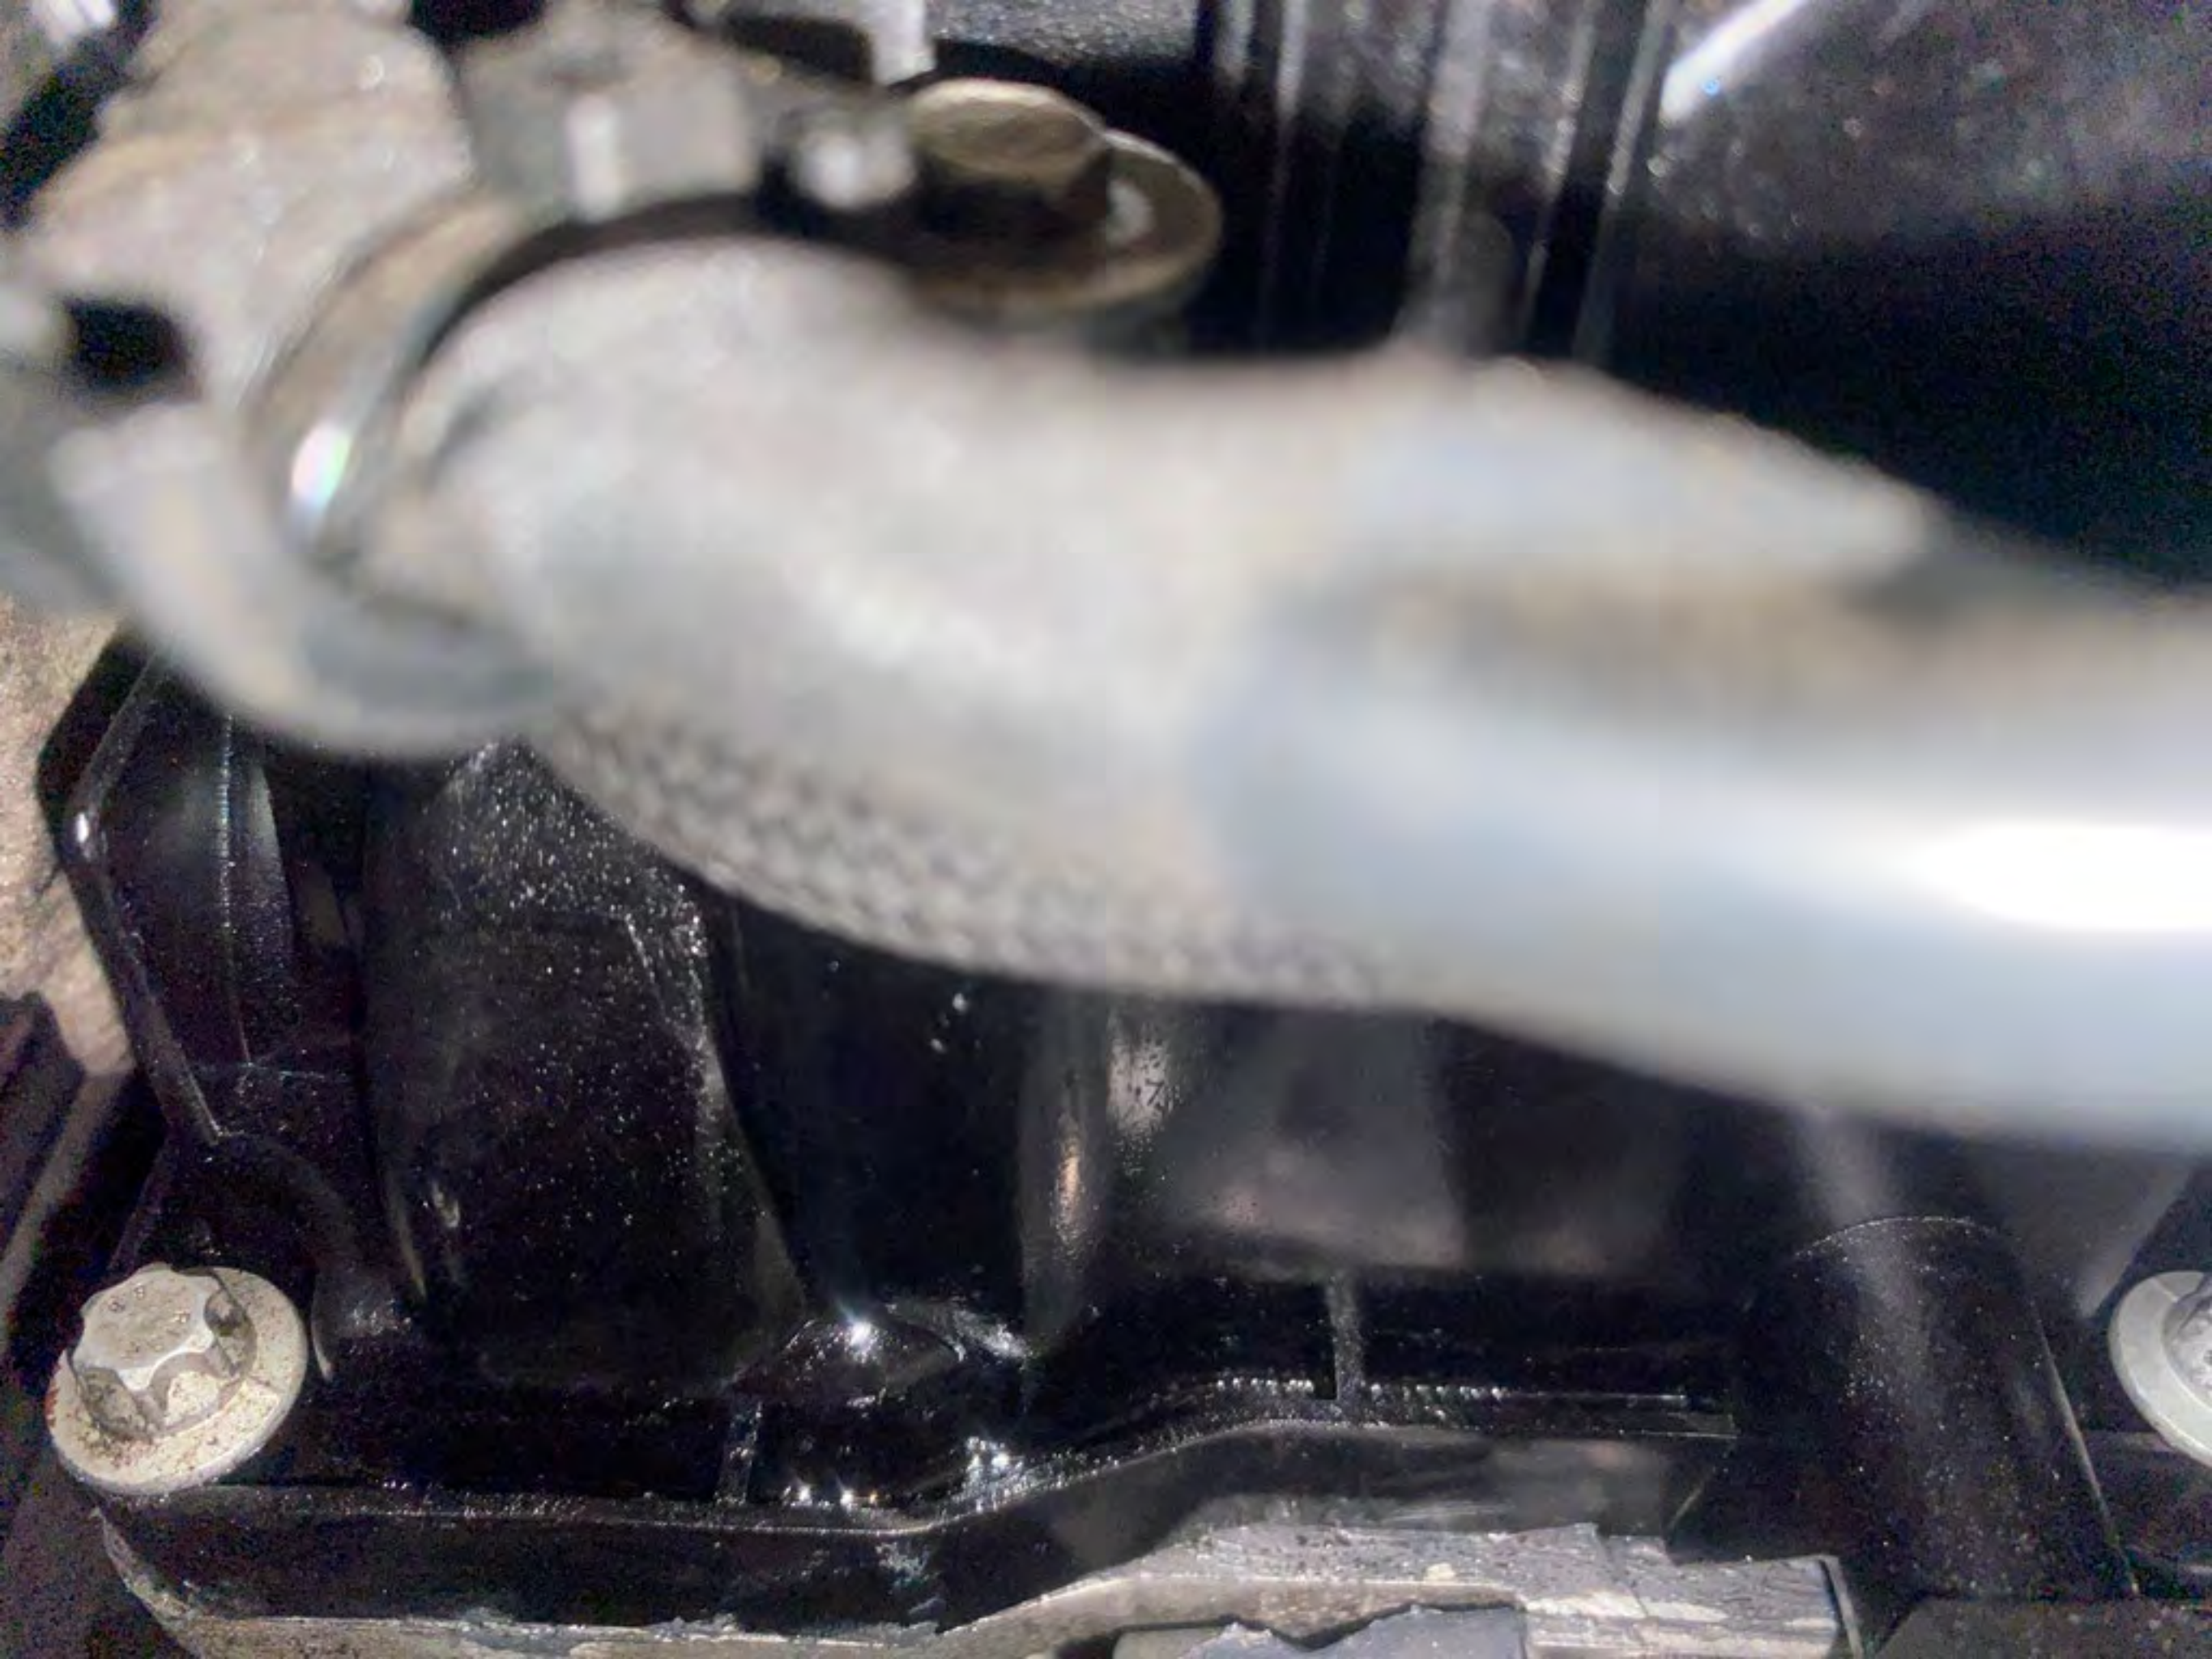
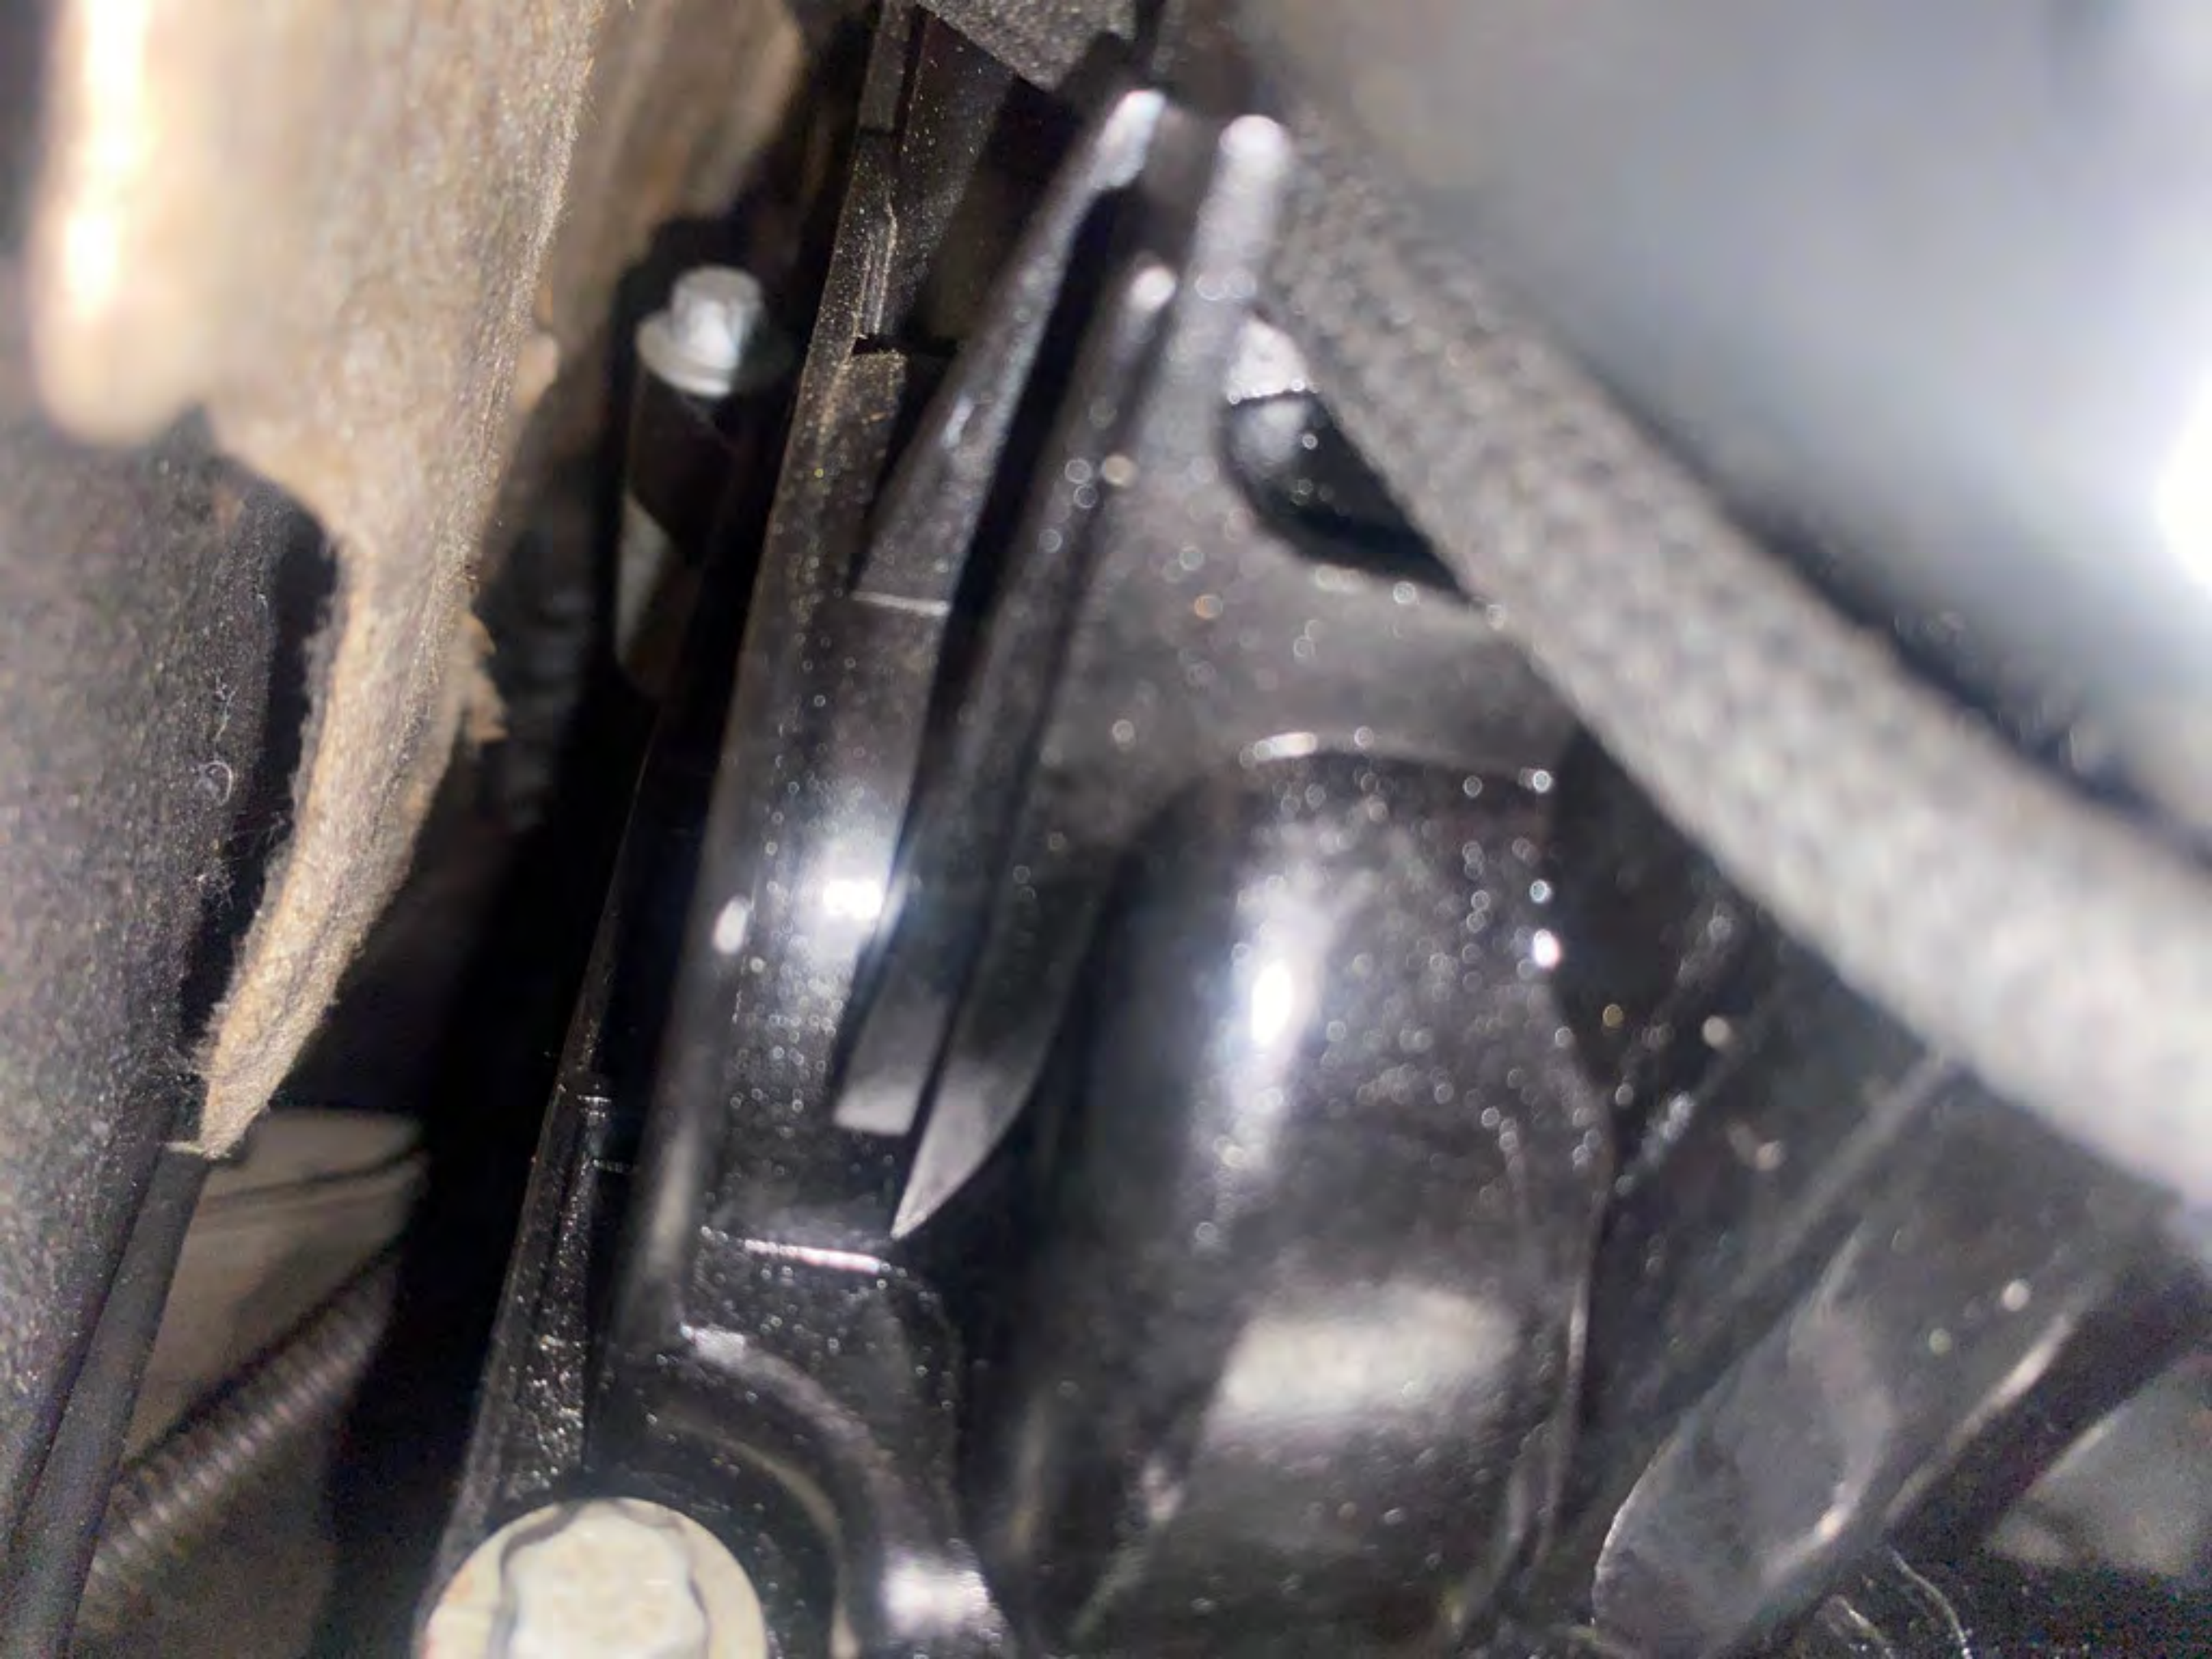
Oily here

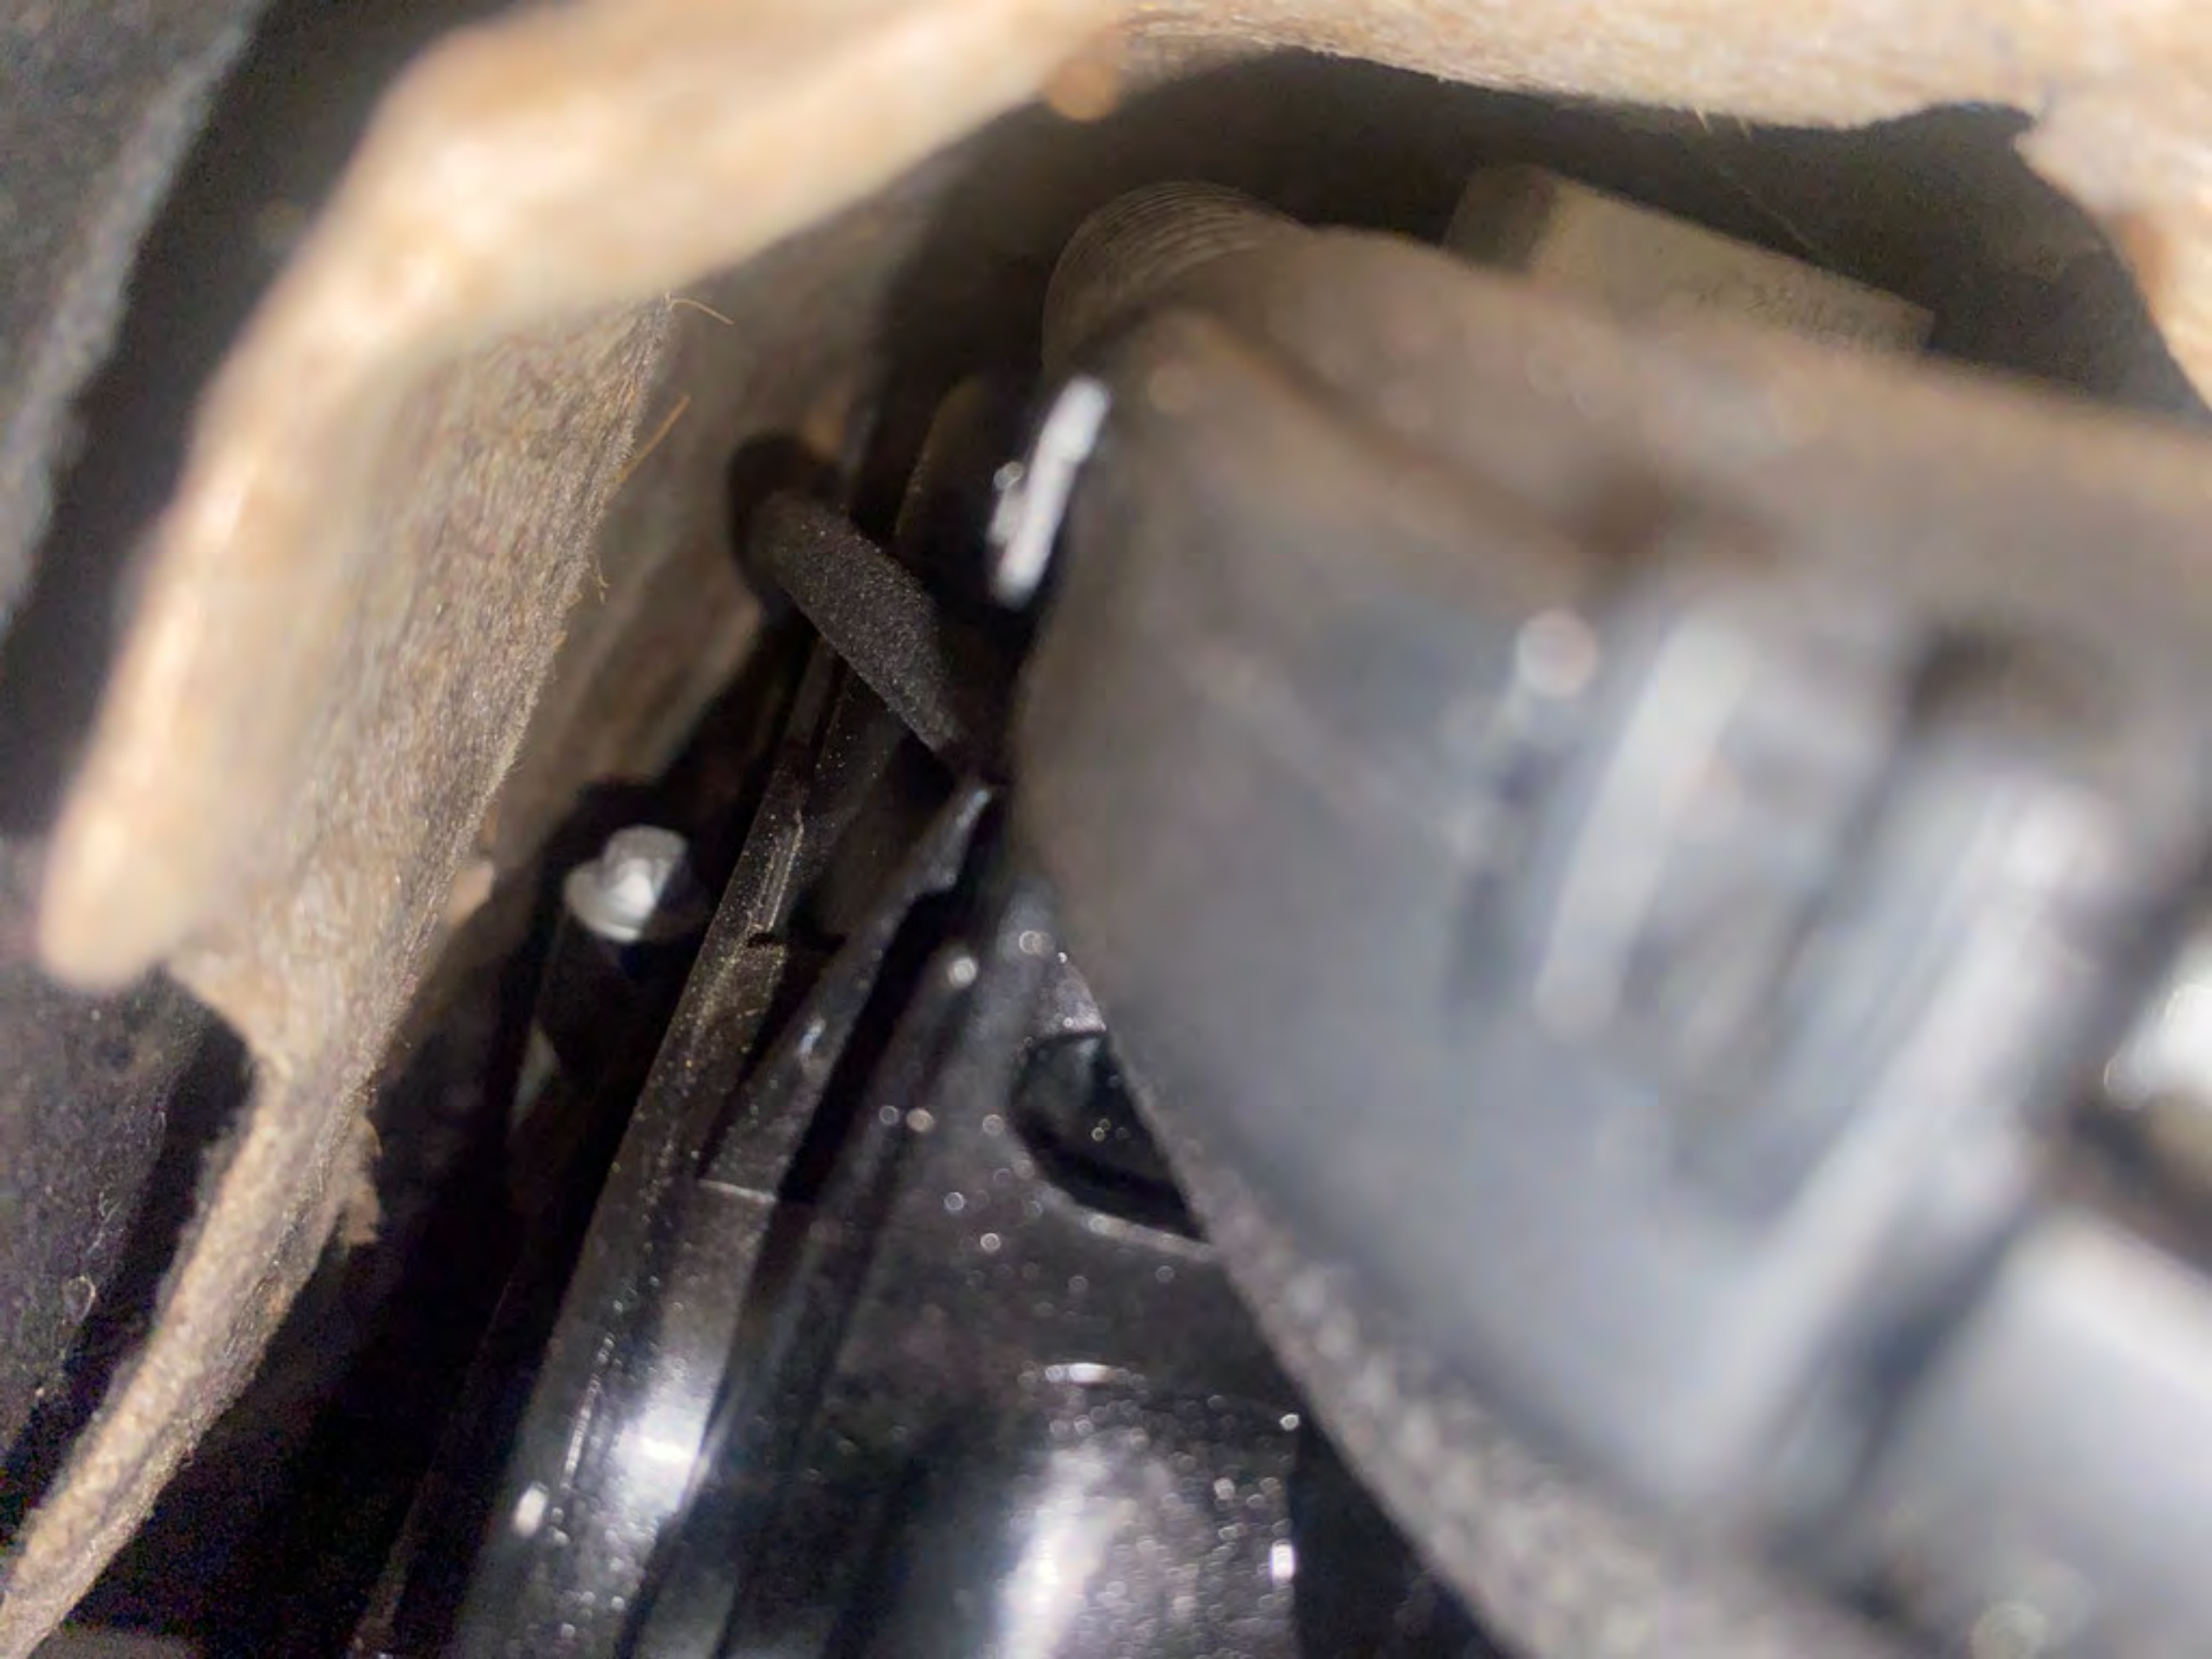
Looks like the  
rocker cover was  
sealed before

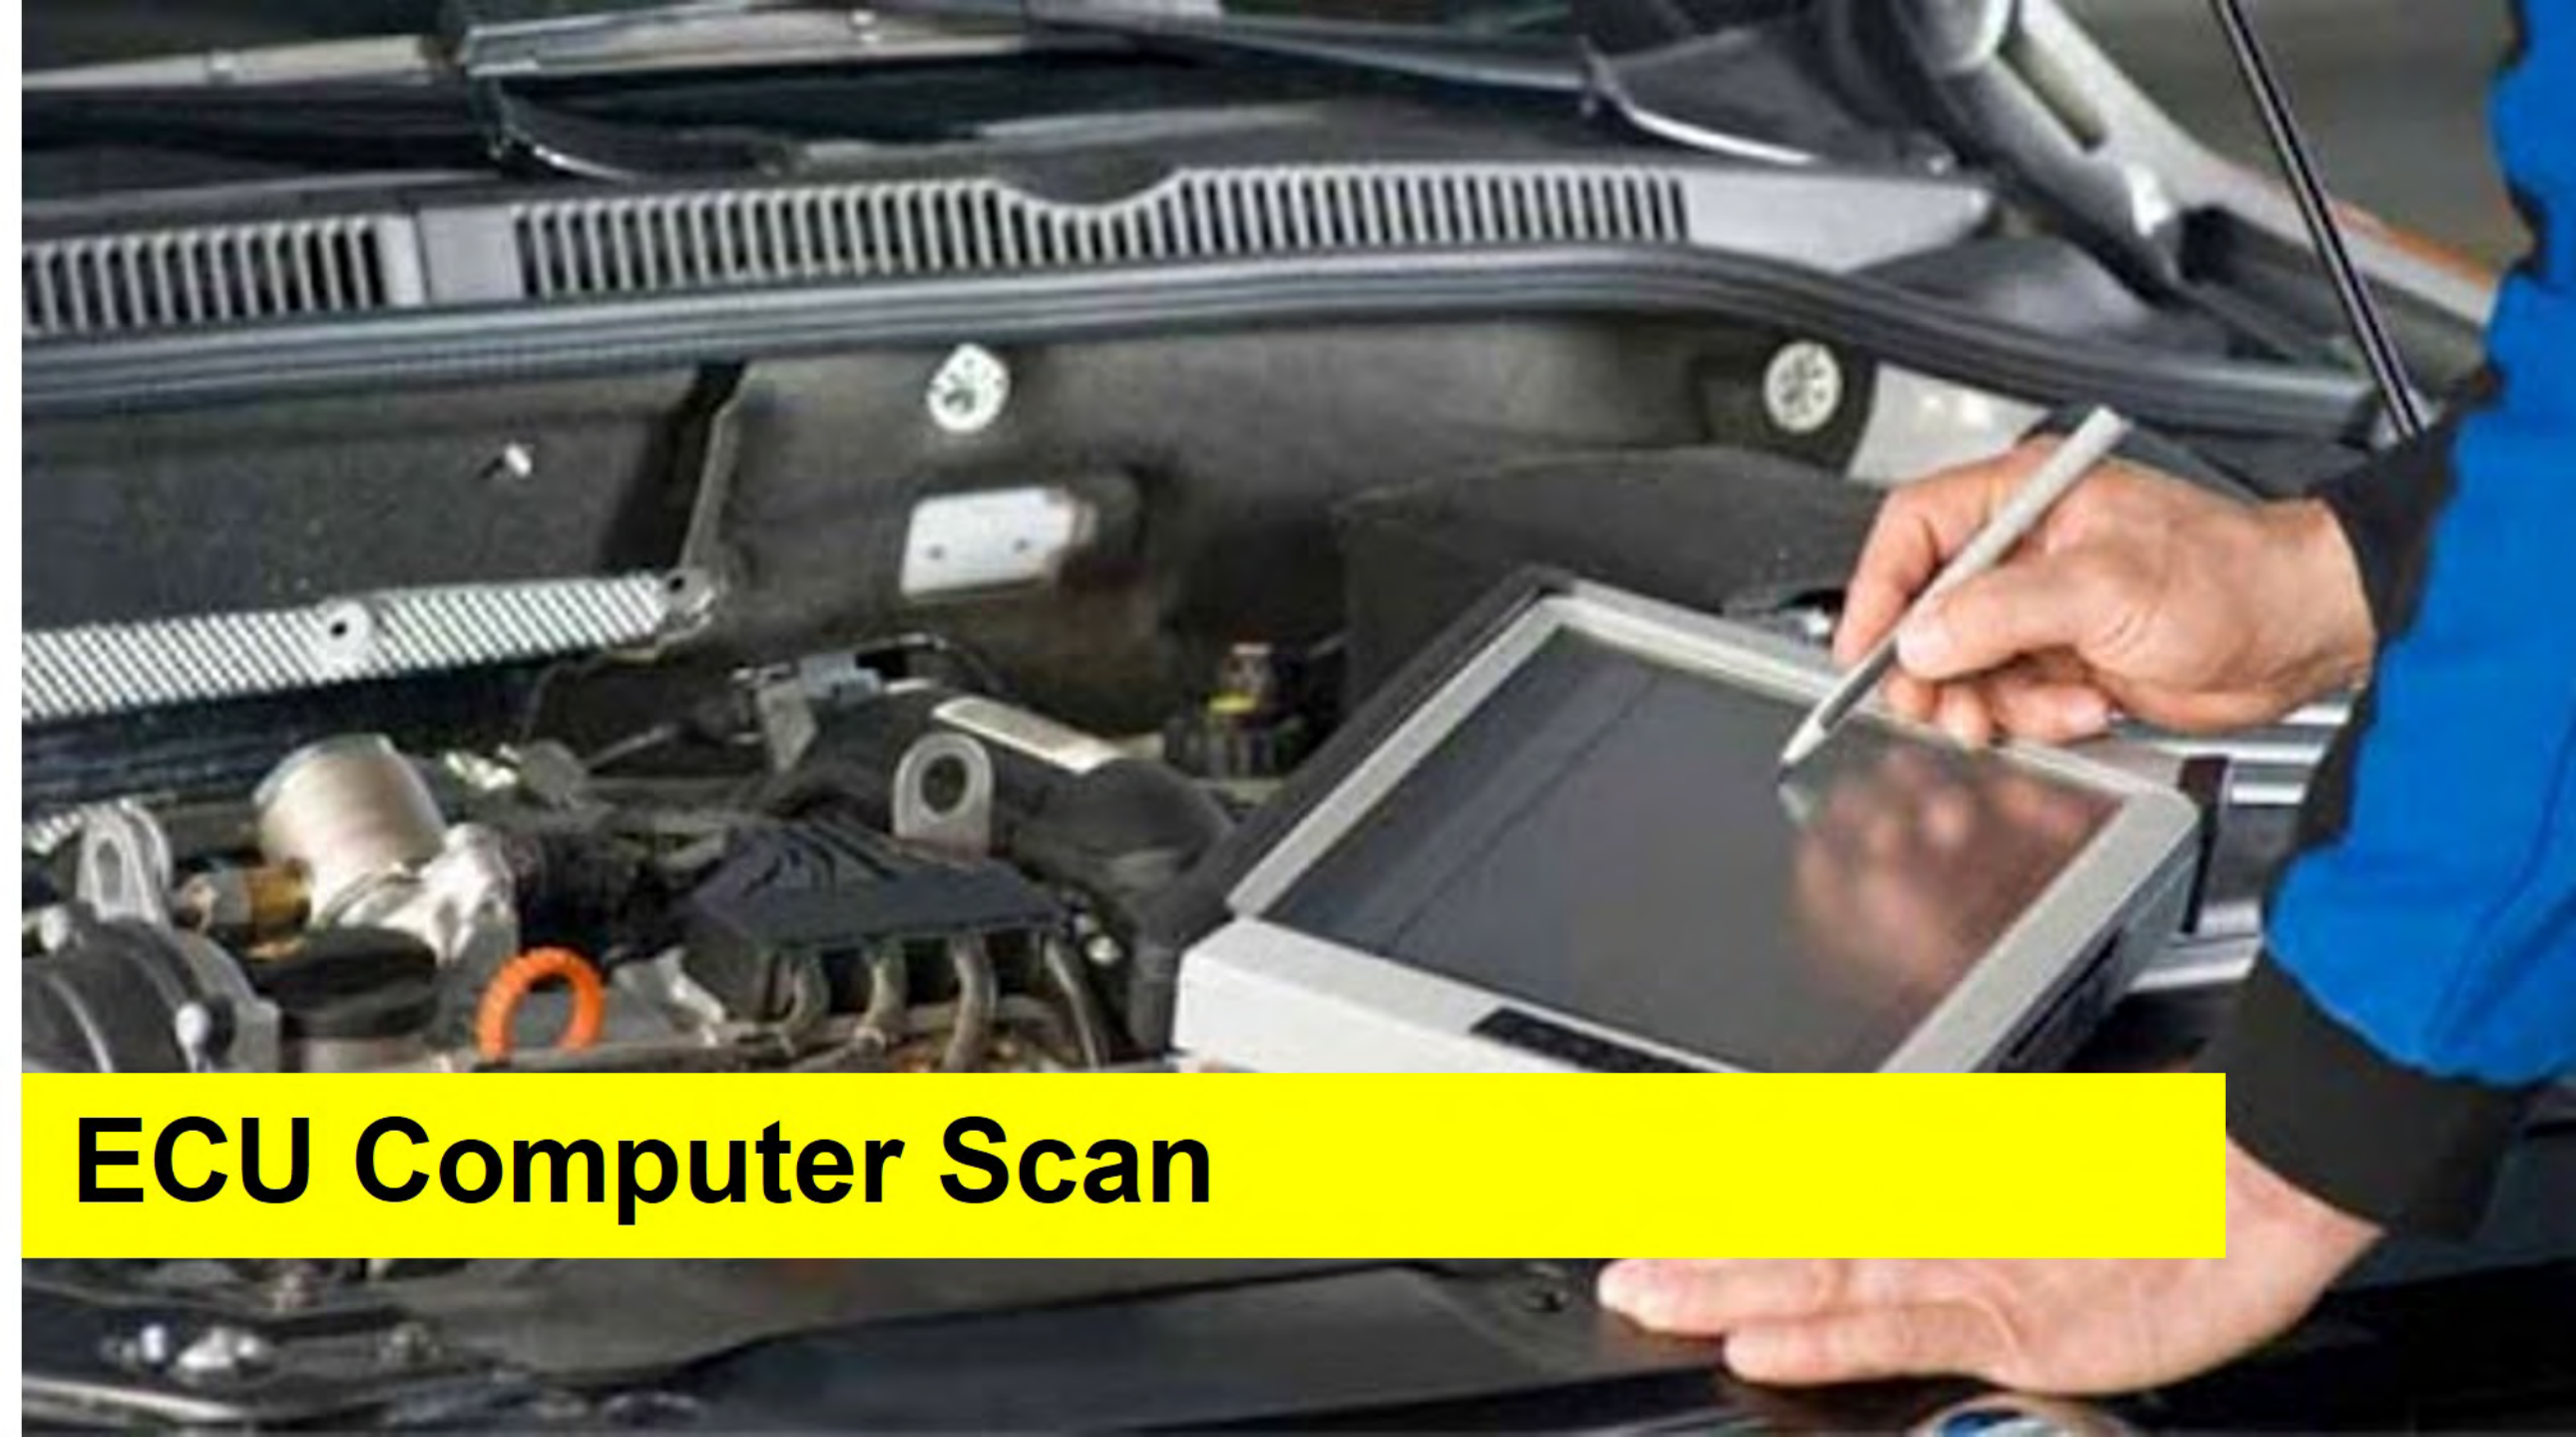
**ECU Computer Scan**

Fault|1

| 16 Engine-DDE Diesel Electronics | Fault 2 |

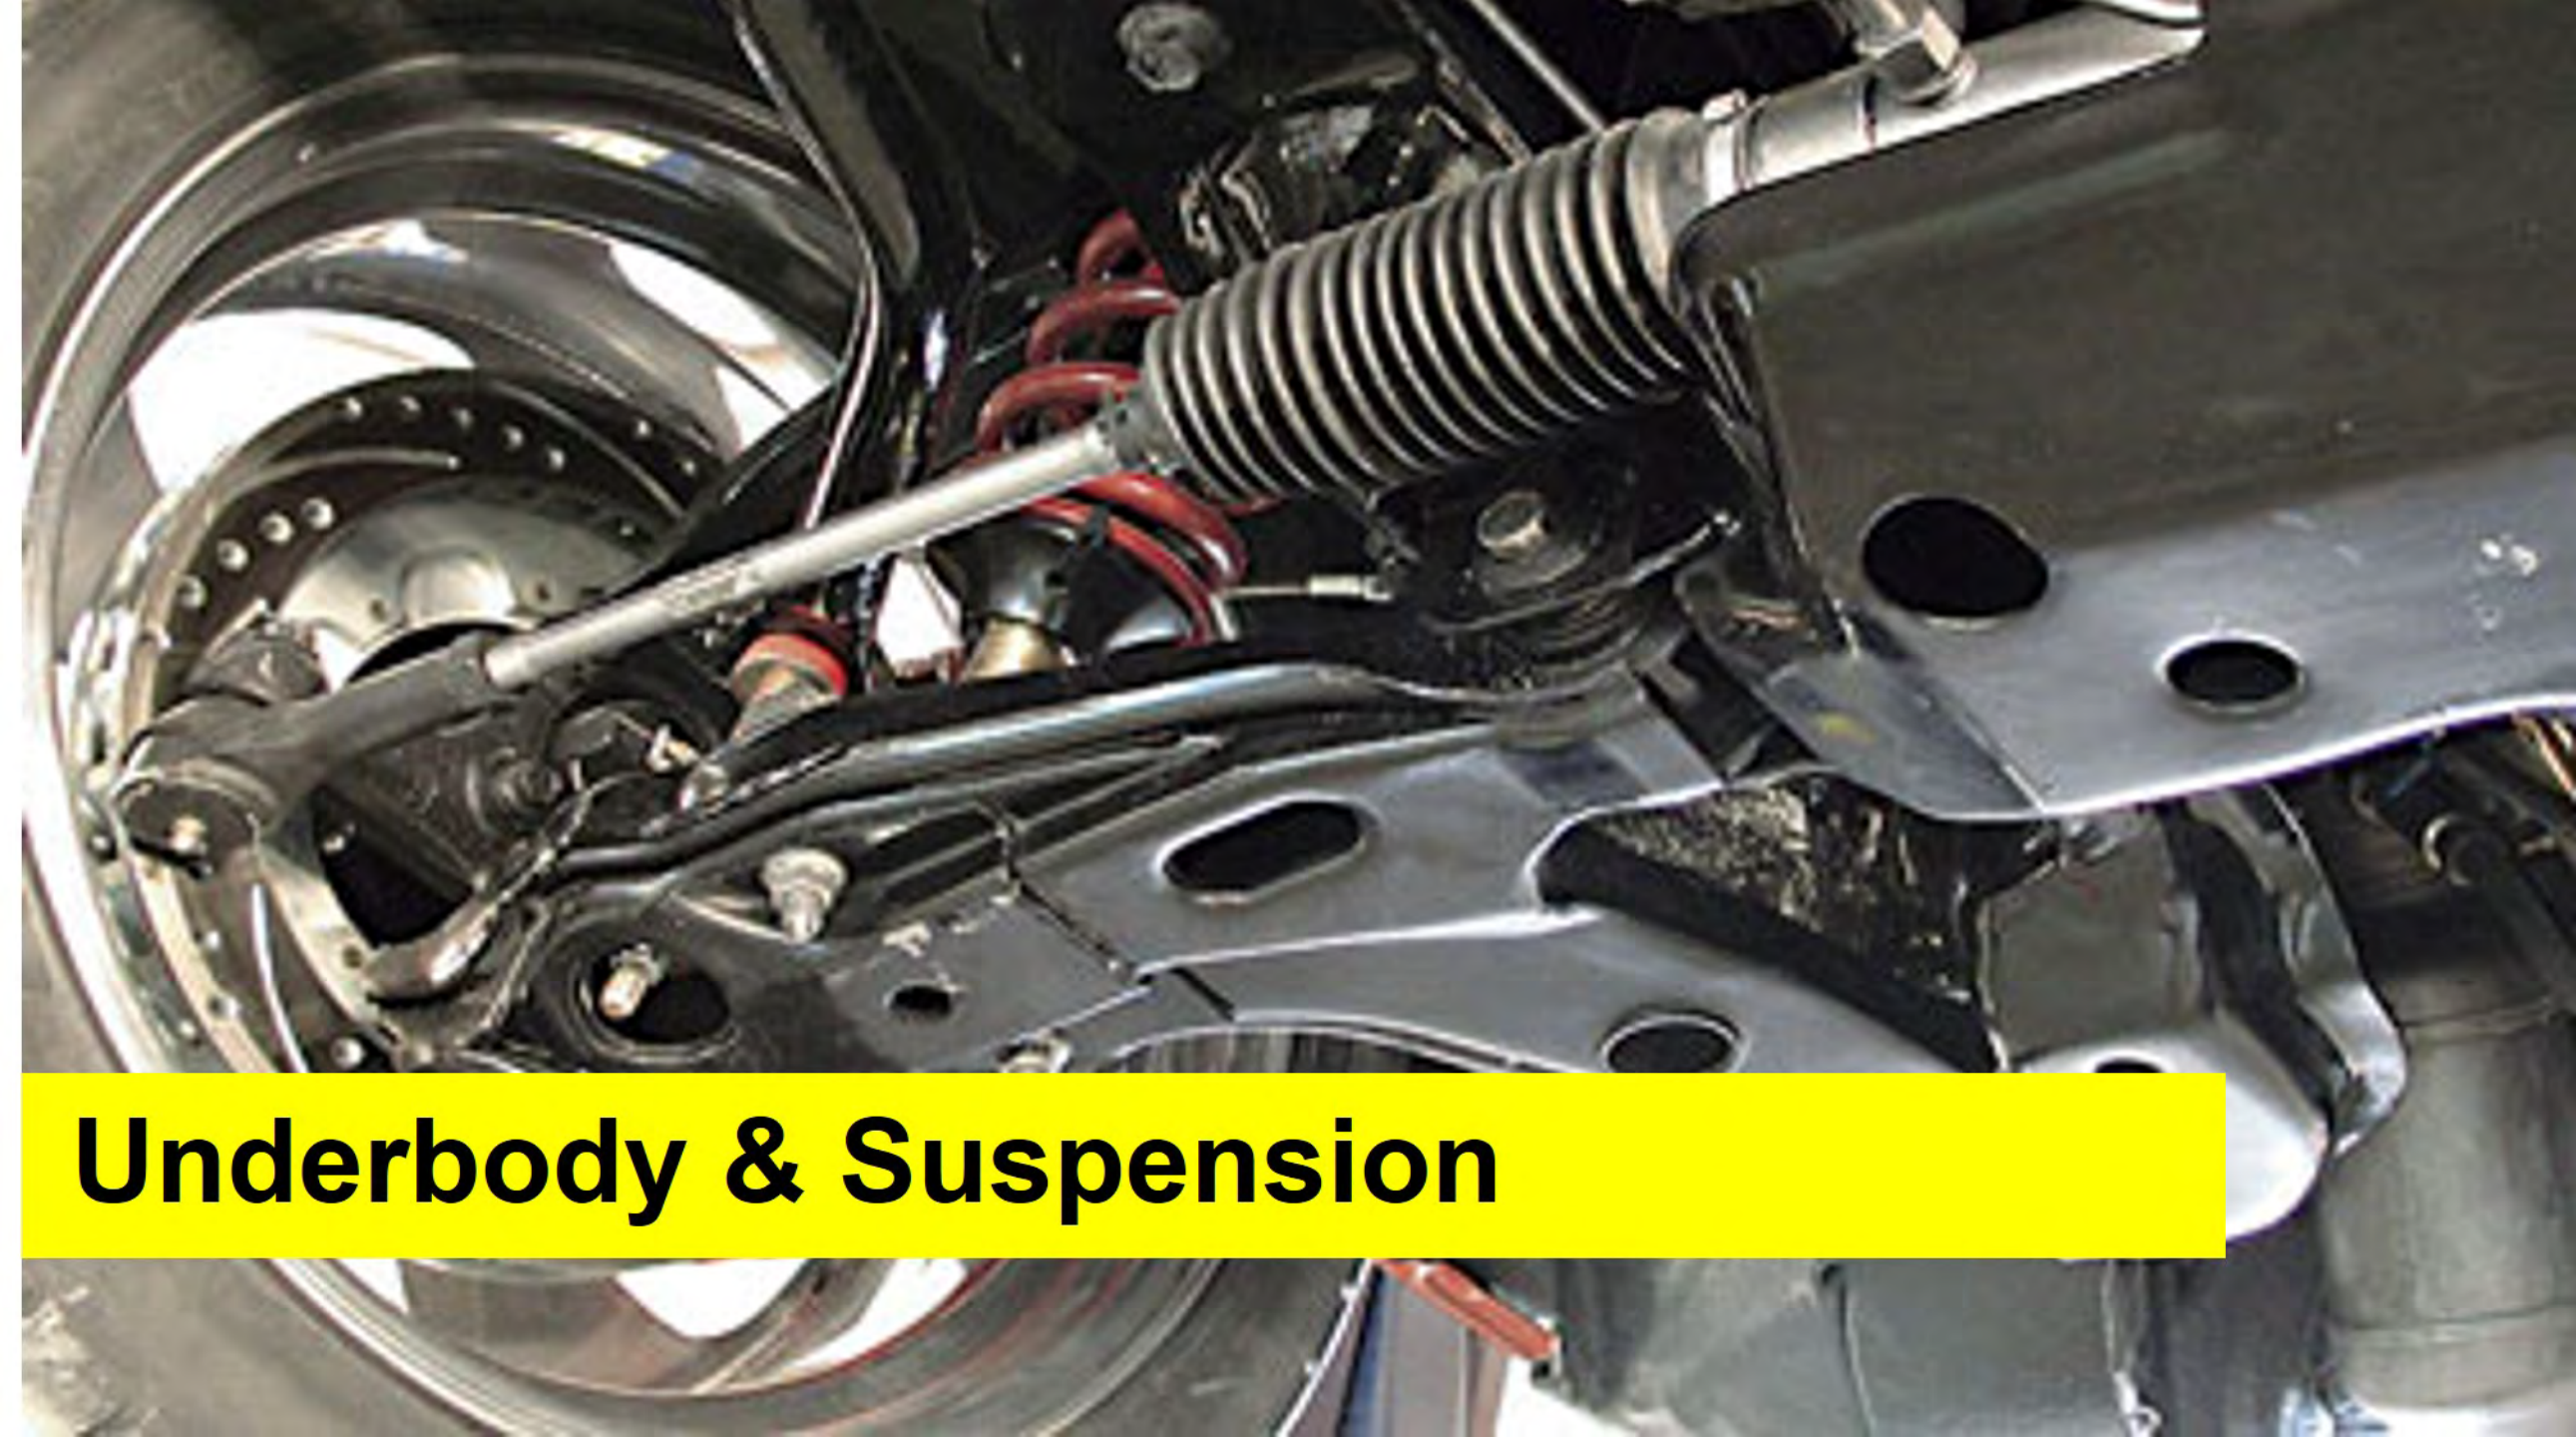
| 3EED | not present | DDE: Power management,<br>closed-circuit current violation |
| 4A66 | not present | DDE: Power management,<br>vehicle electrical system |

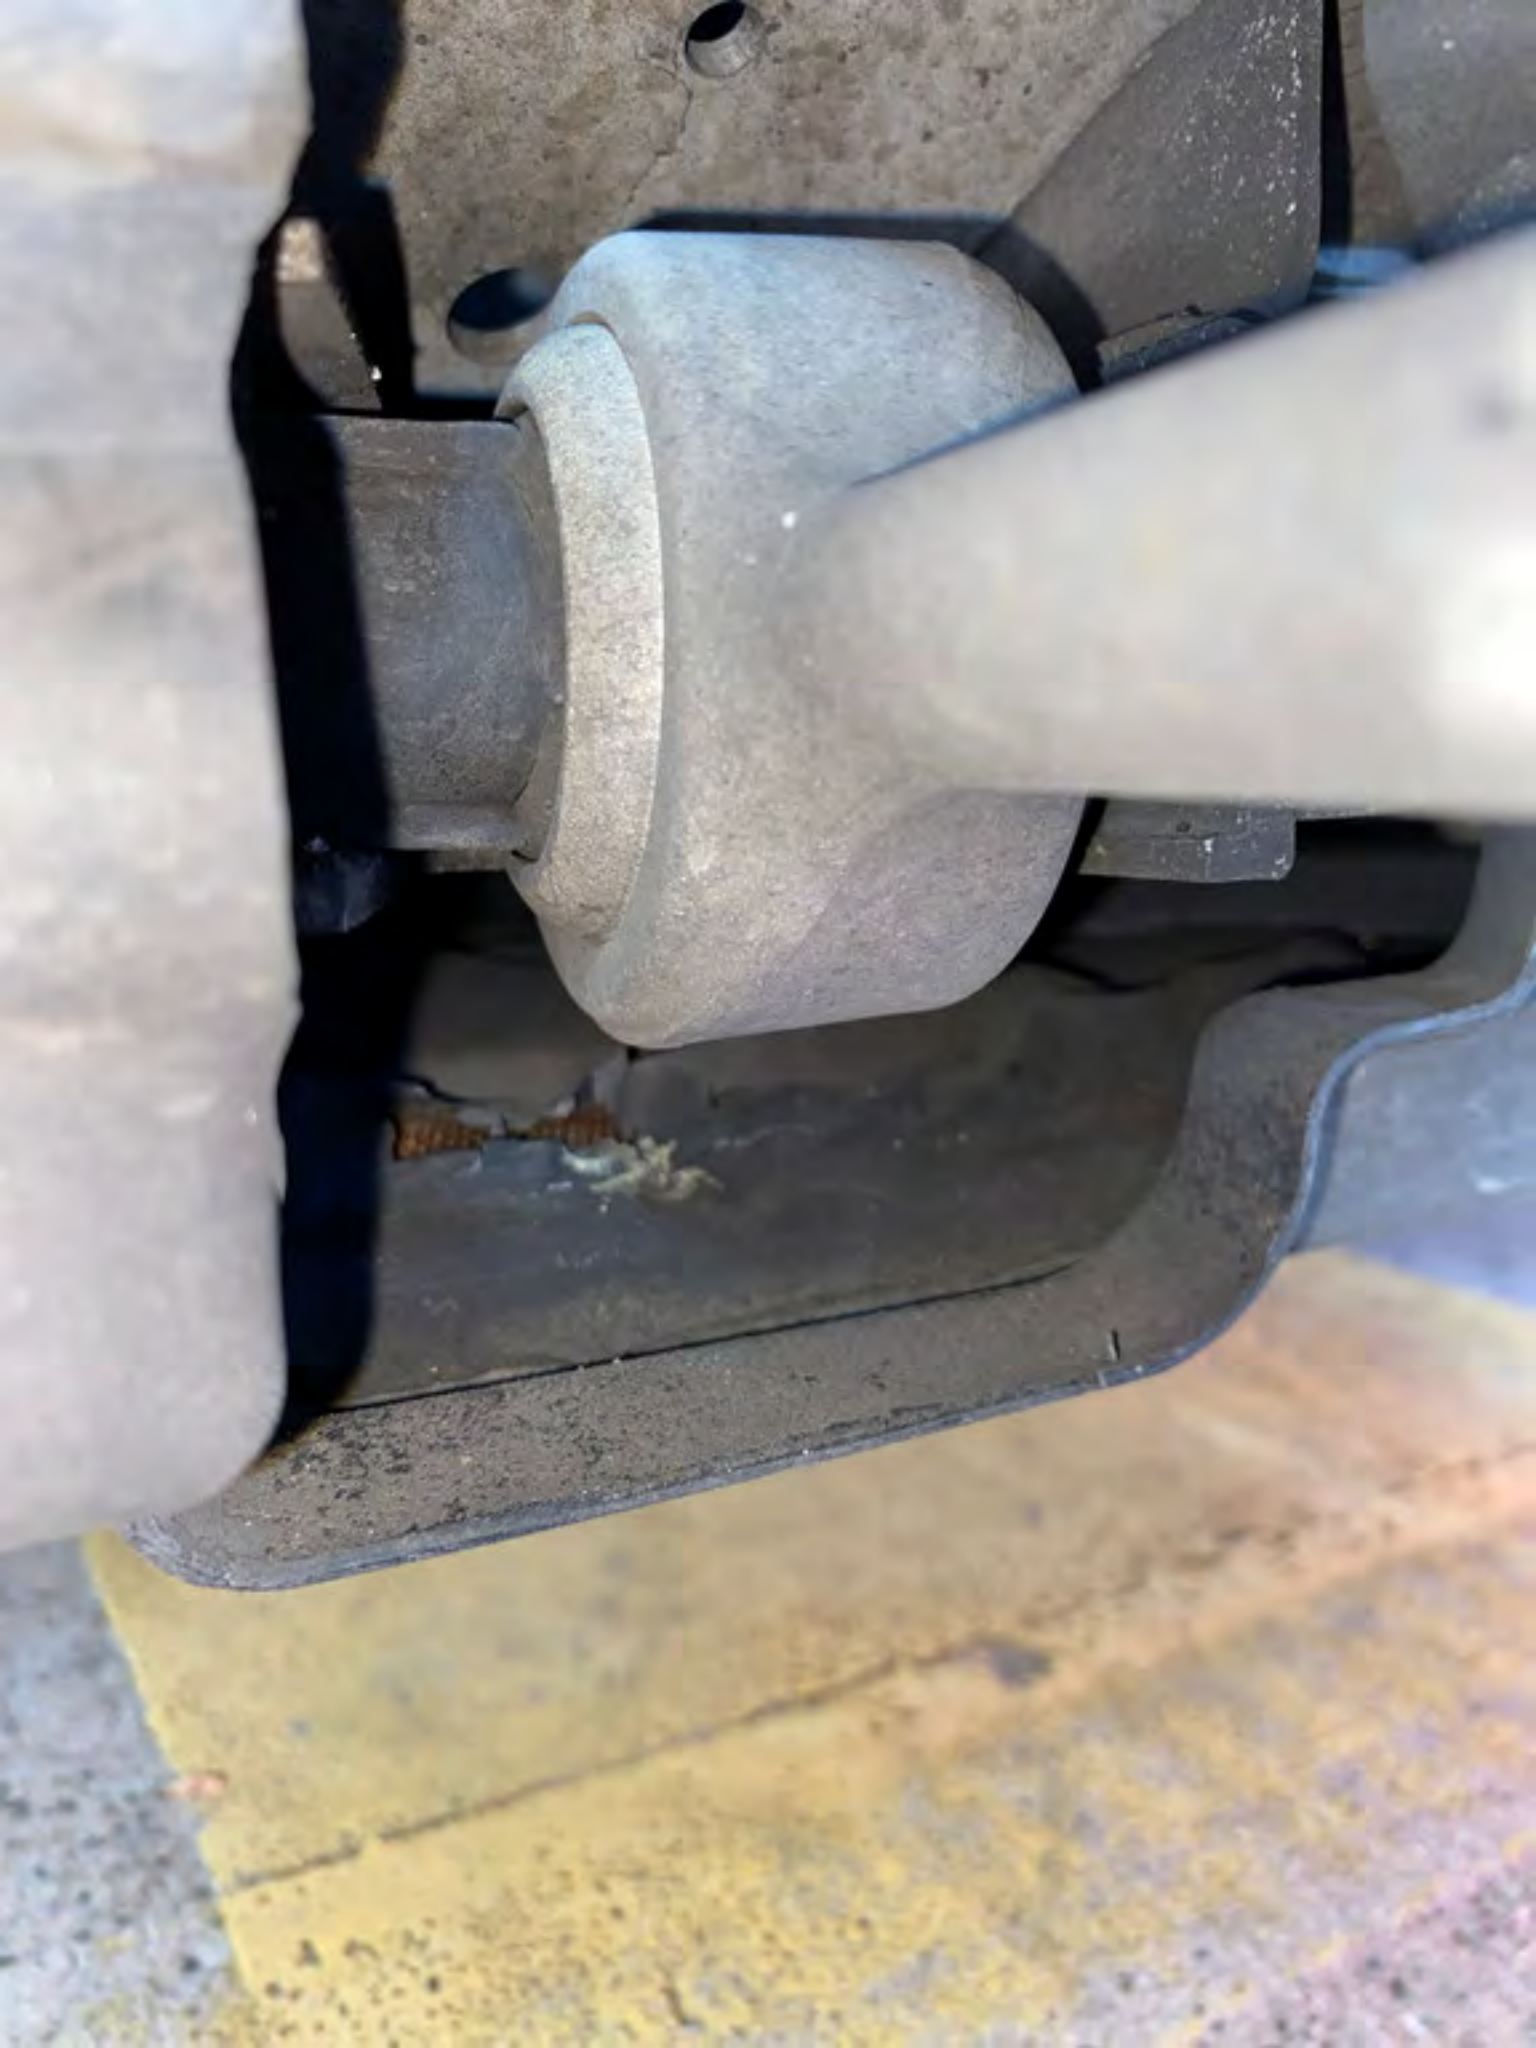
Leak
