BMW A.G.

3 Series - E90

# Engine & Servicing

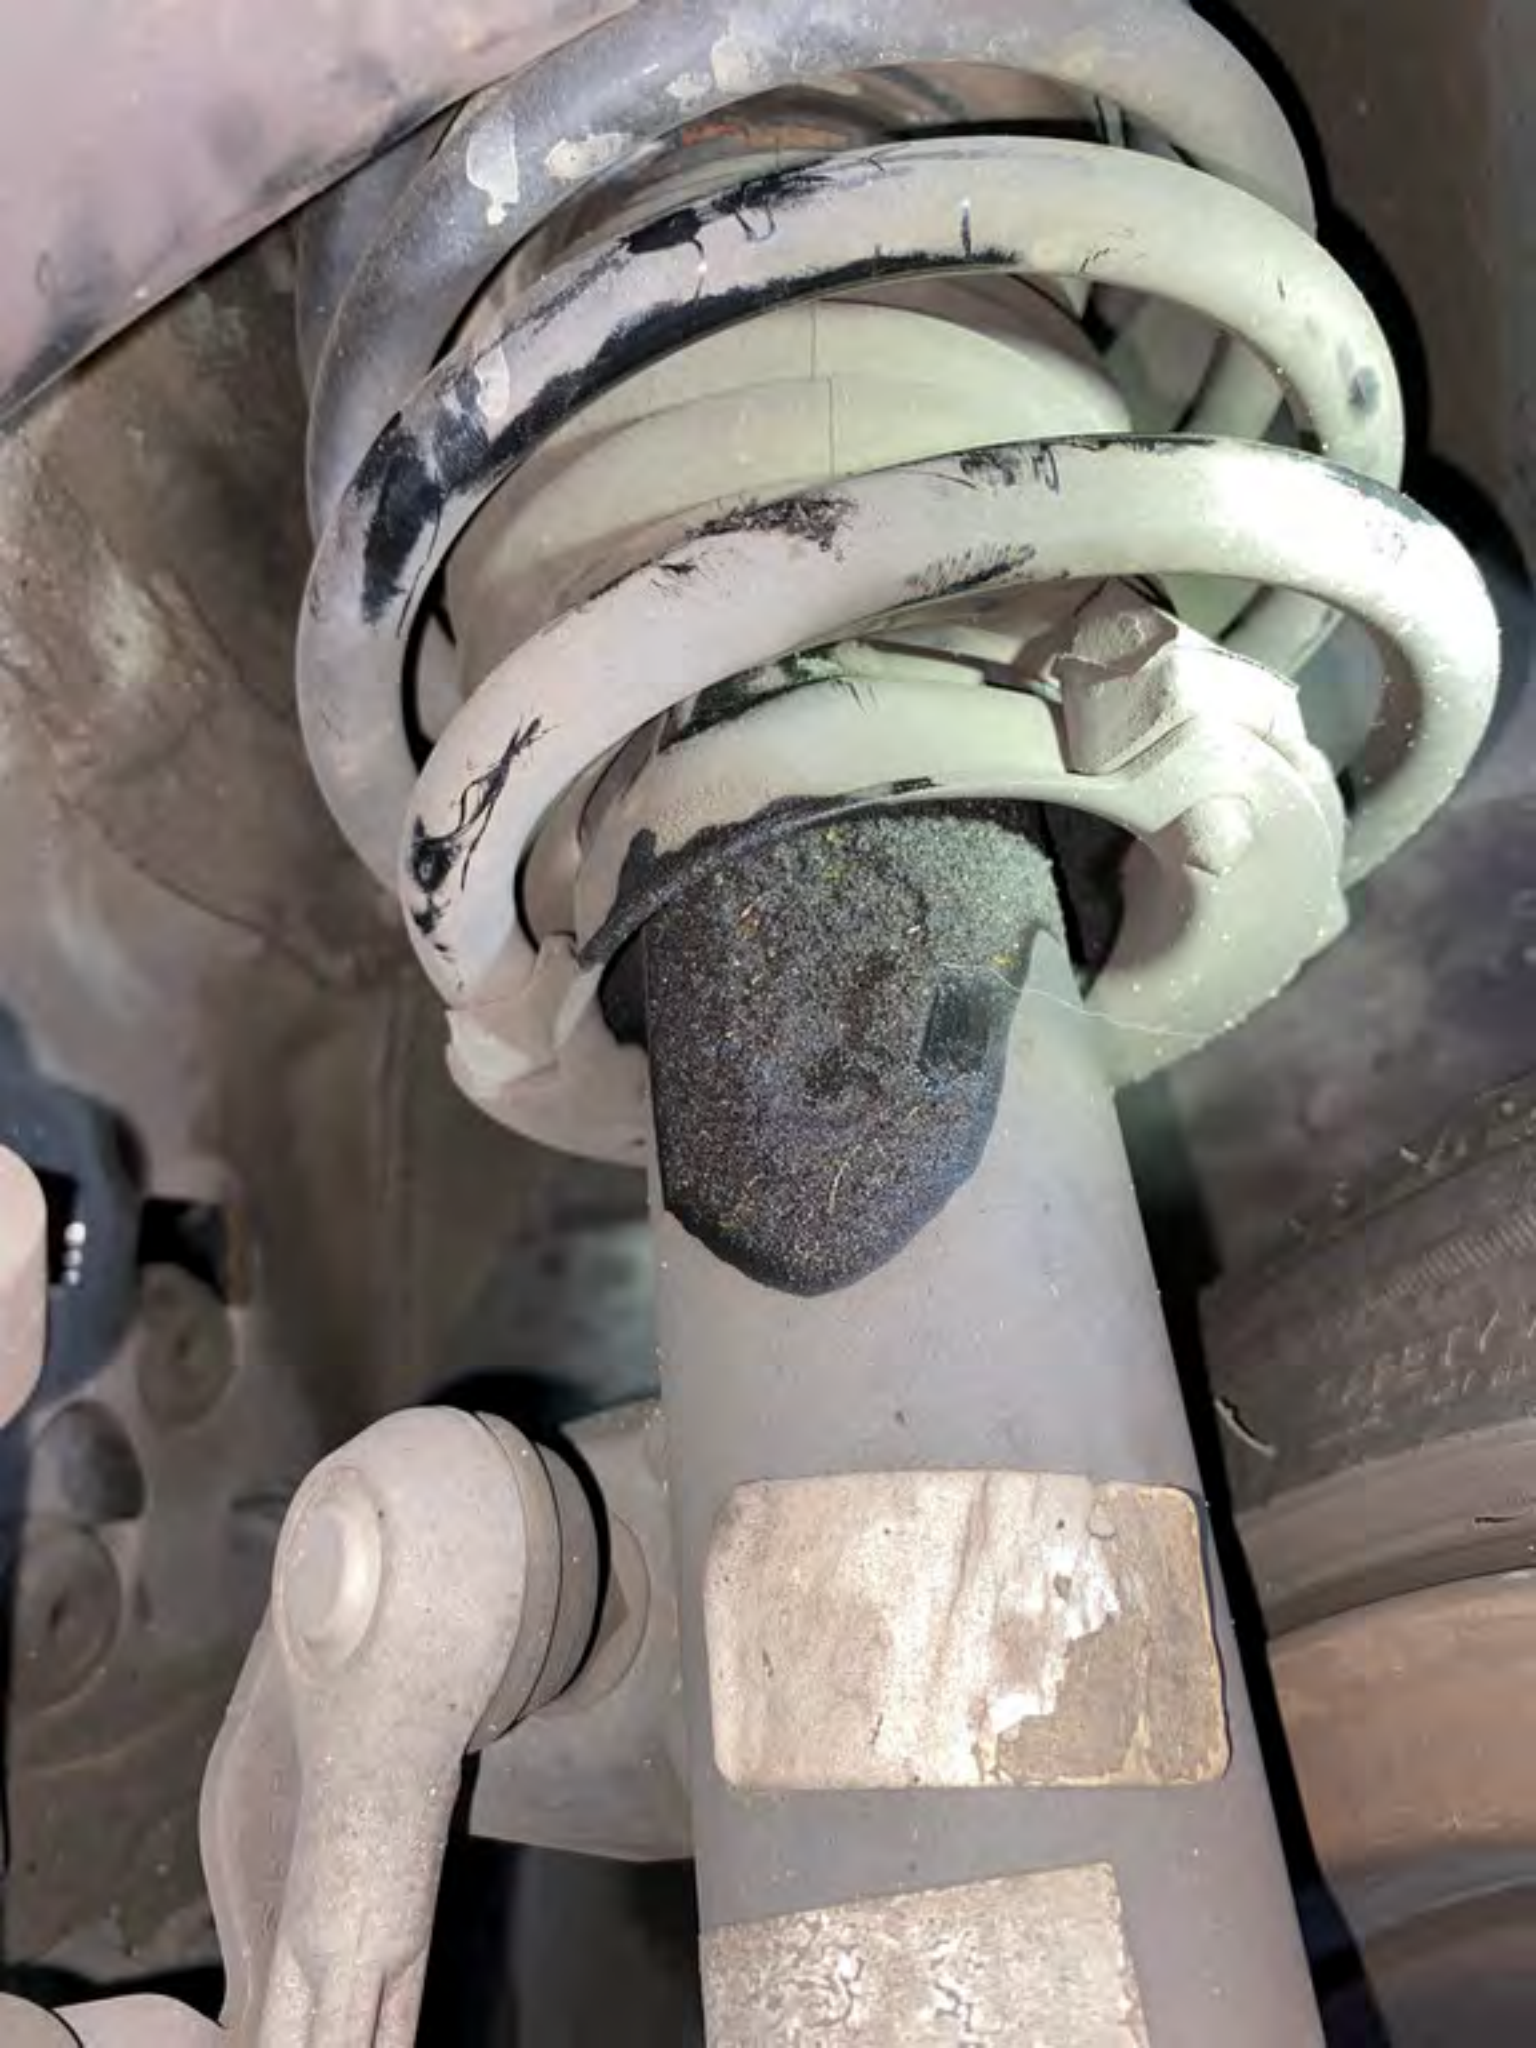
P/S/F shock  
(starting to  
leak)

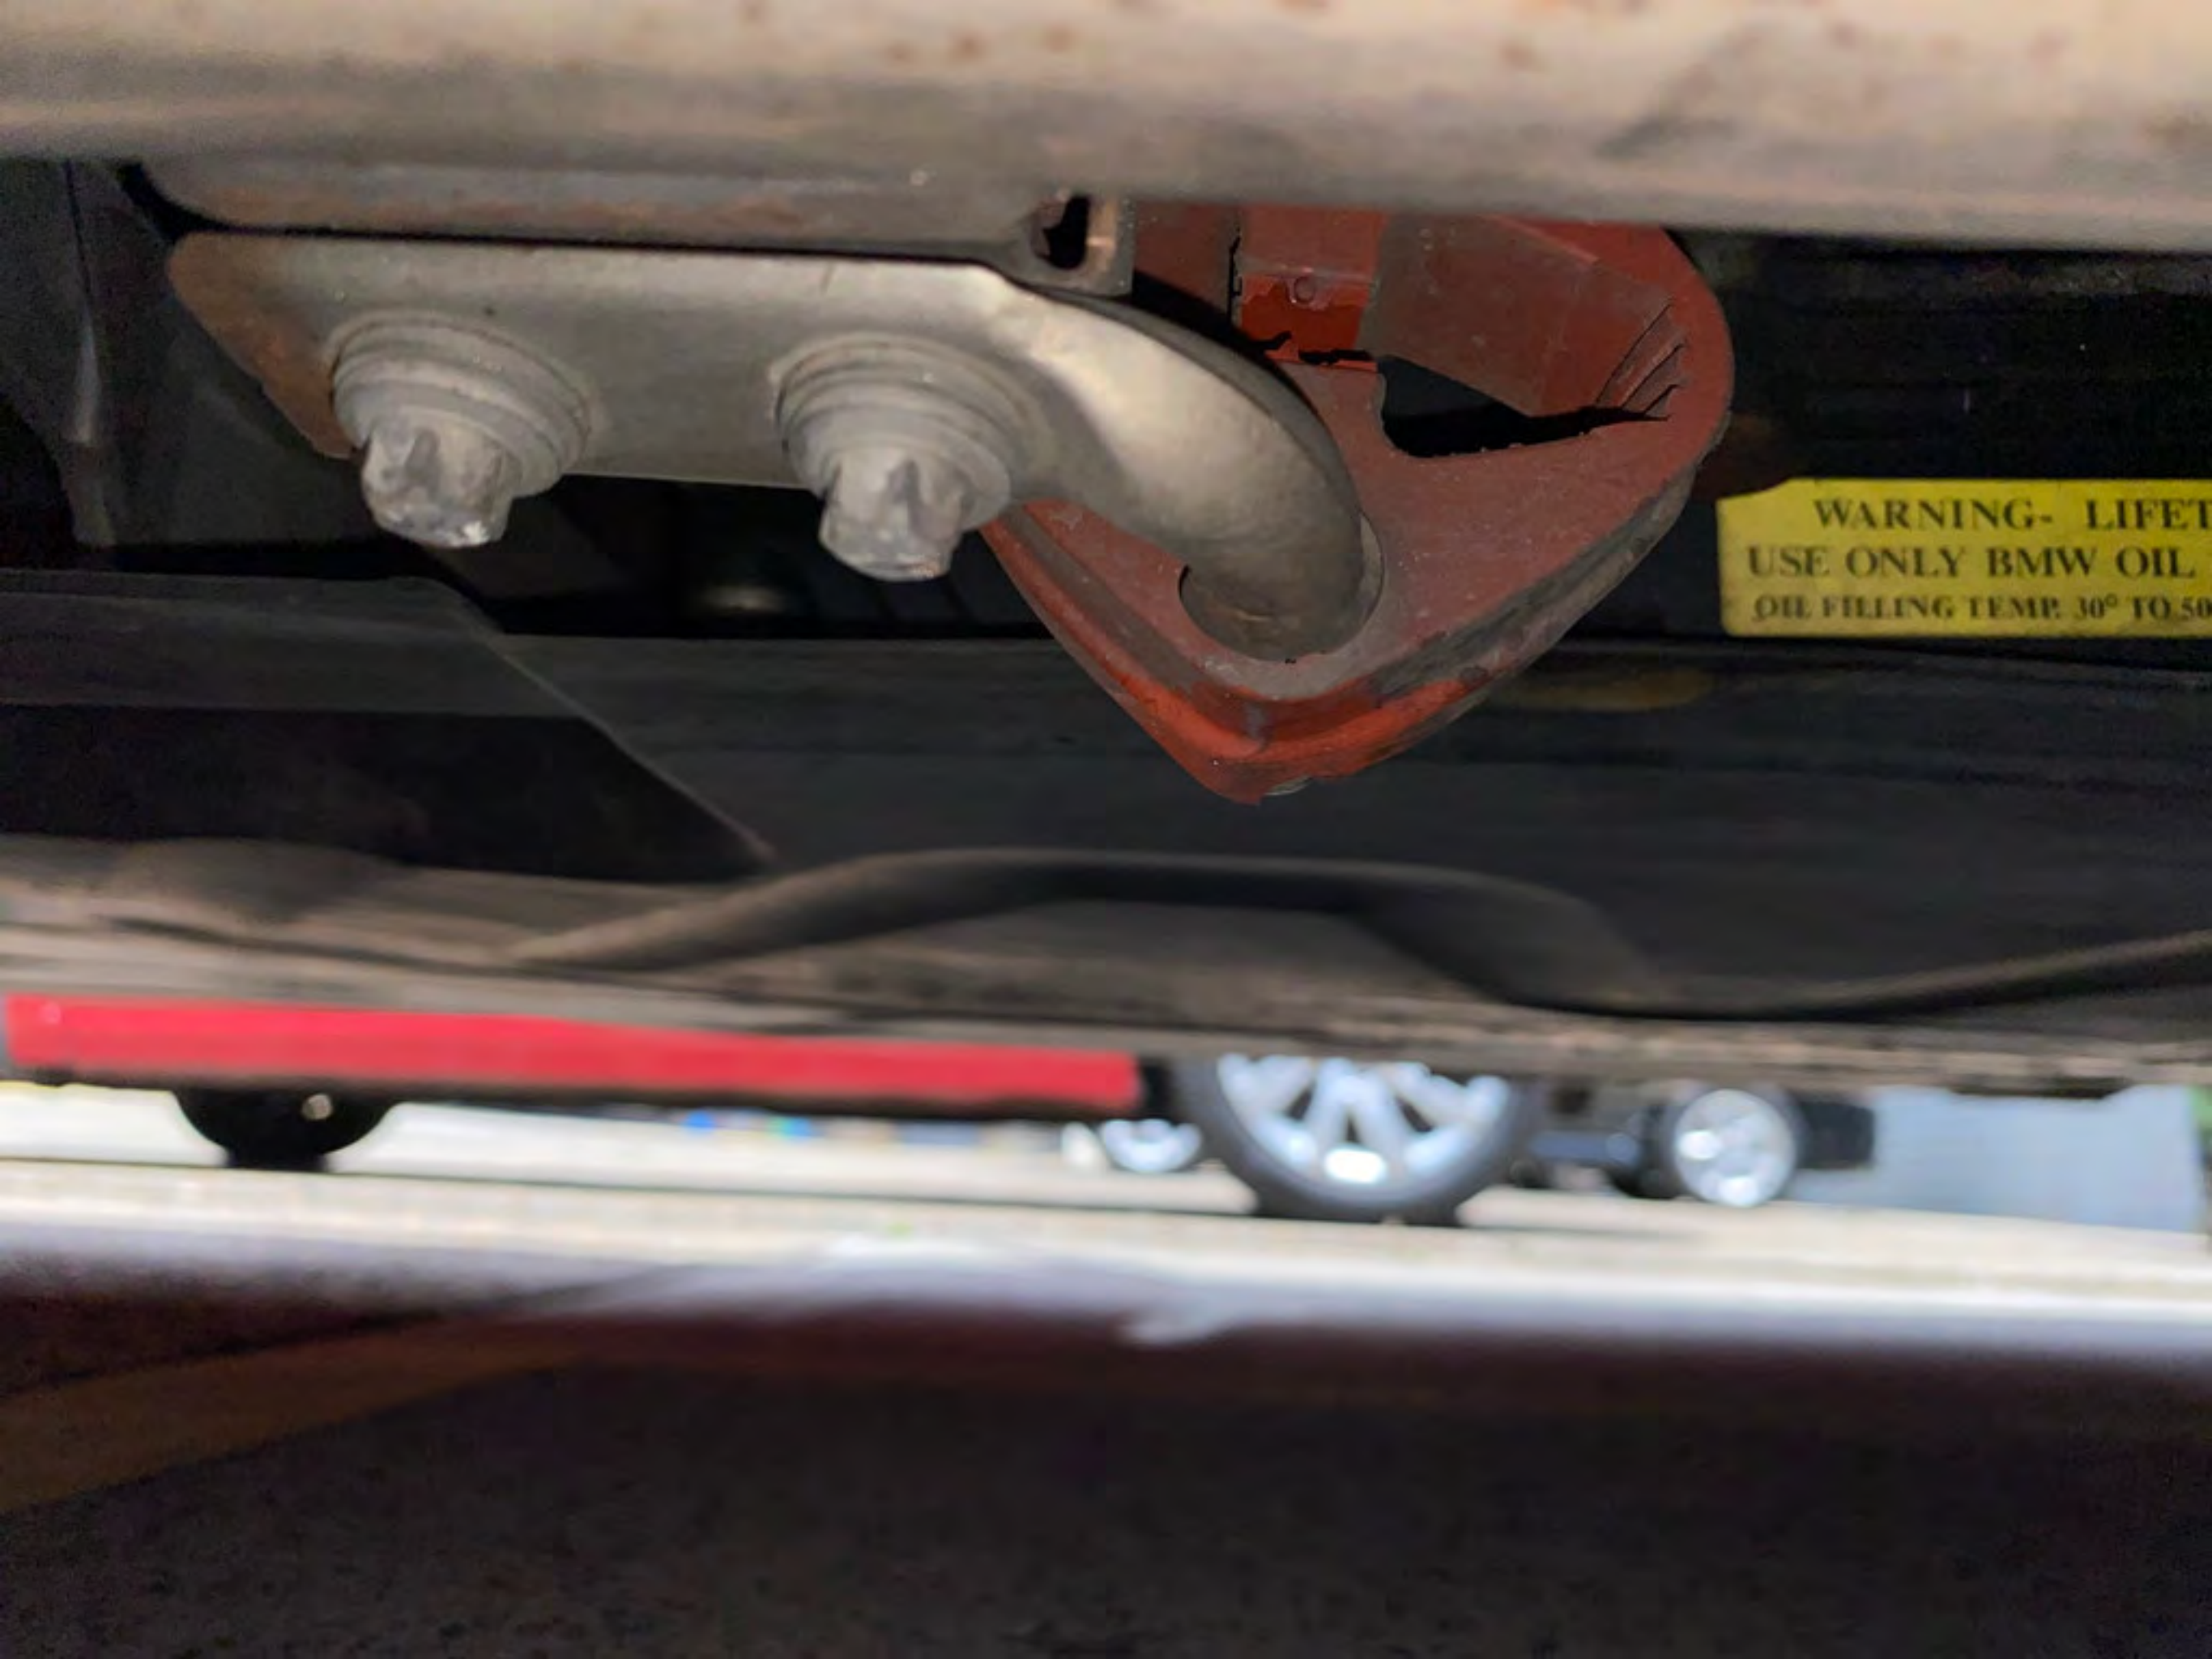
No oil leaks on  
engine tray

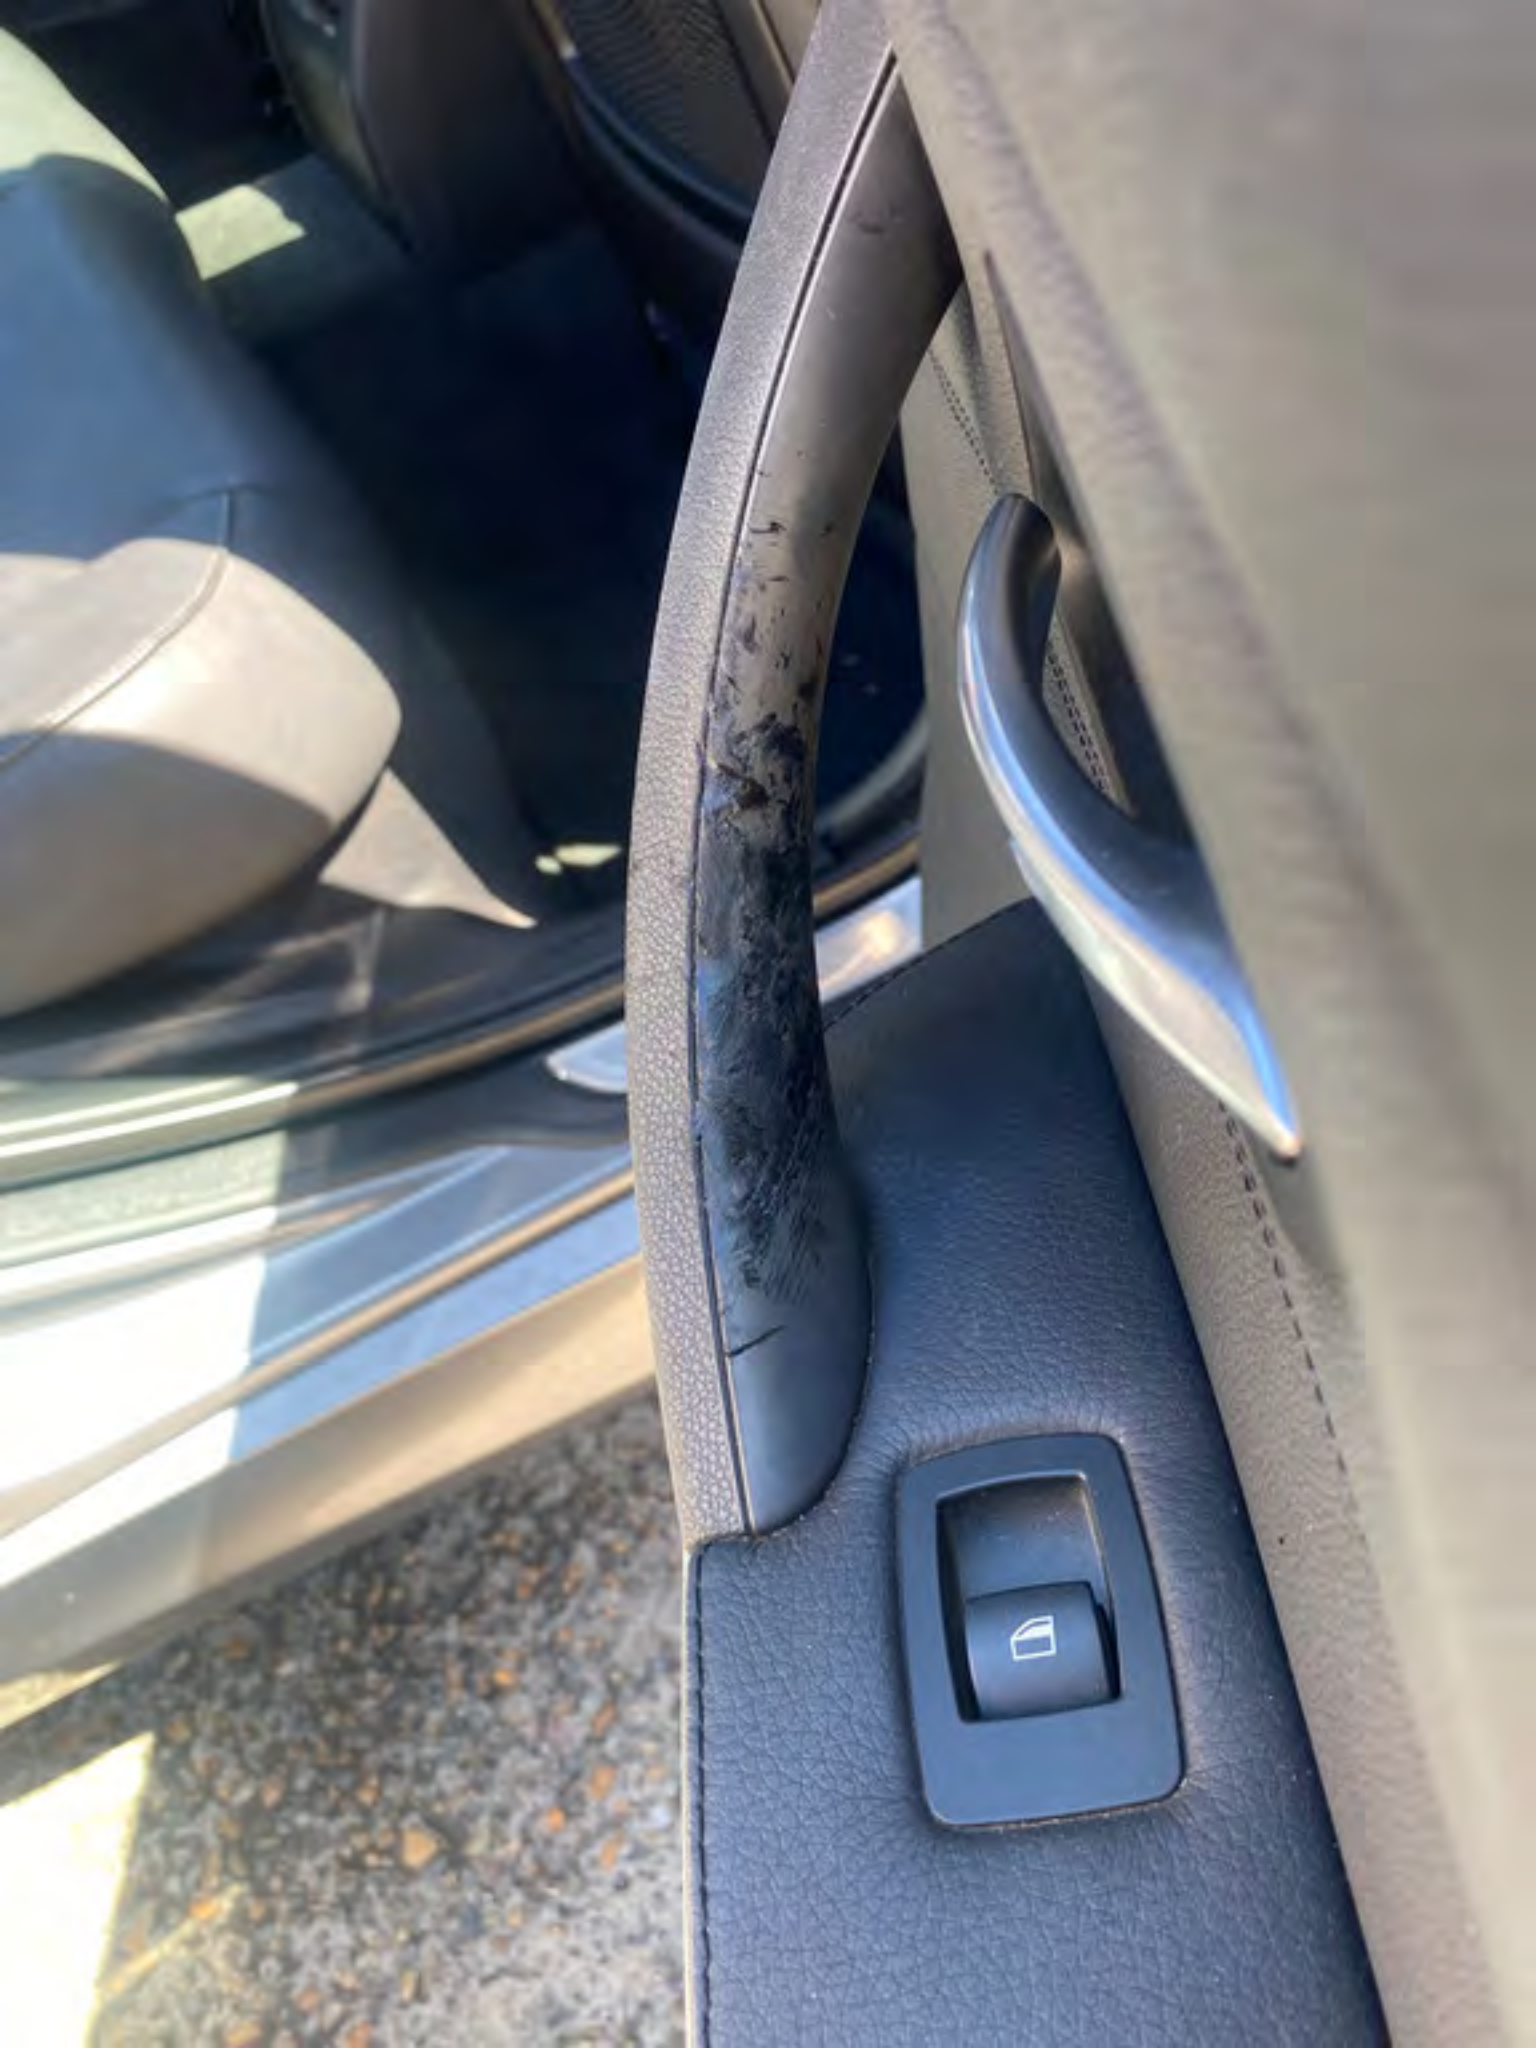
D/S/R door handle  
rubber (perished)

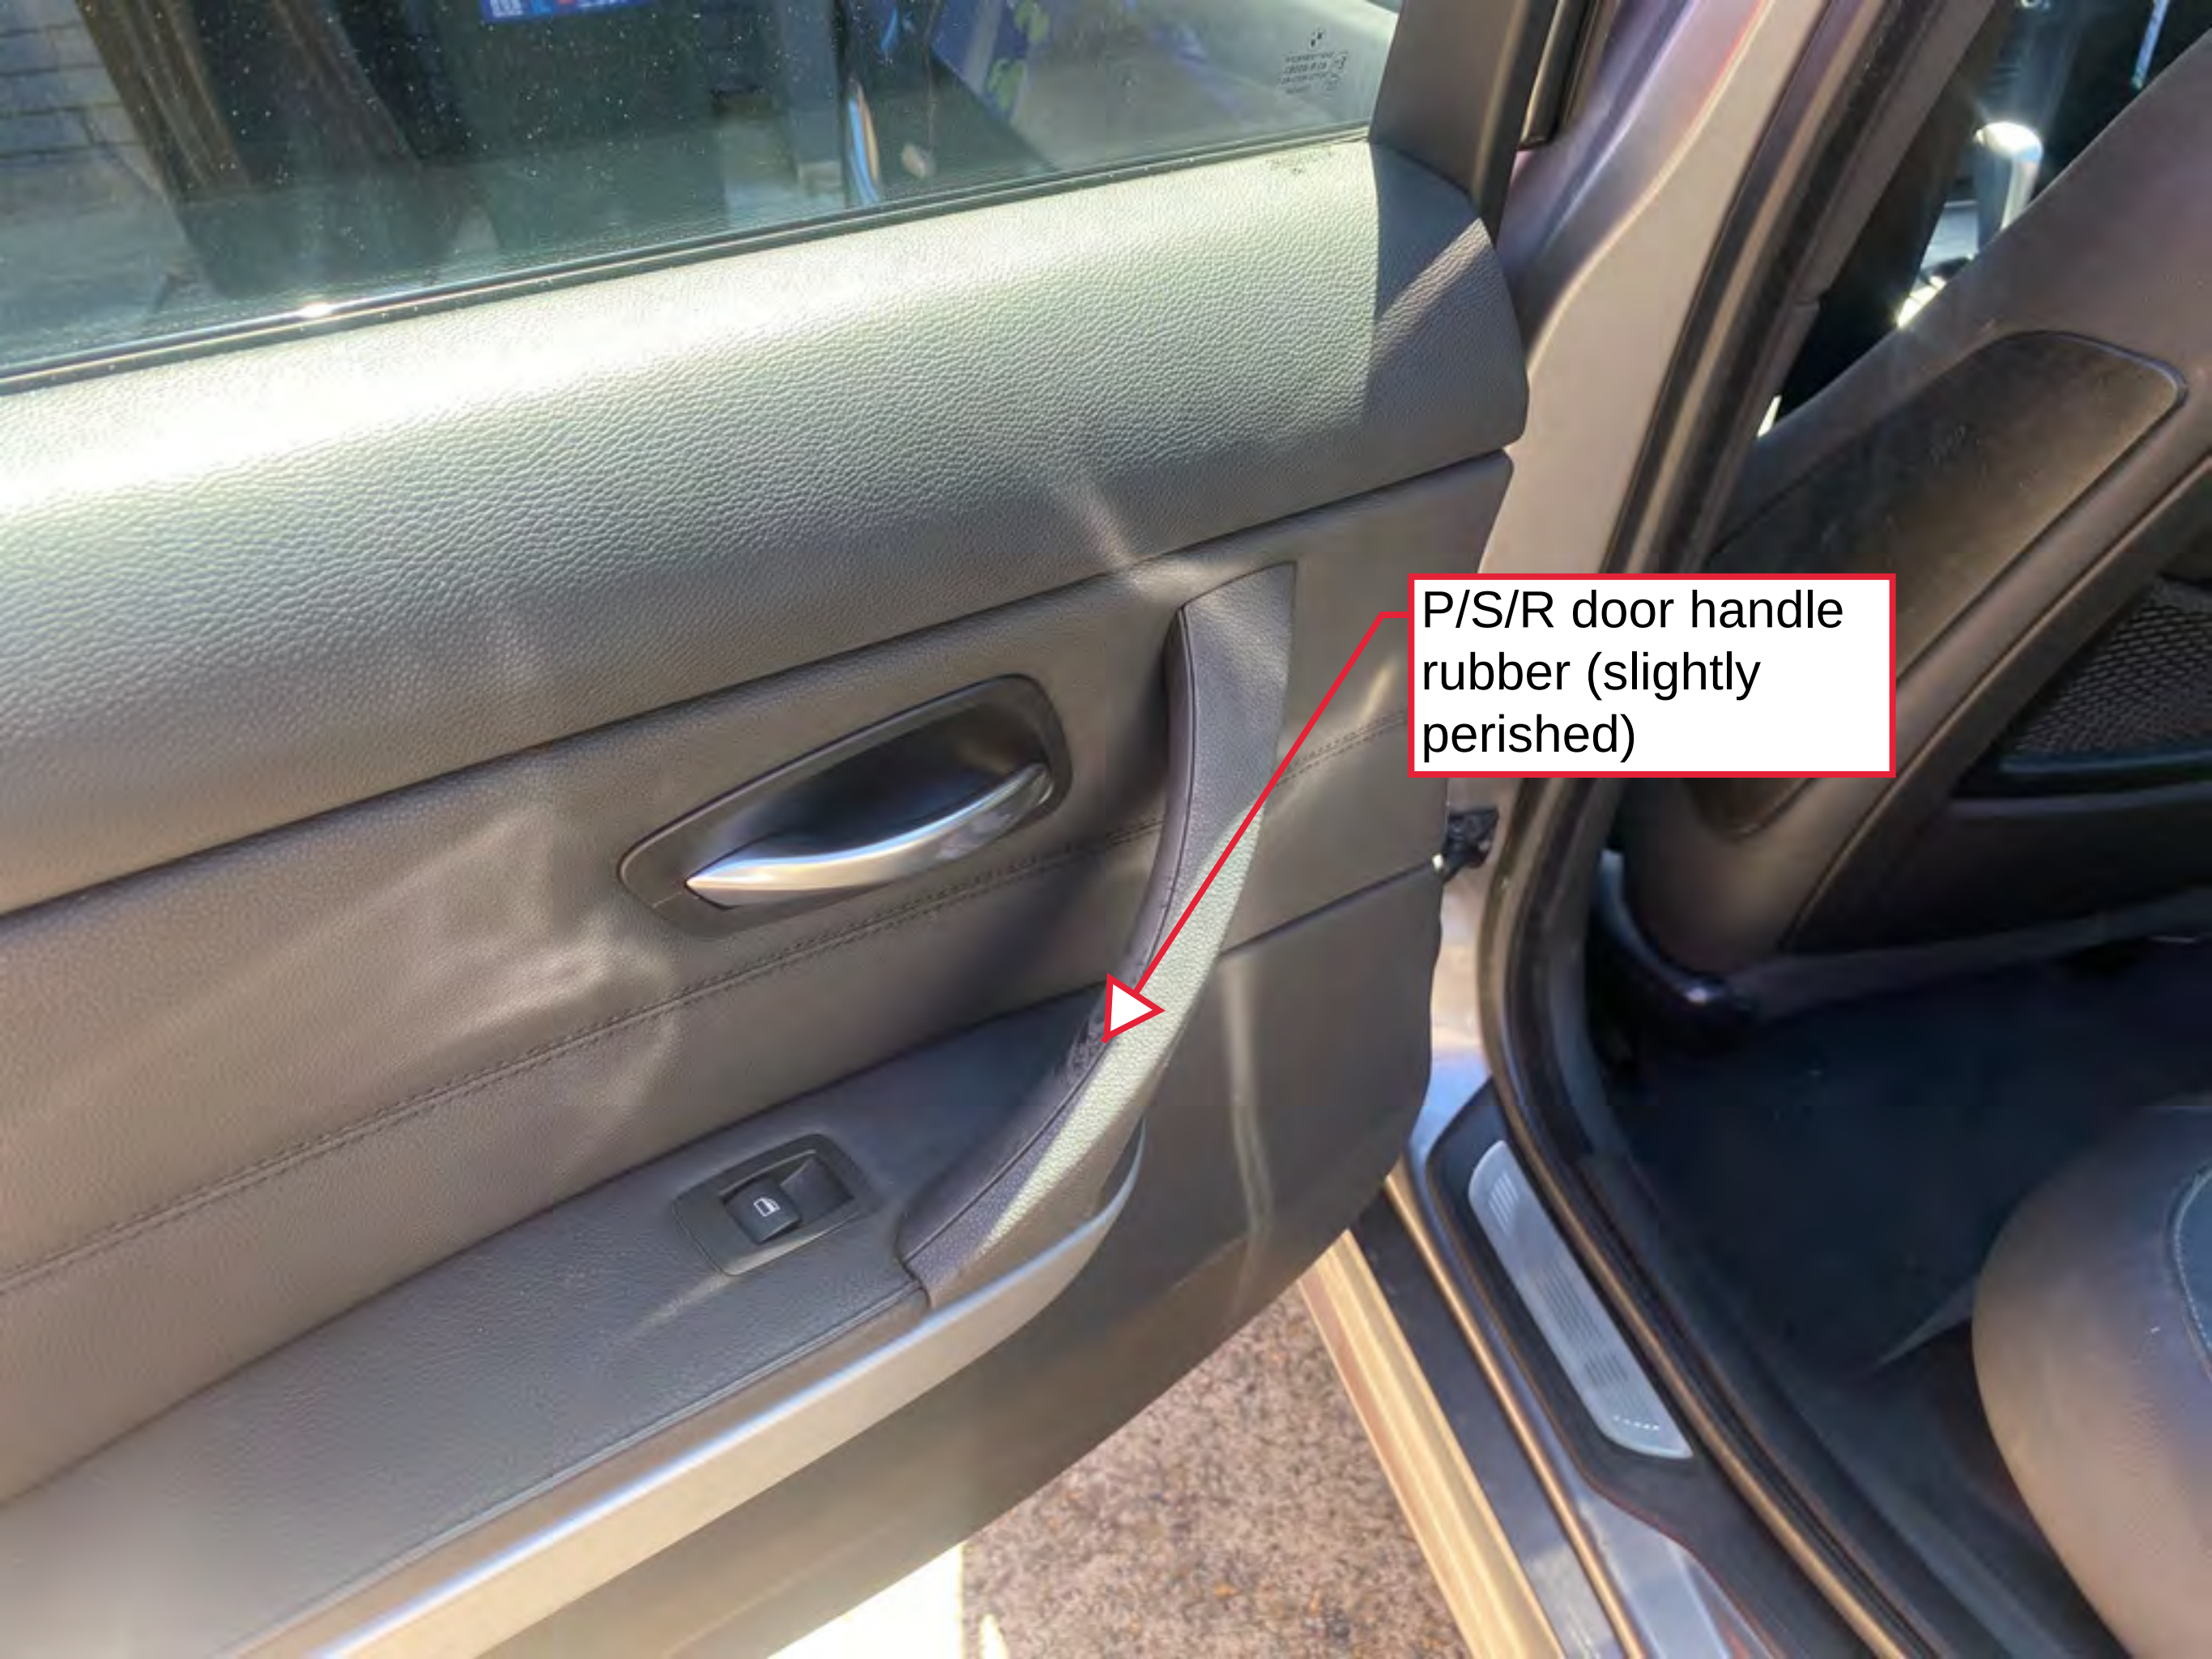
P/S/R door handle  
rubber (slightly  
perished)

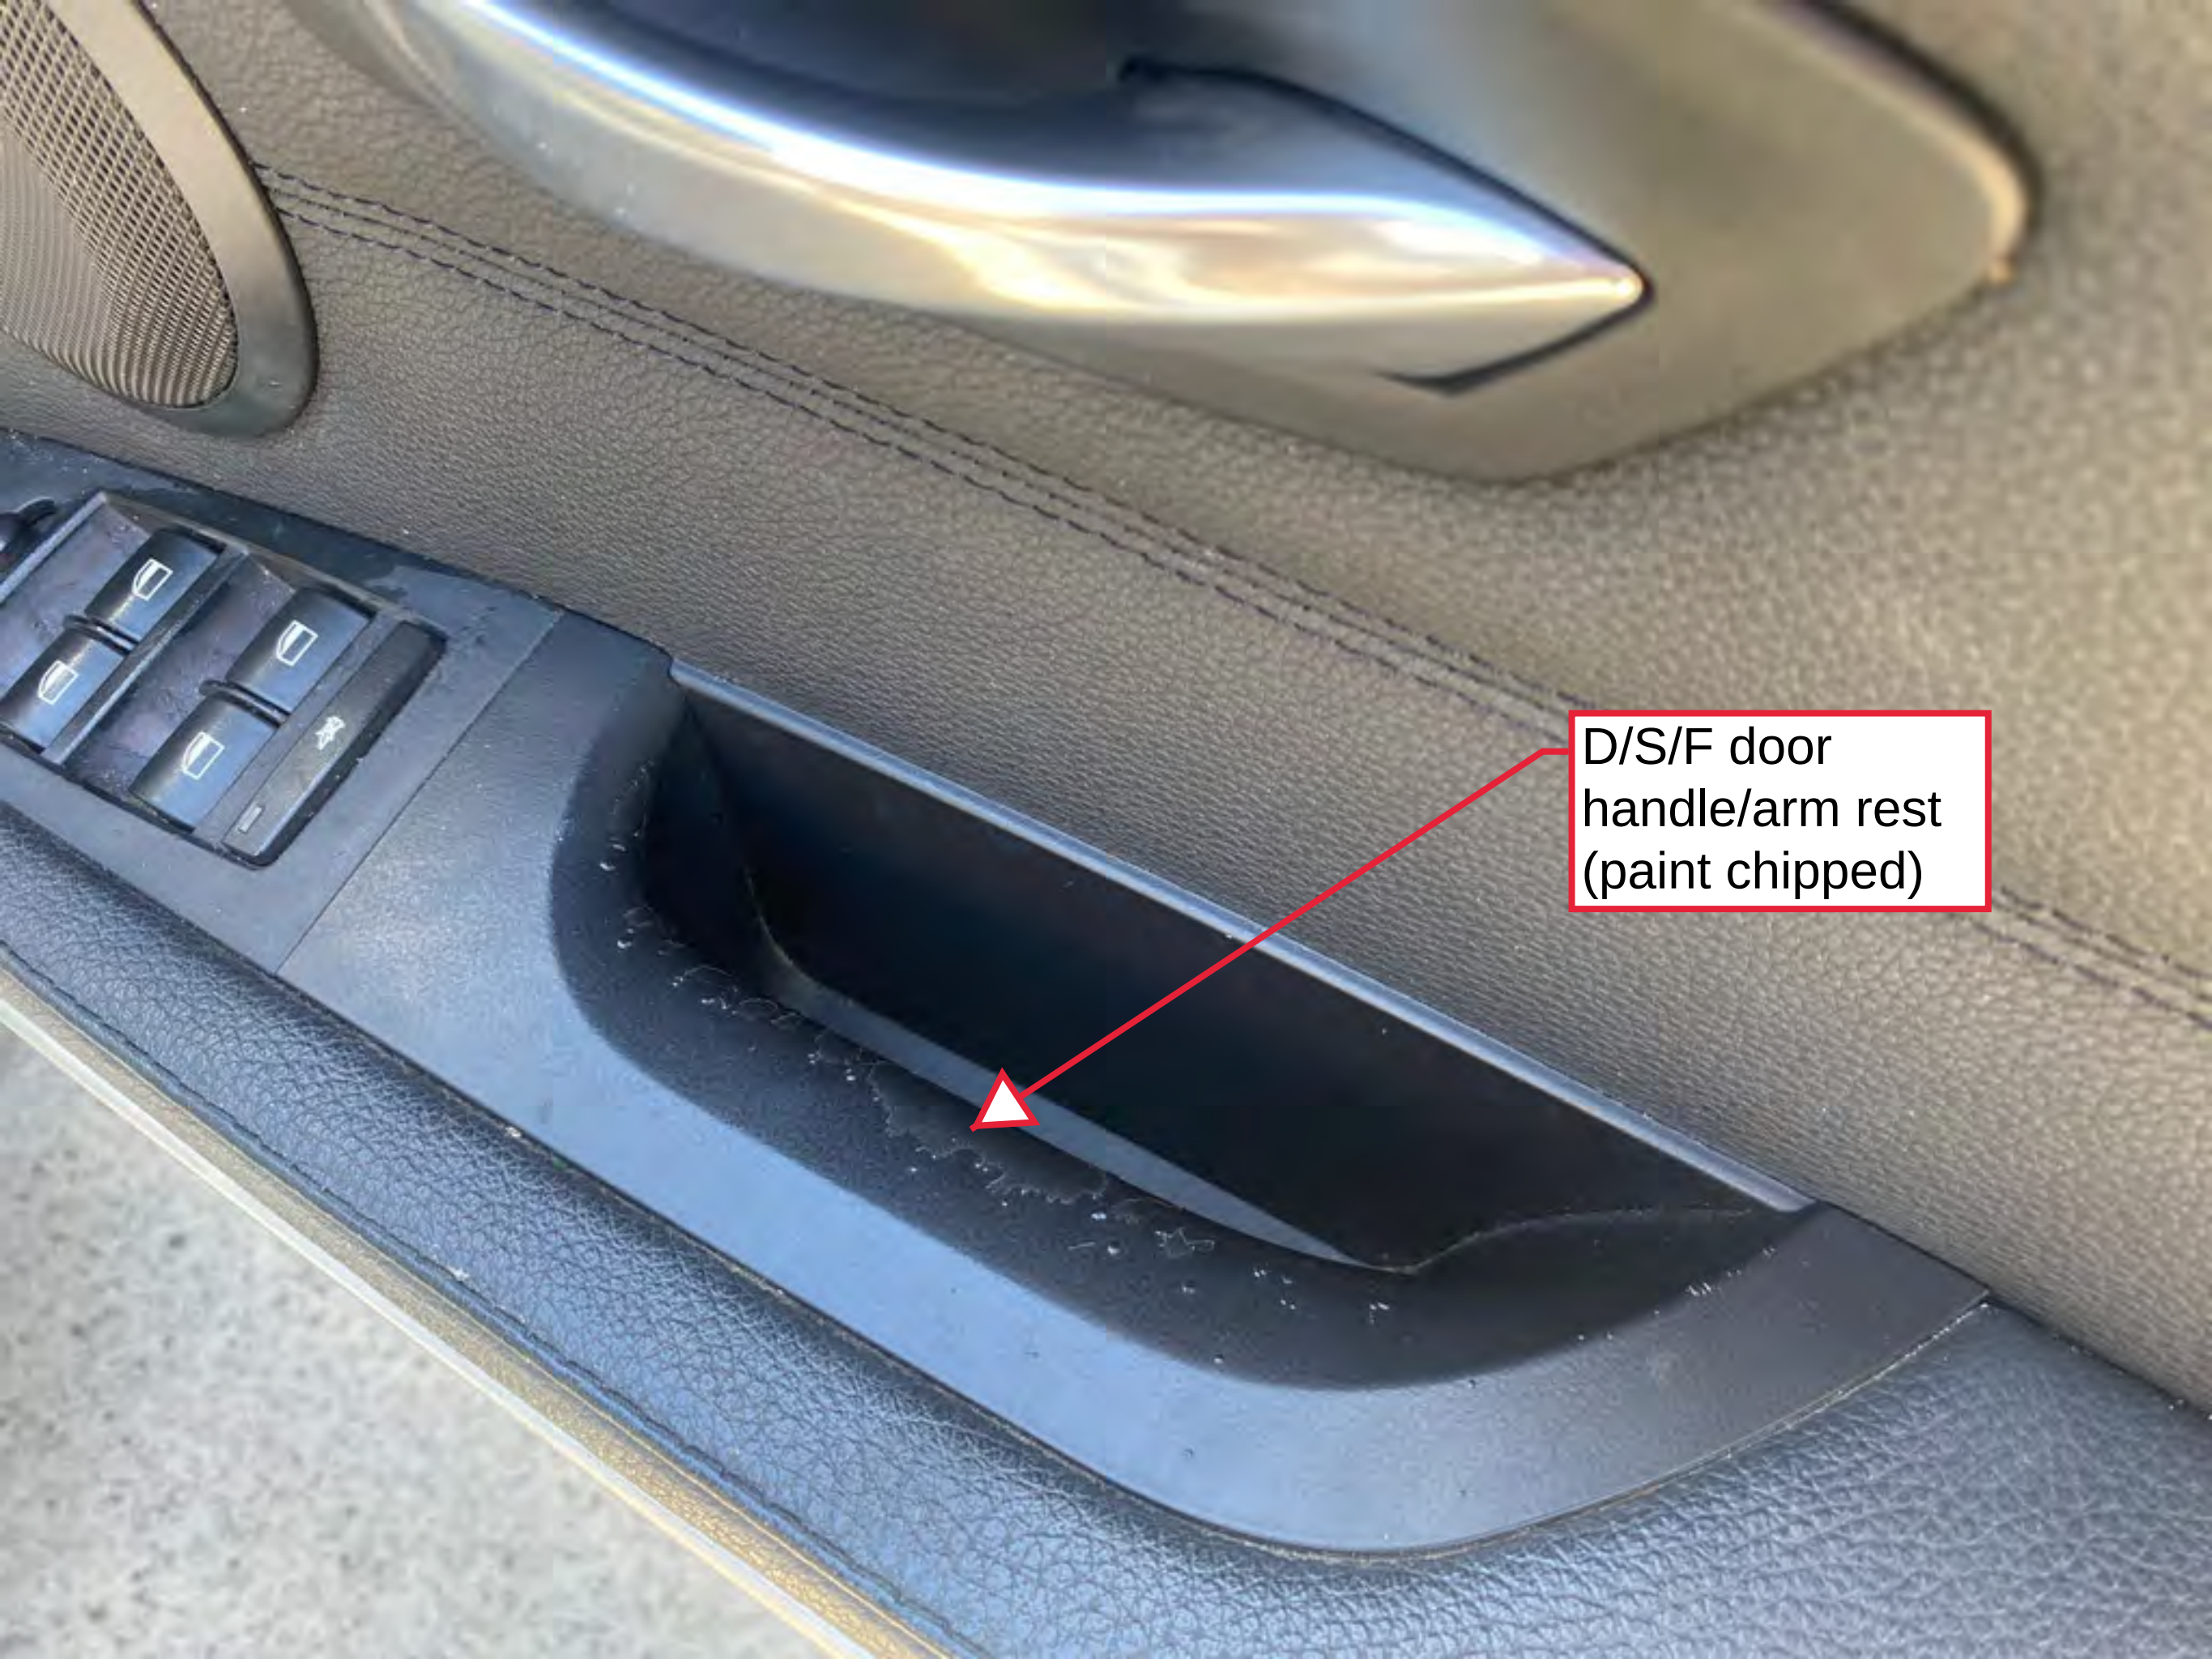
D/S/F door  
handle/arm rest  
(paint chipped)

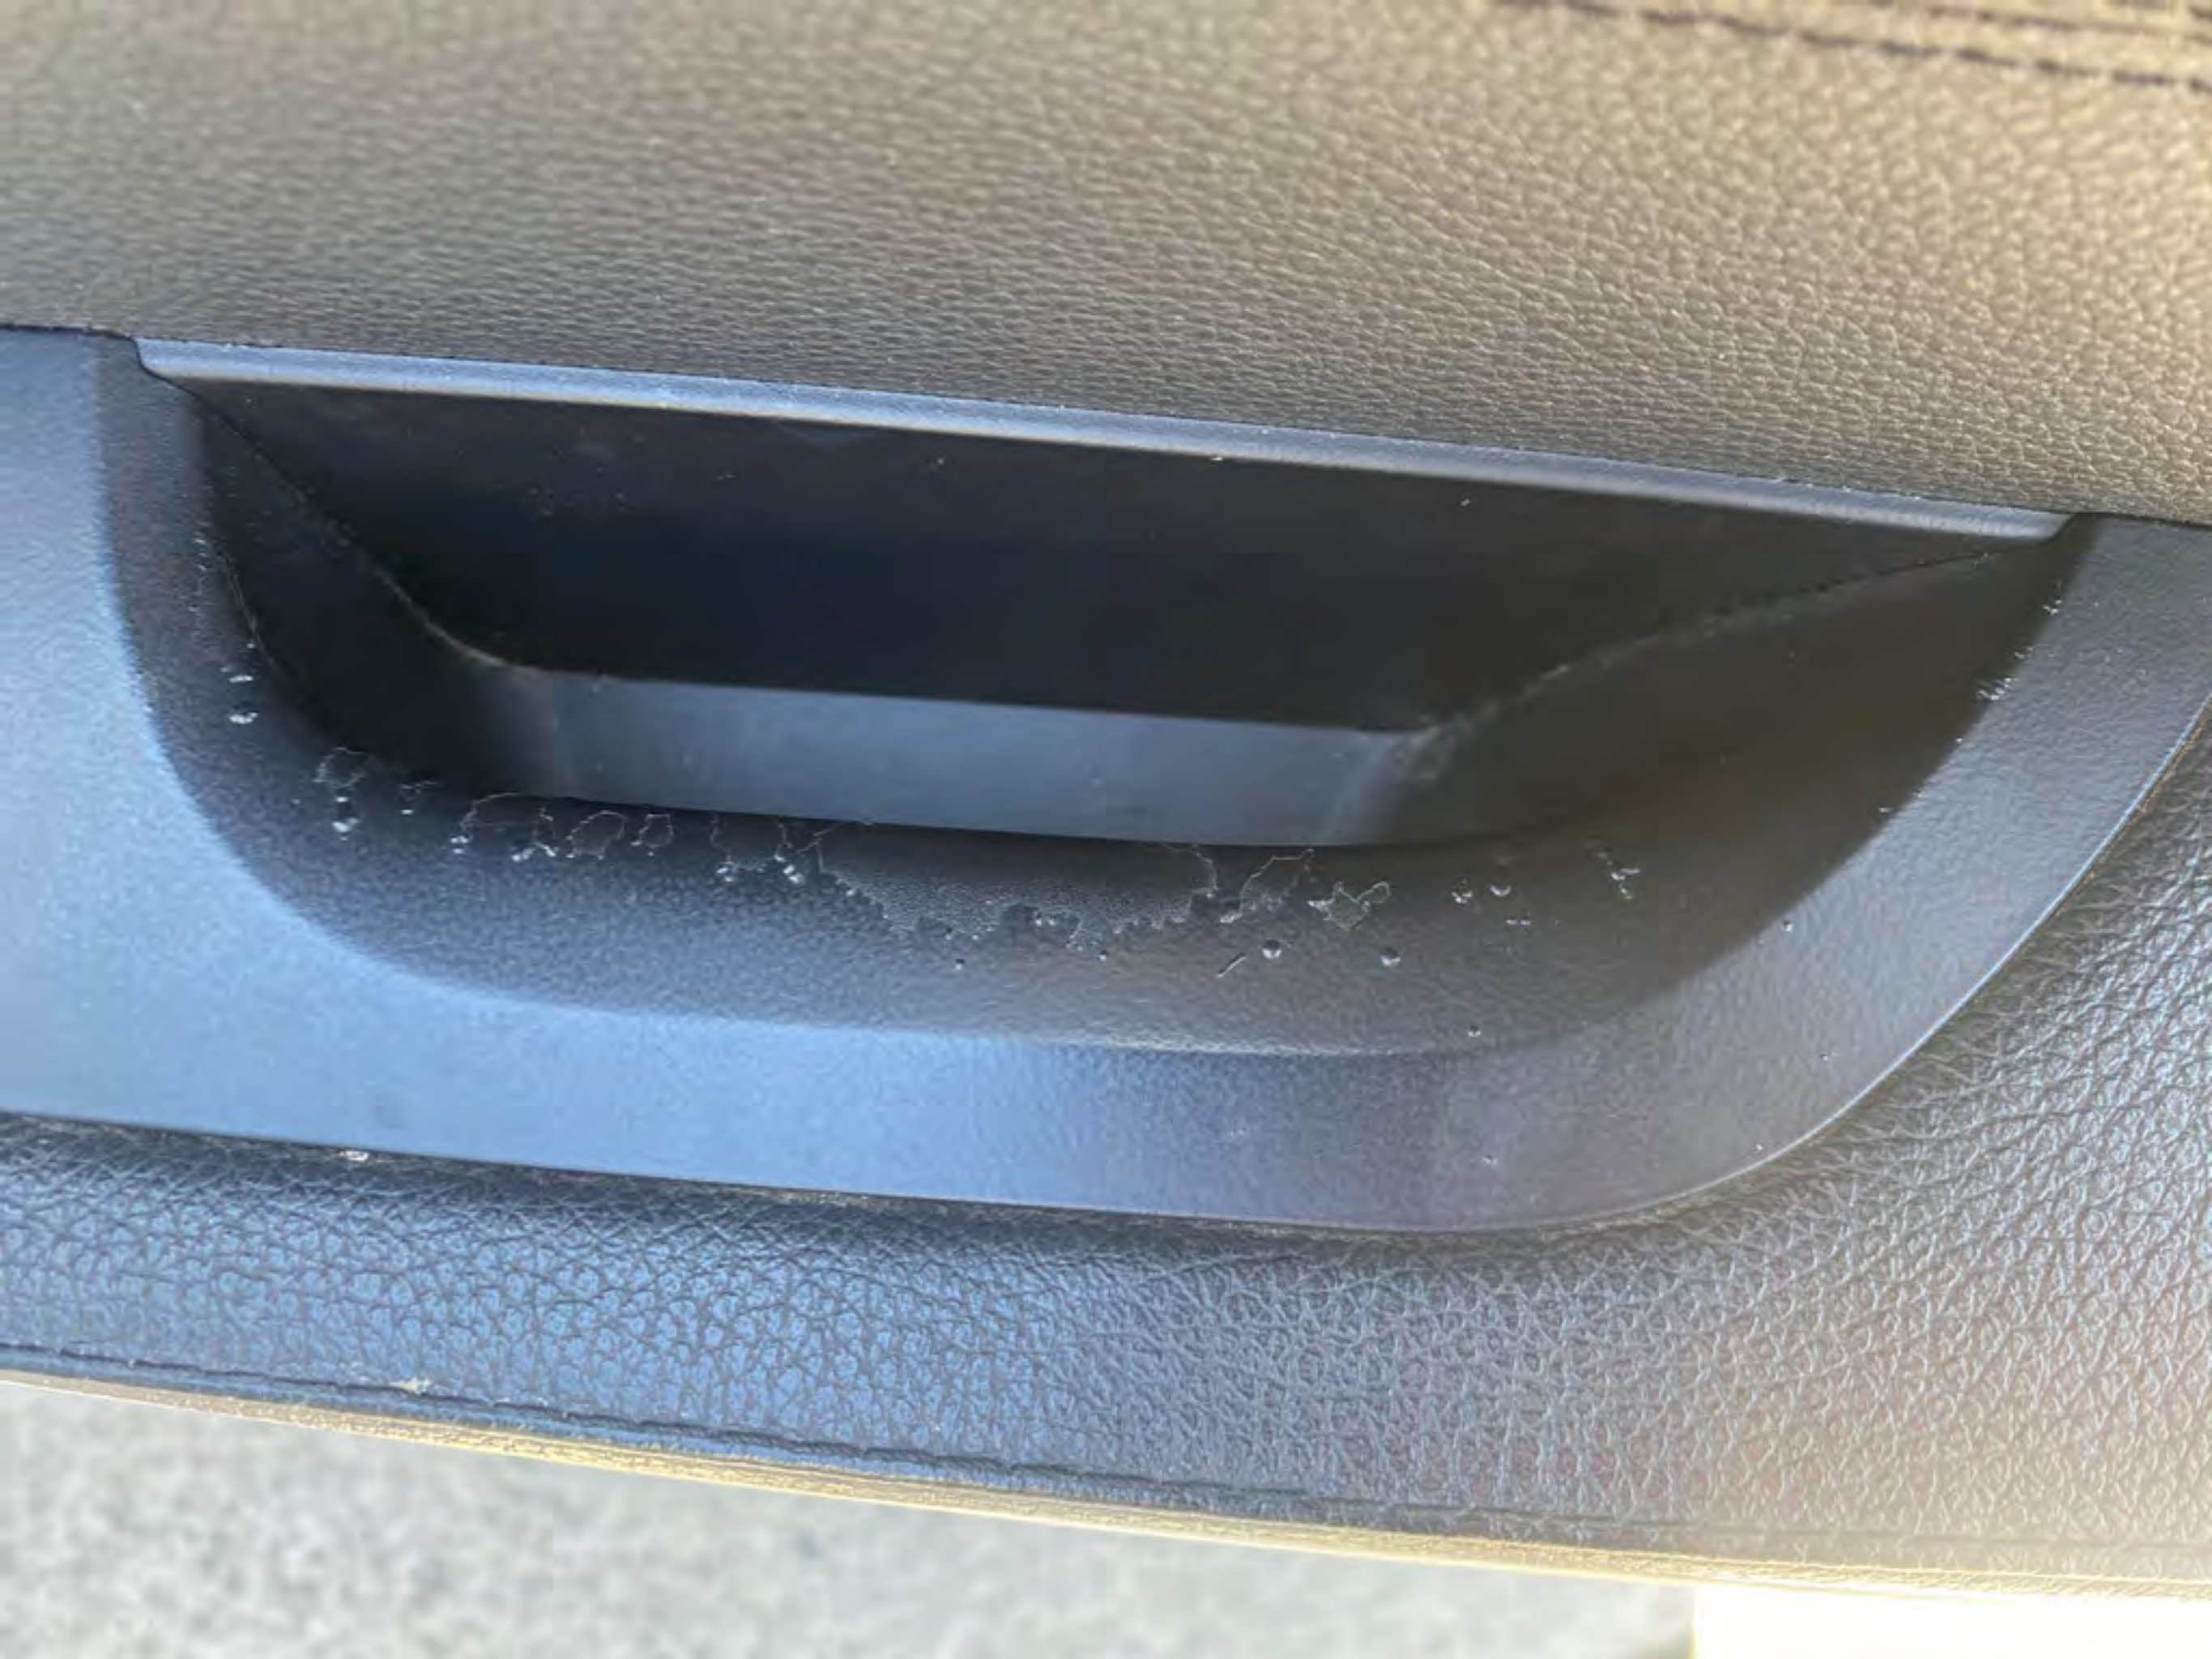
D/S/F door  
rubber (split)
