BMW A.G.

3 Series - E90

# Engine & Servicing

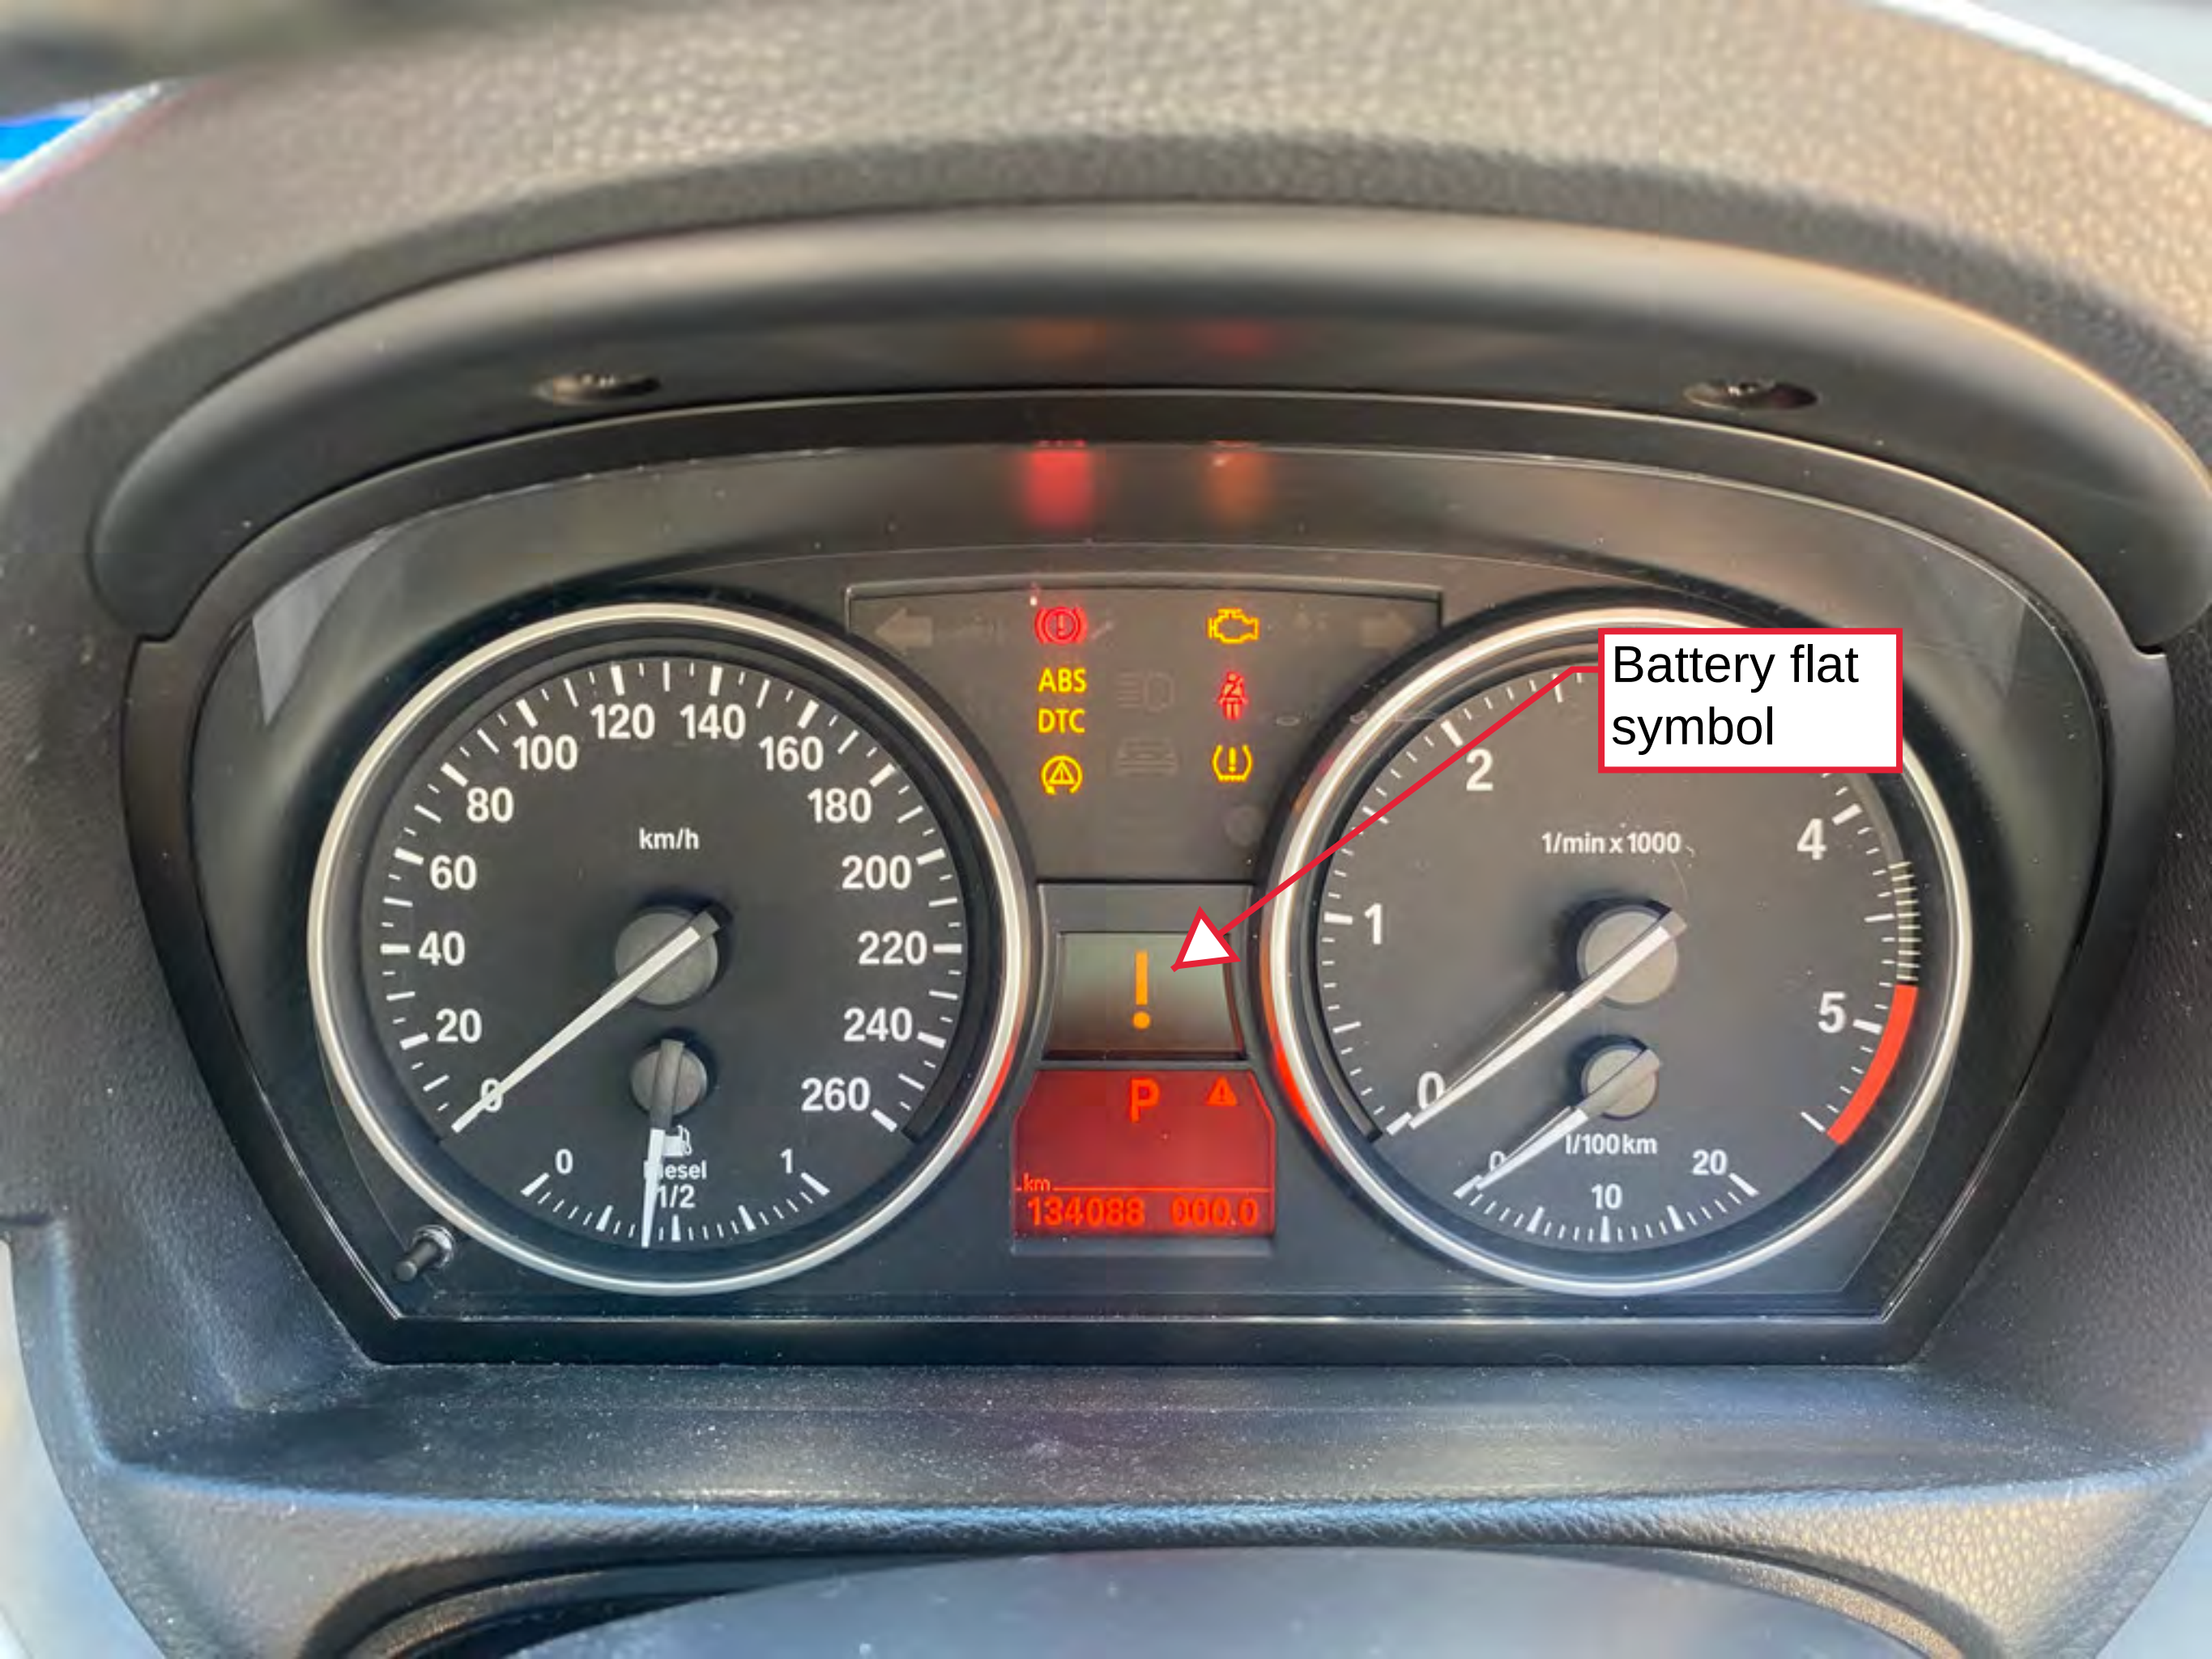
Warning lights: ABS, DTC, and battery flat symbol.

Digital display: 134088 km, 000.0 l/100 km.

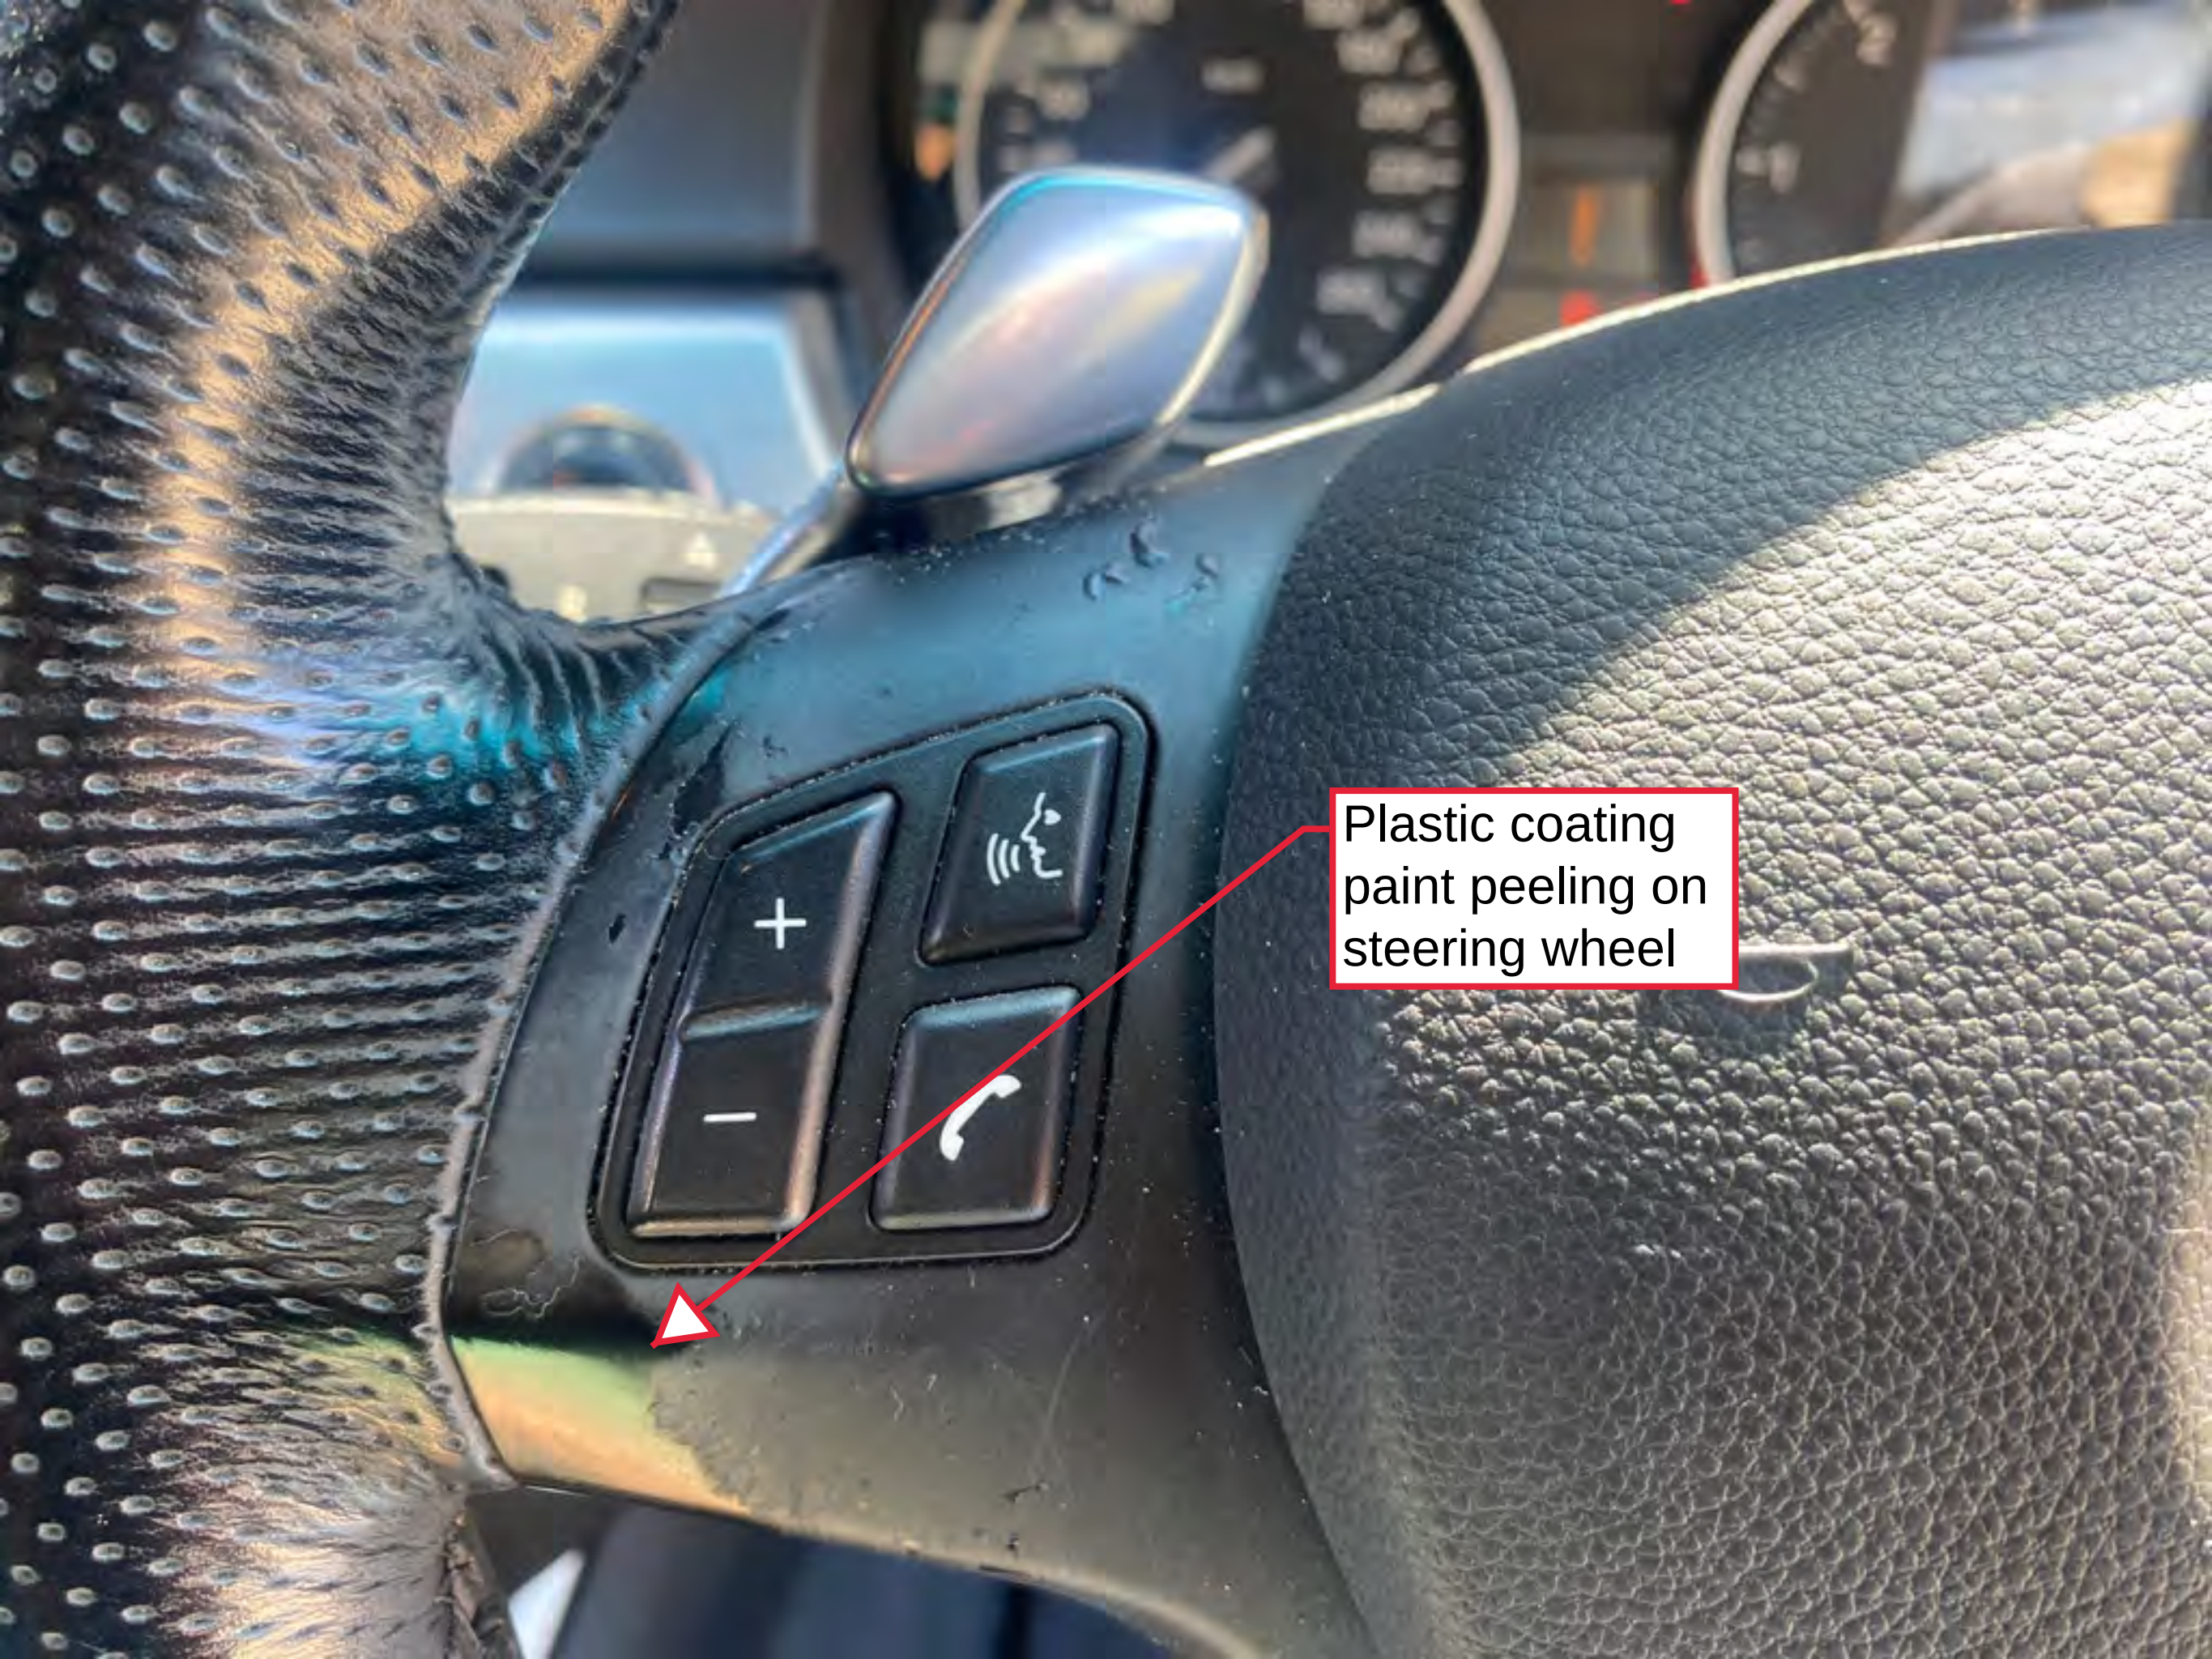
Plastic coating  
paint peeling on  
steering wheel

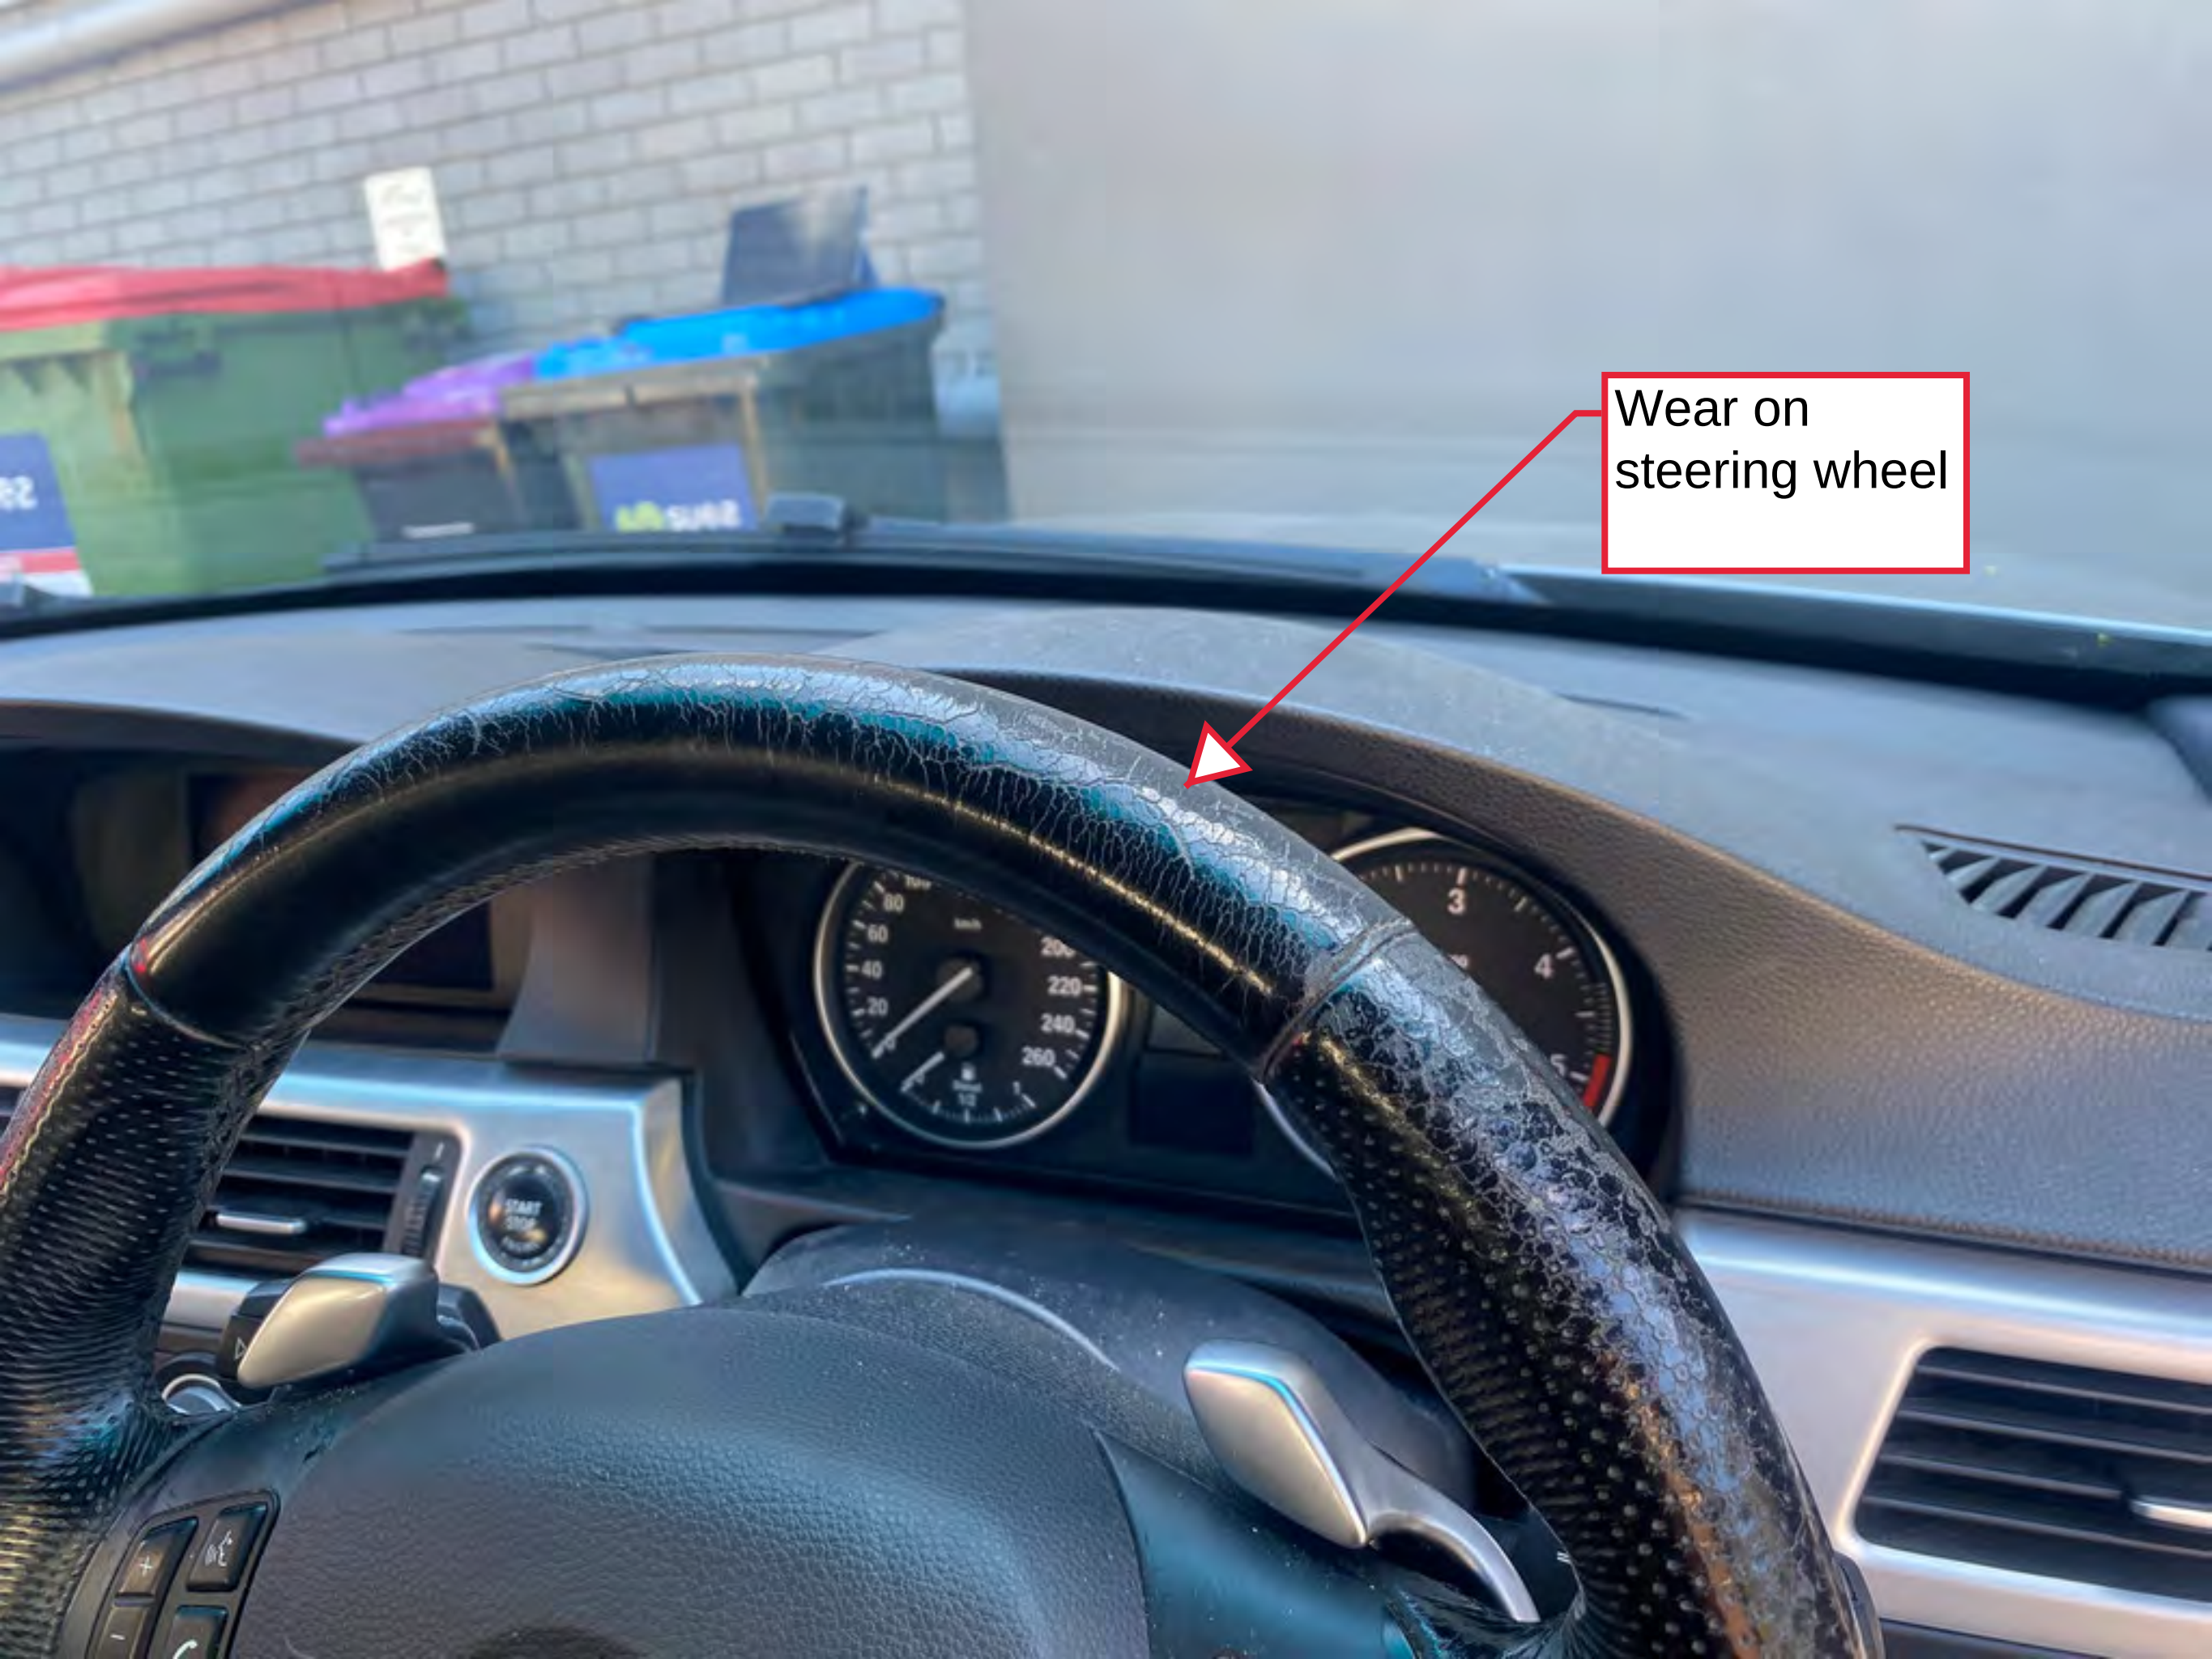
Wear on  
steering wheel

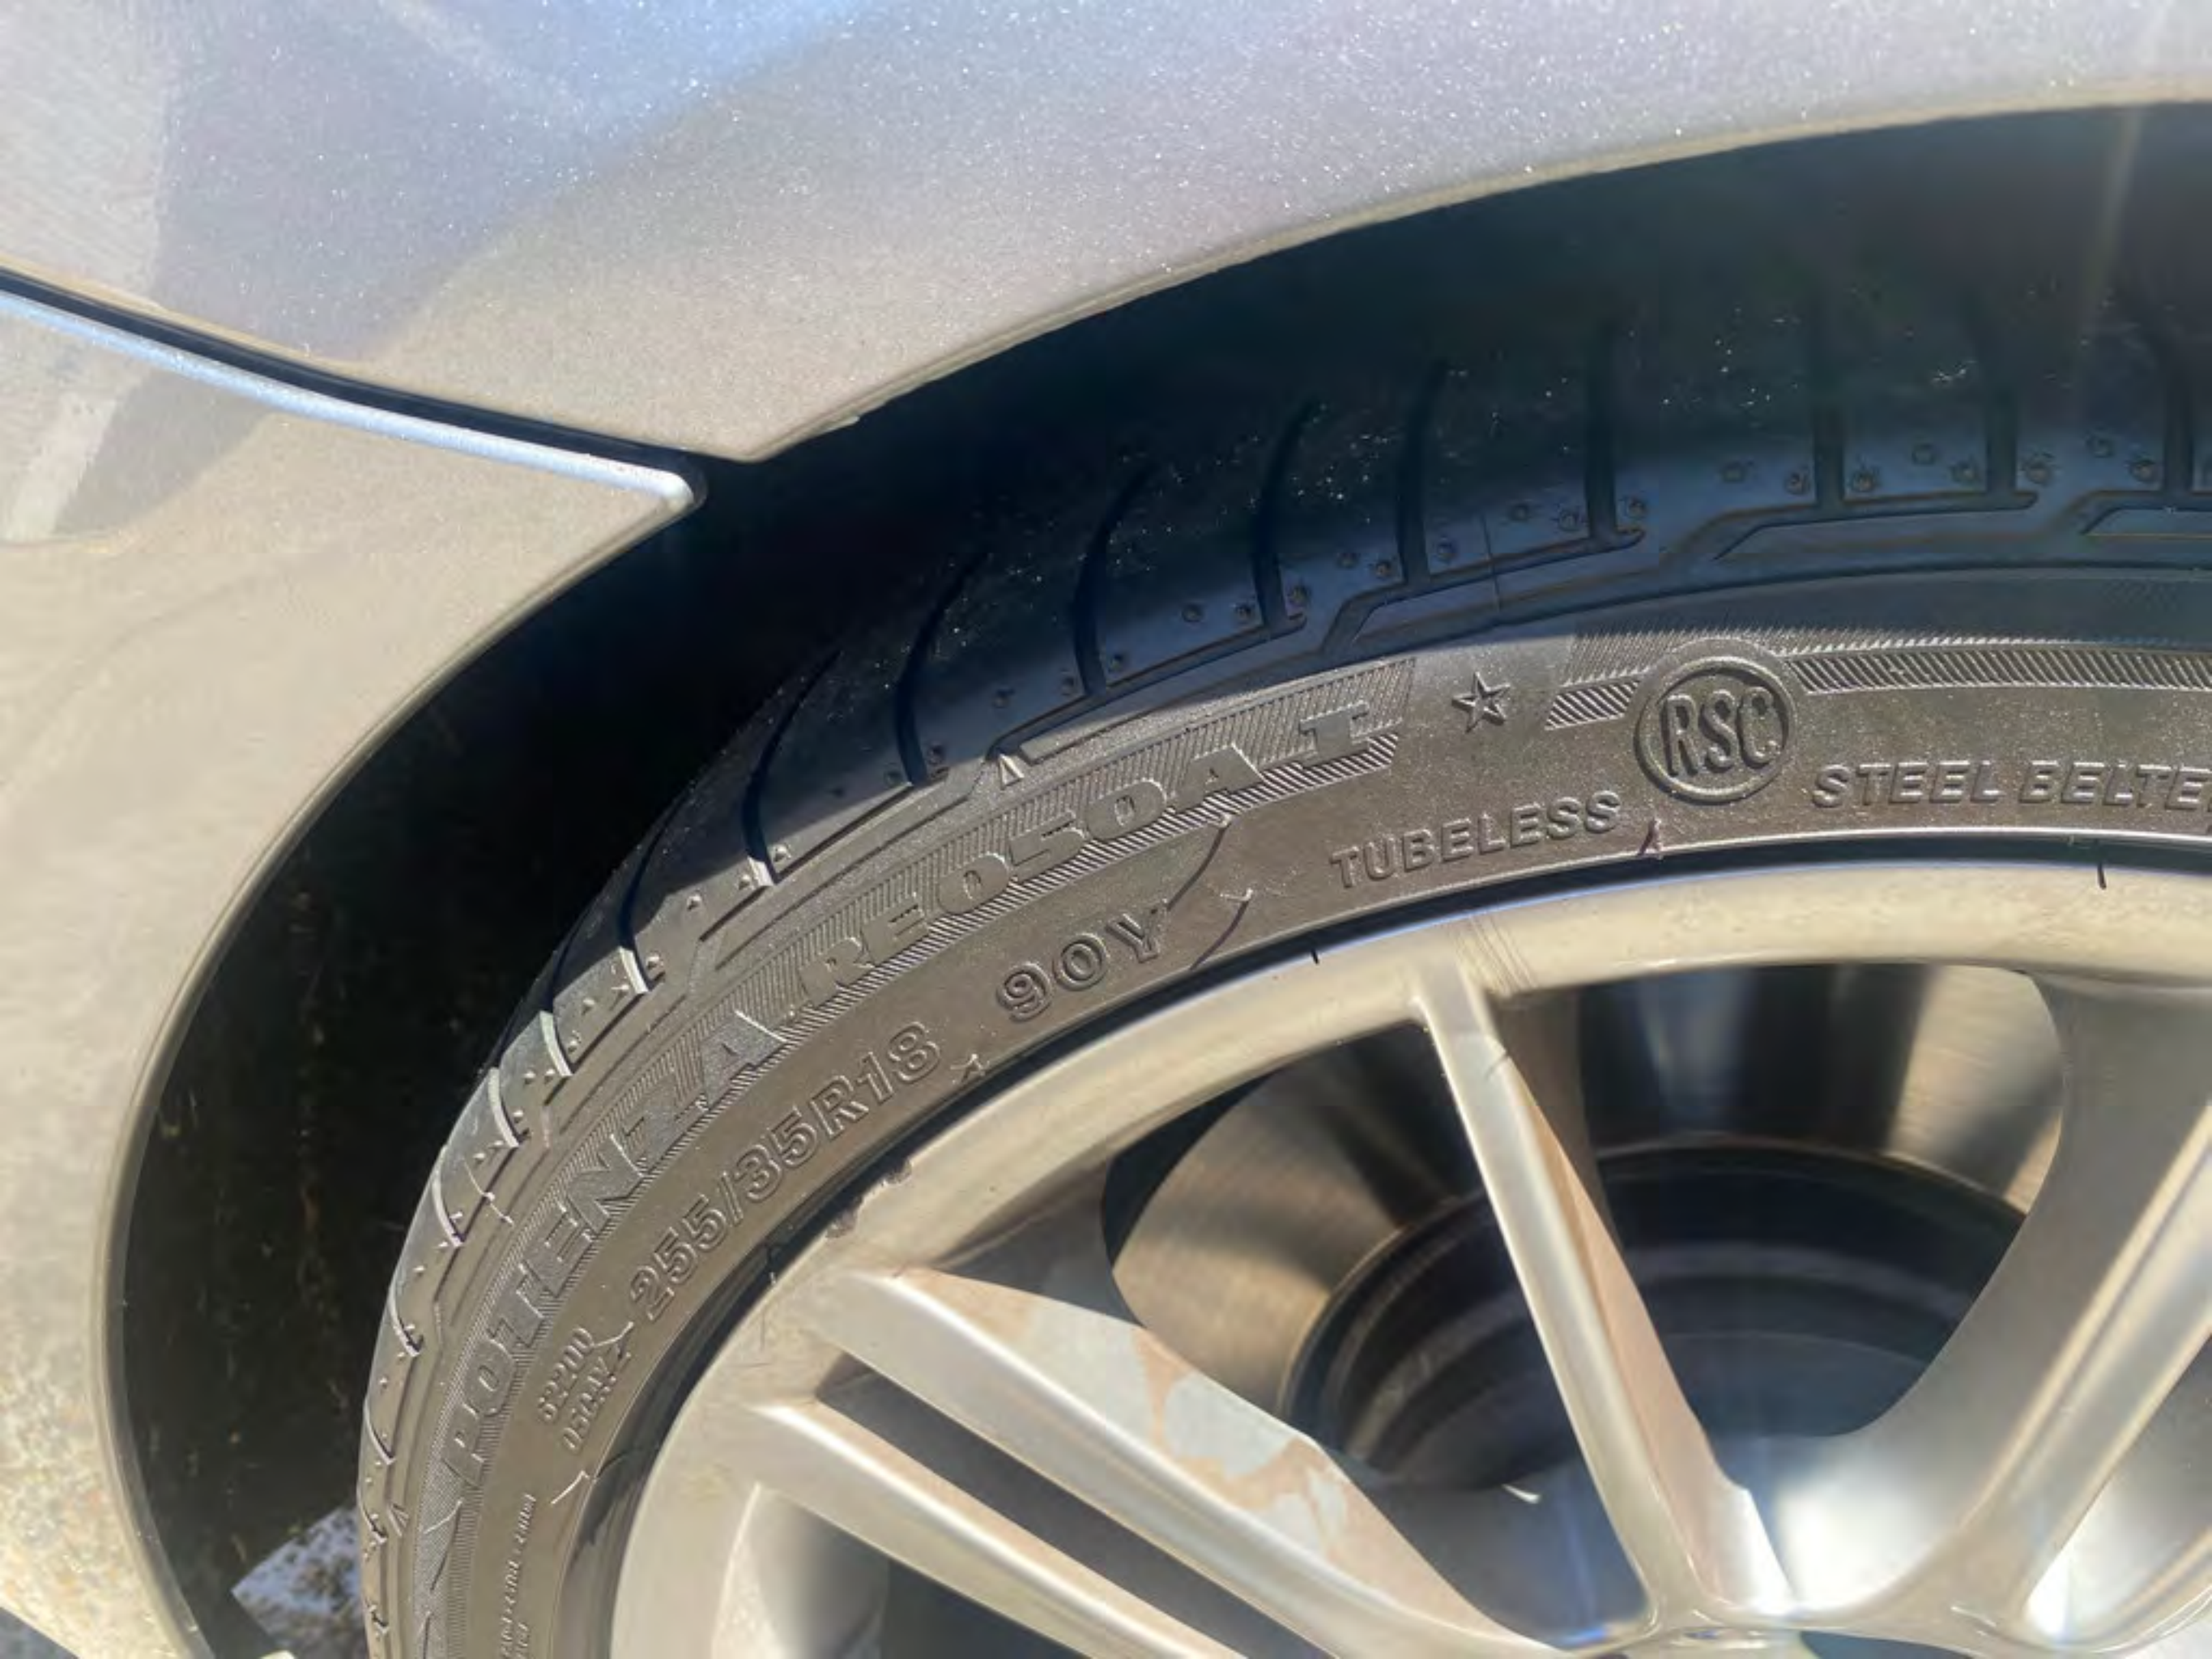
Rear tyres (0-10%  
remaining)

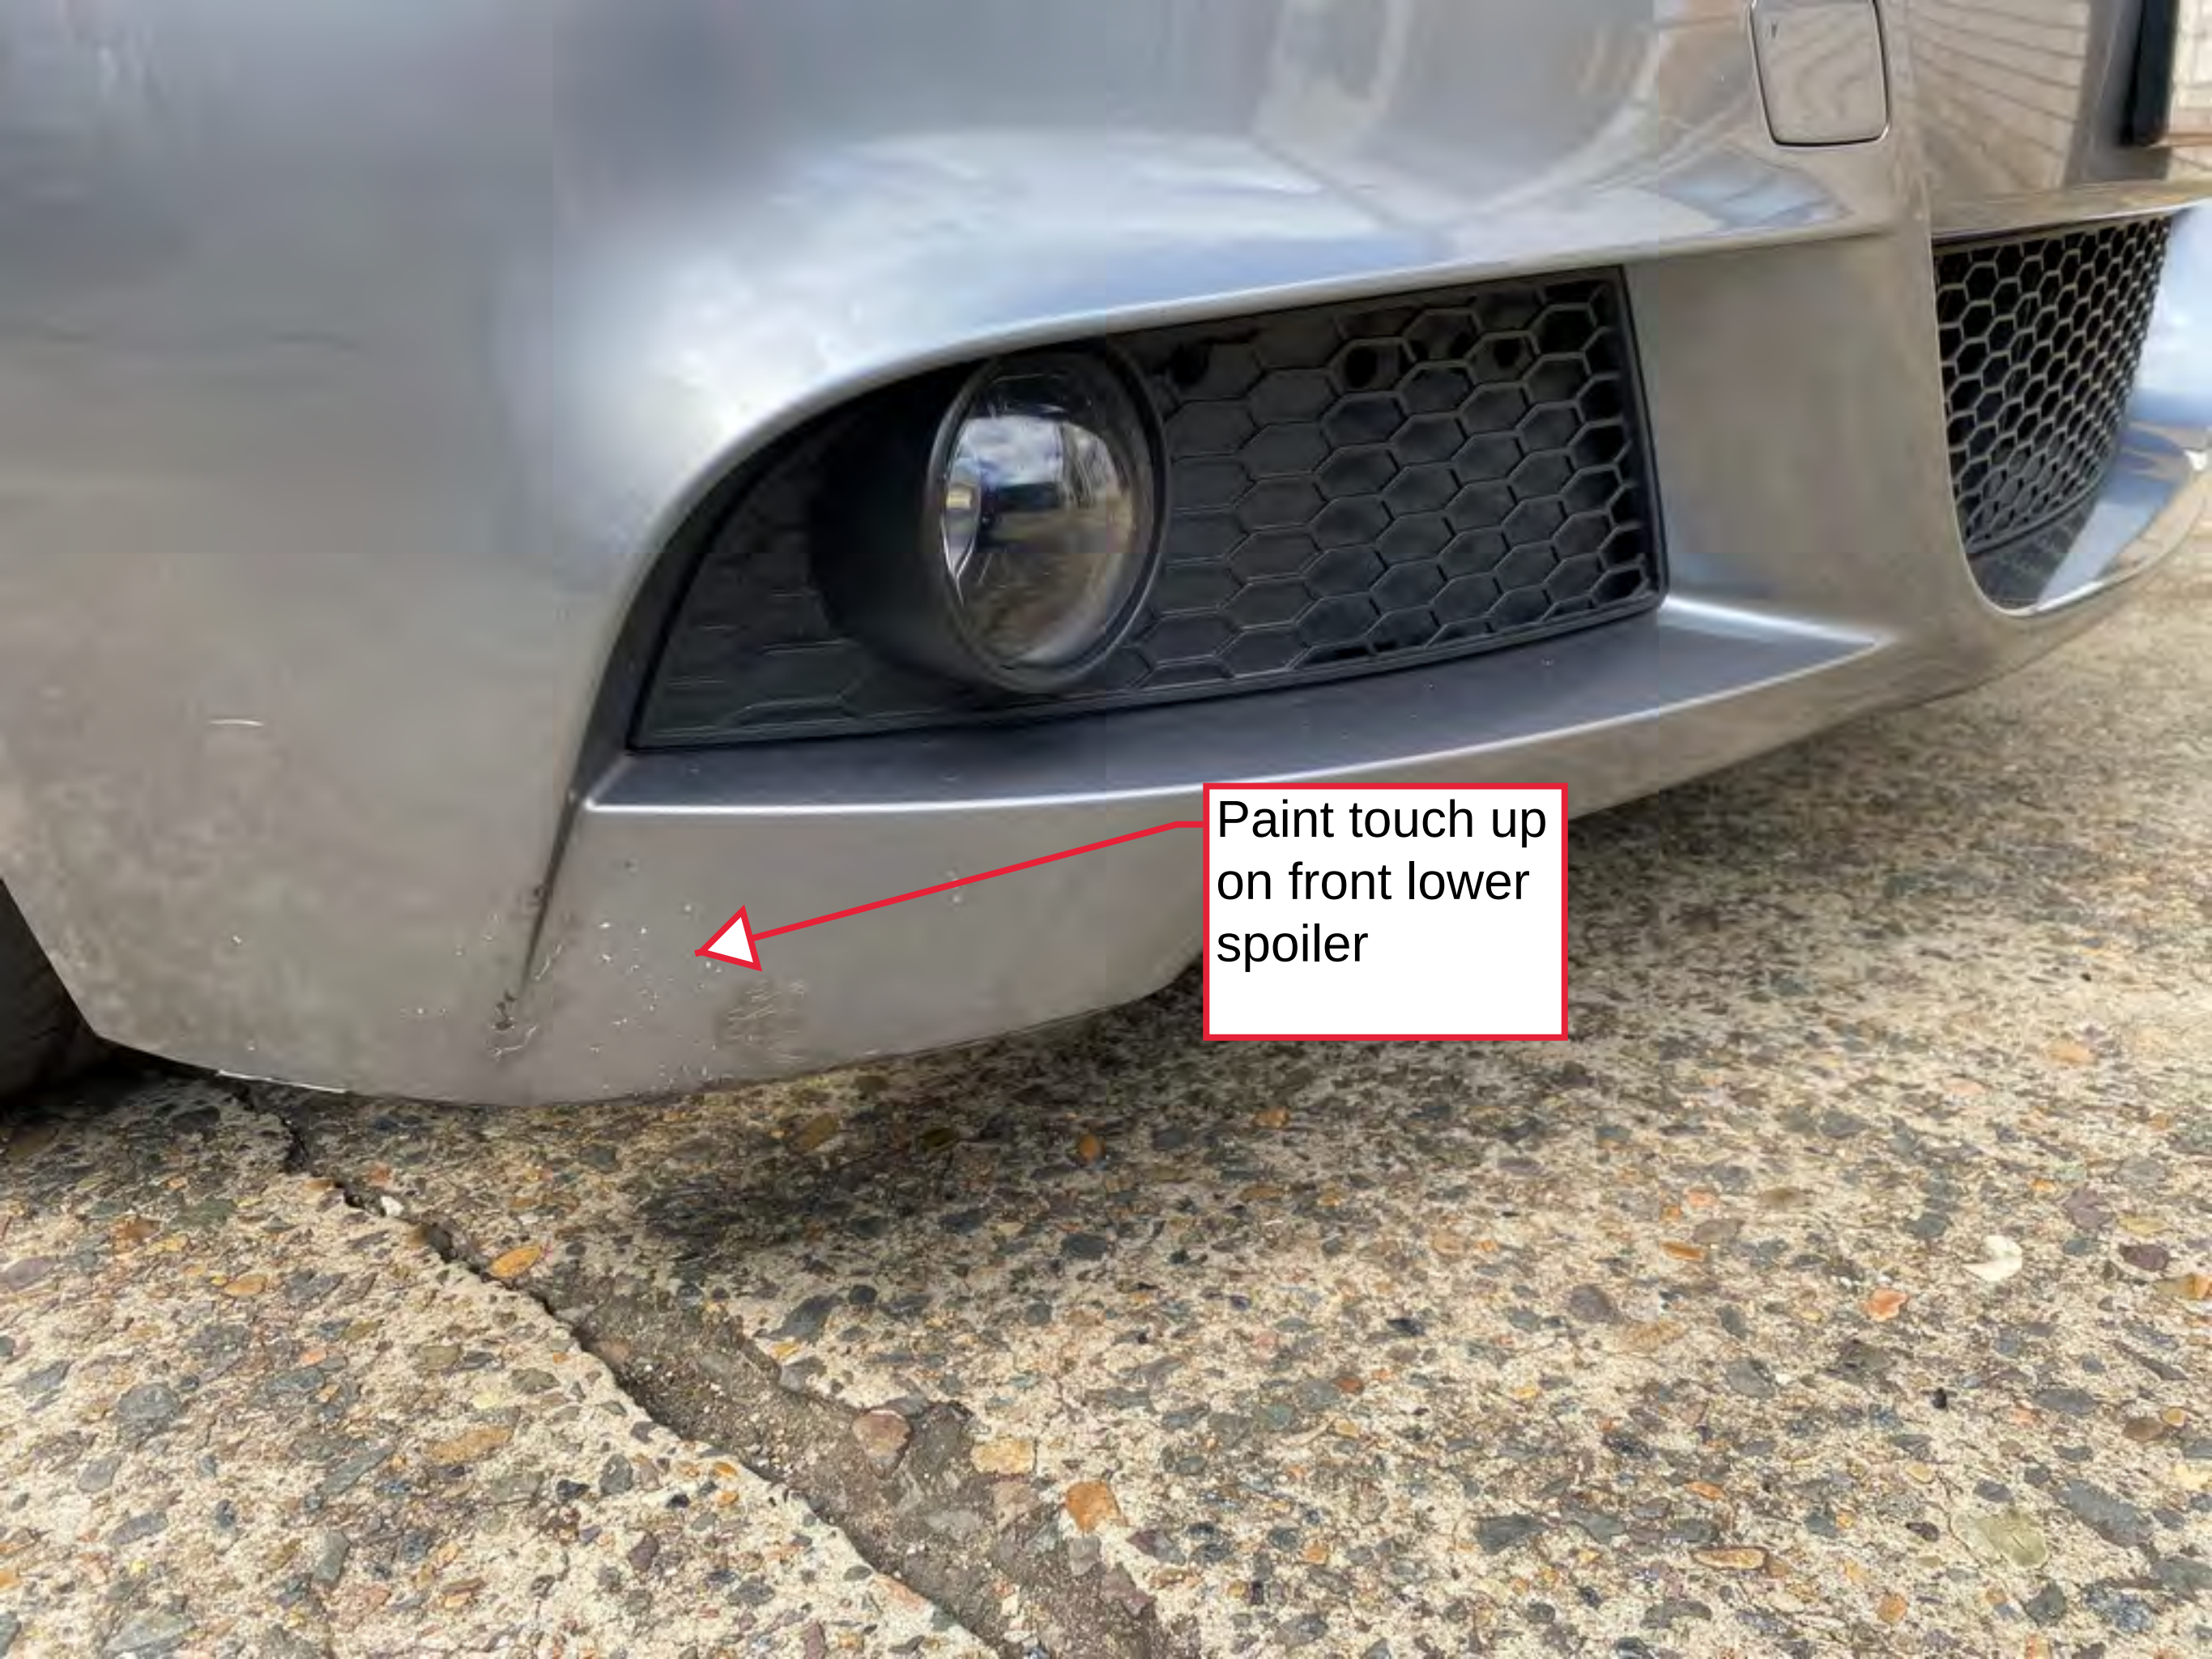
Paint touch up  
on front lower  
spoiler

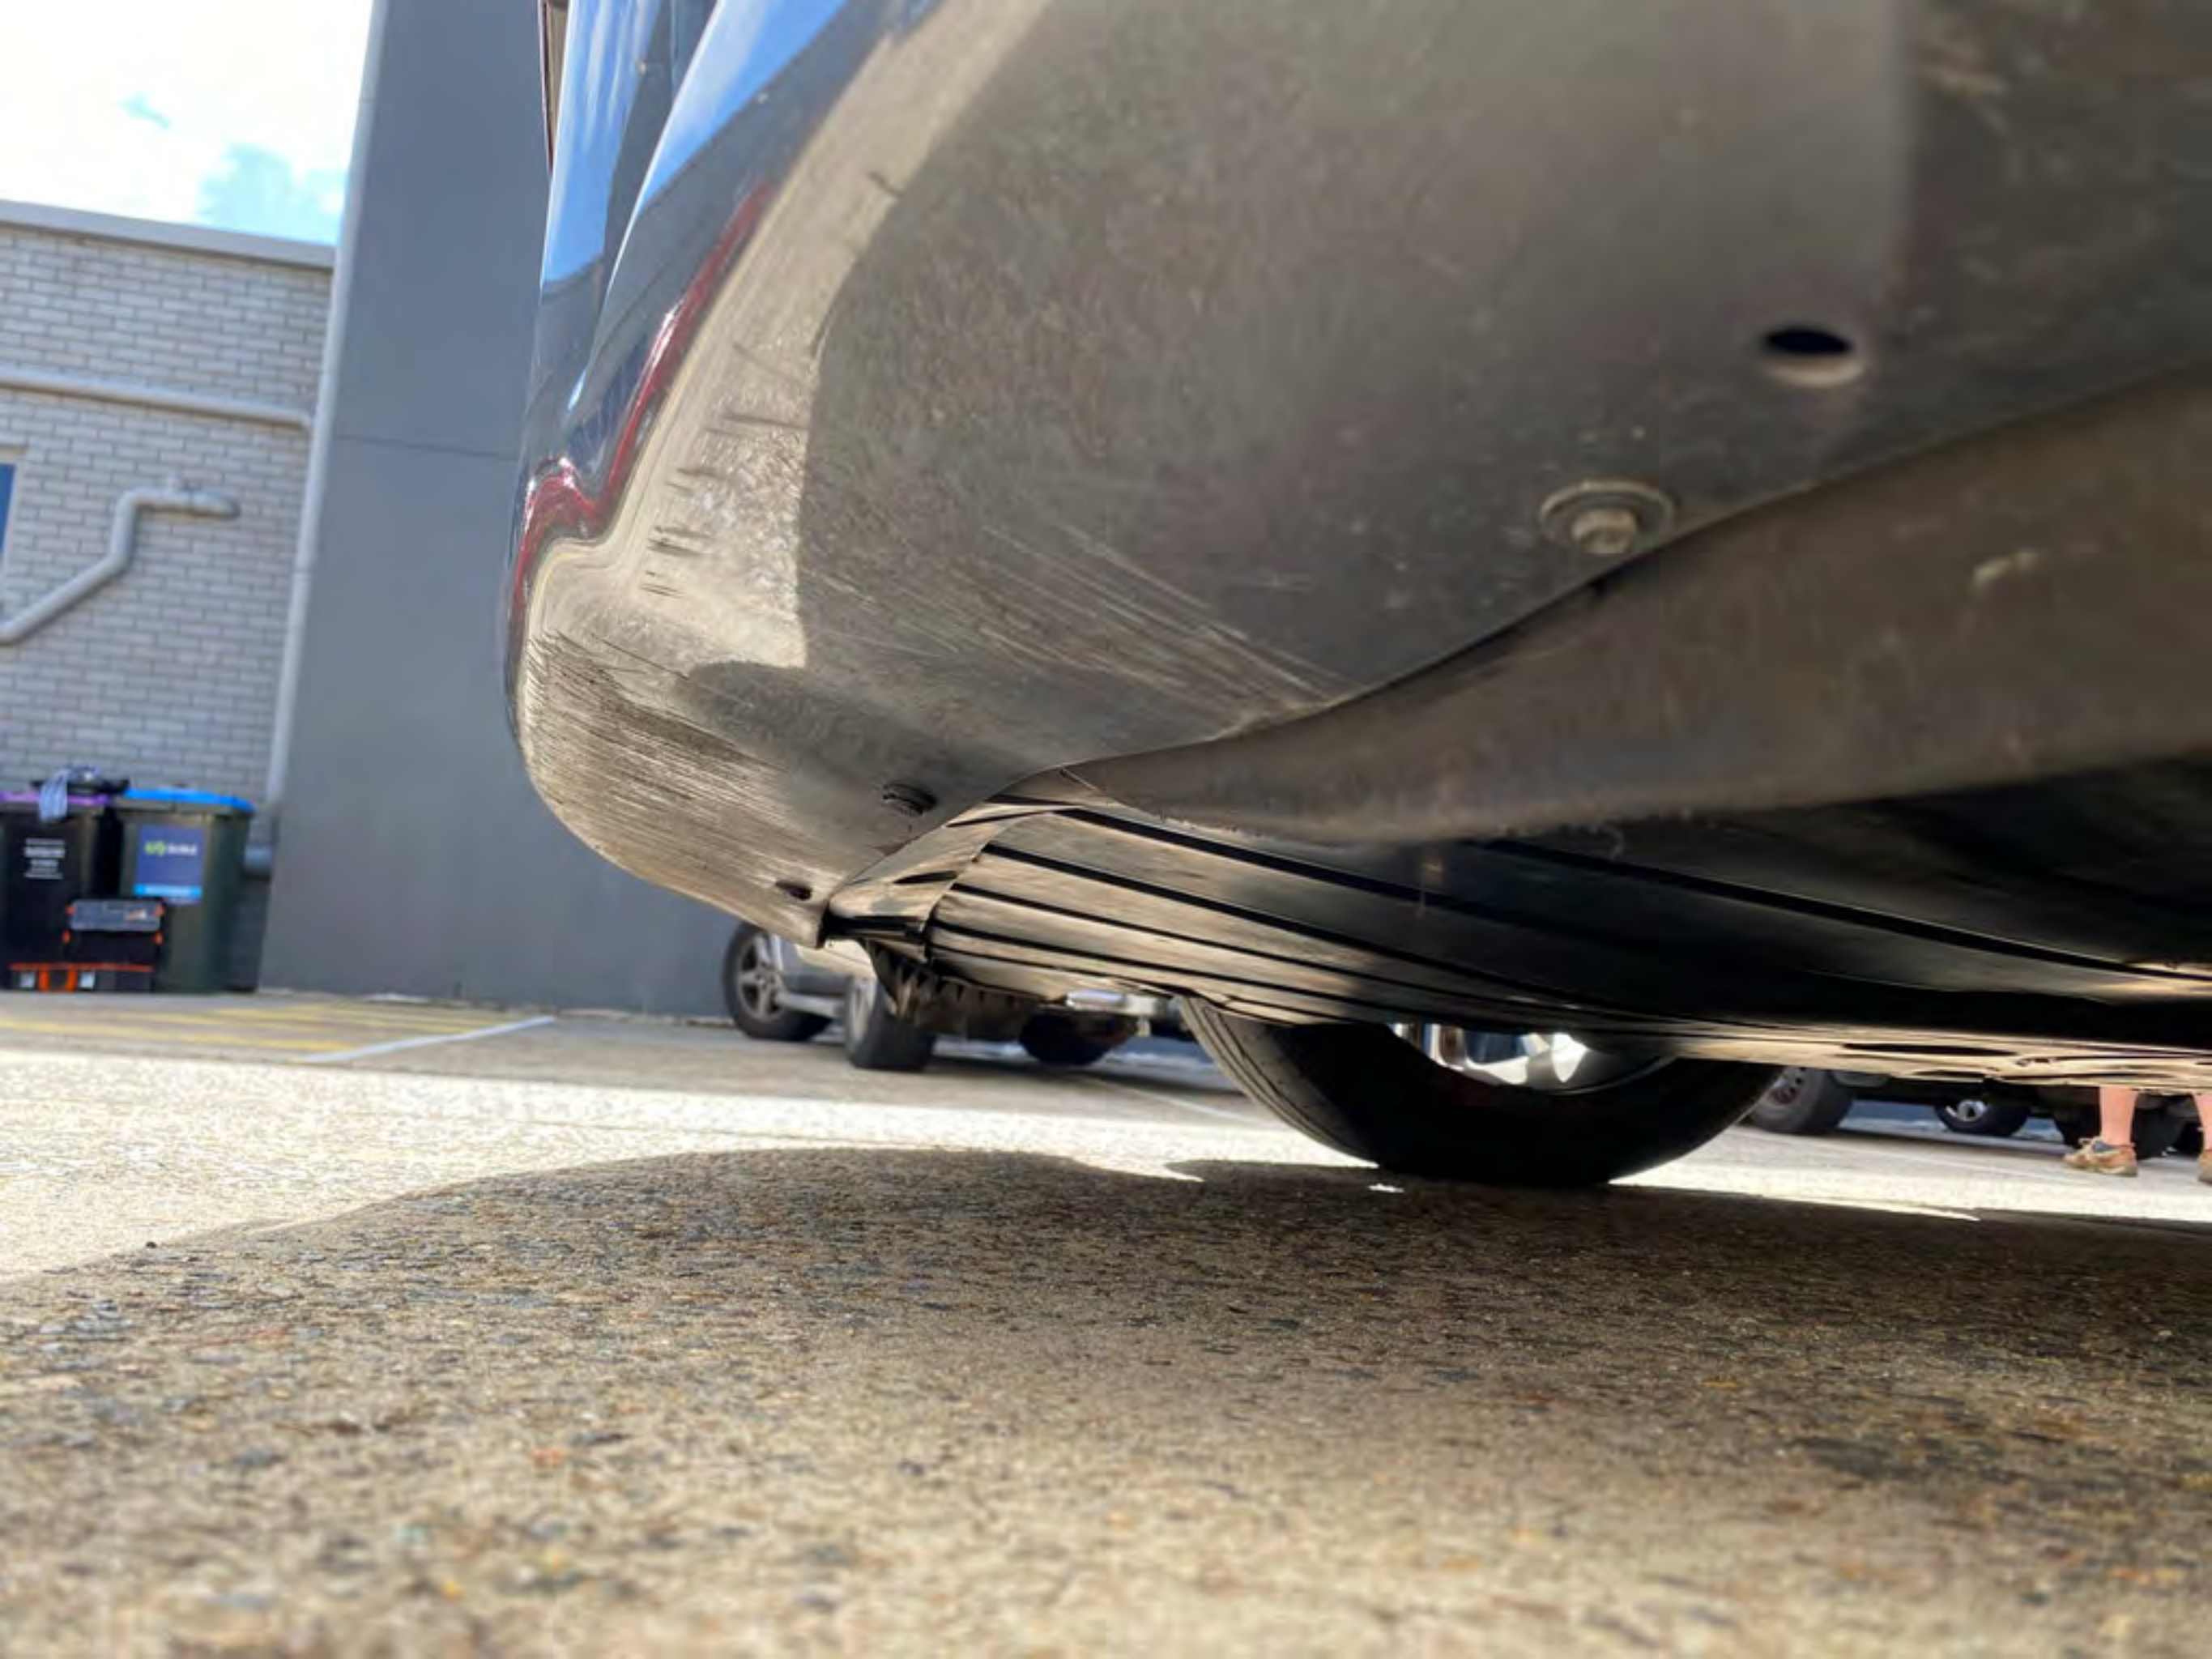
Scraped
