BMW A.G.

3 Series - E90

# Engine & Servicing

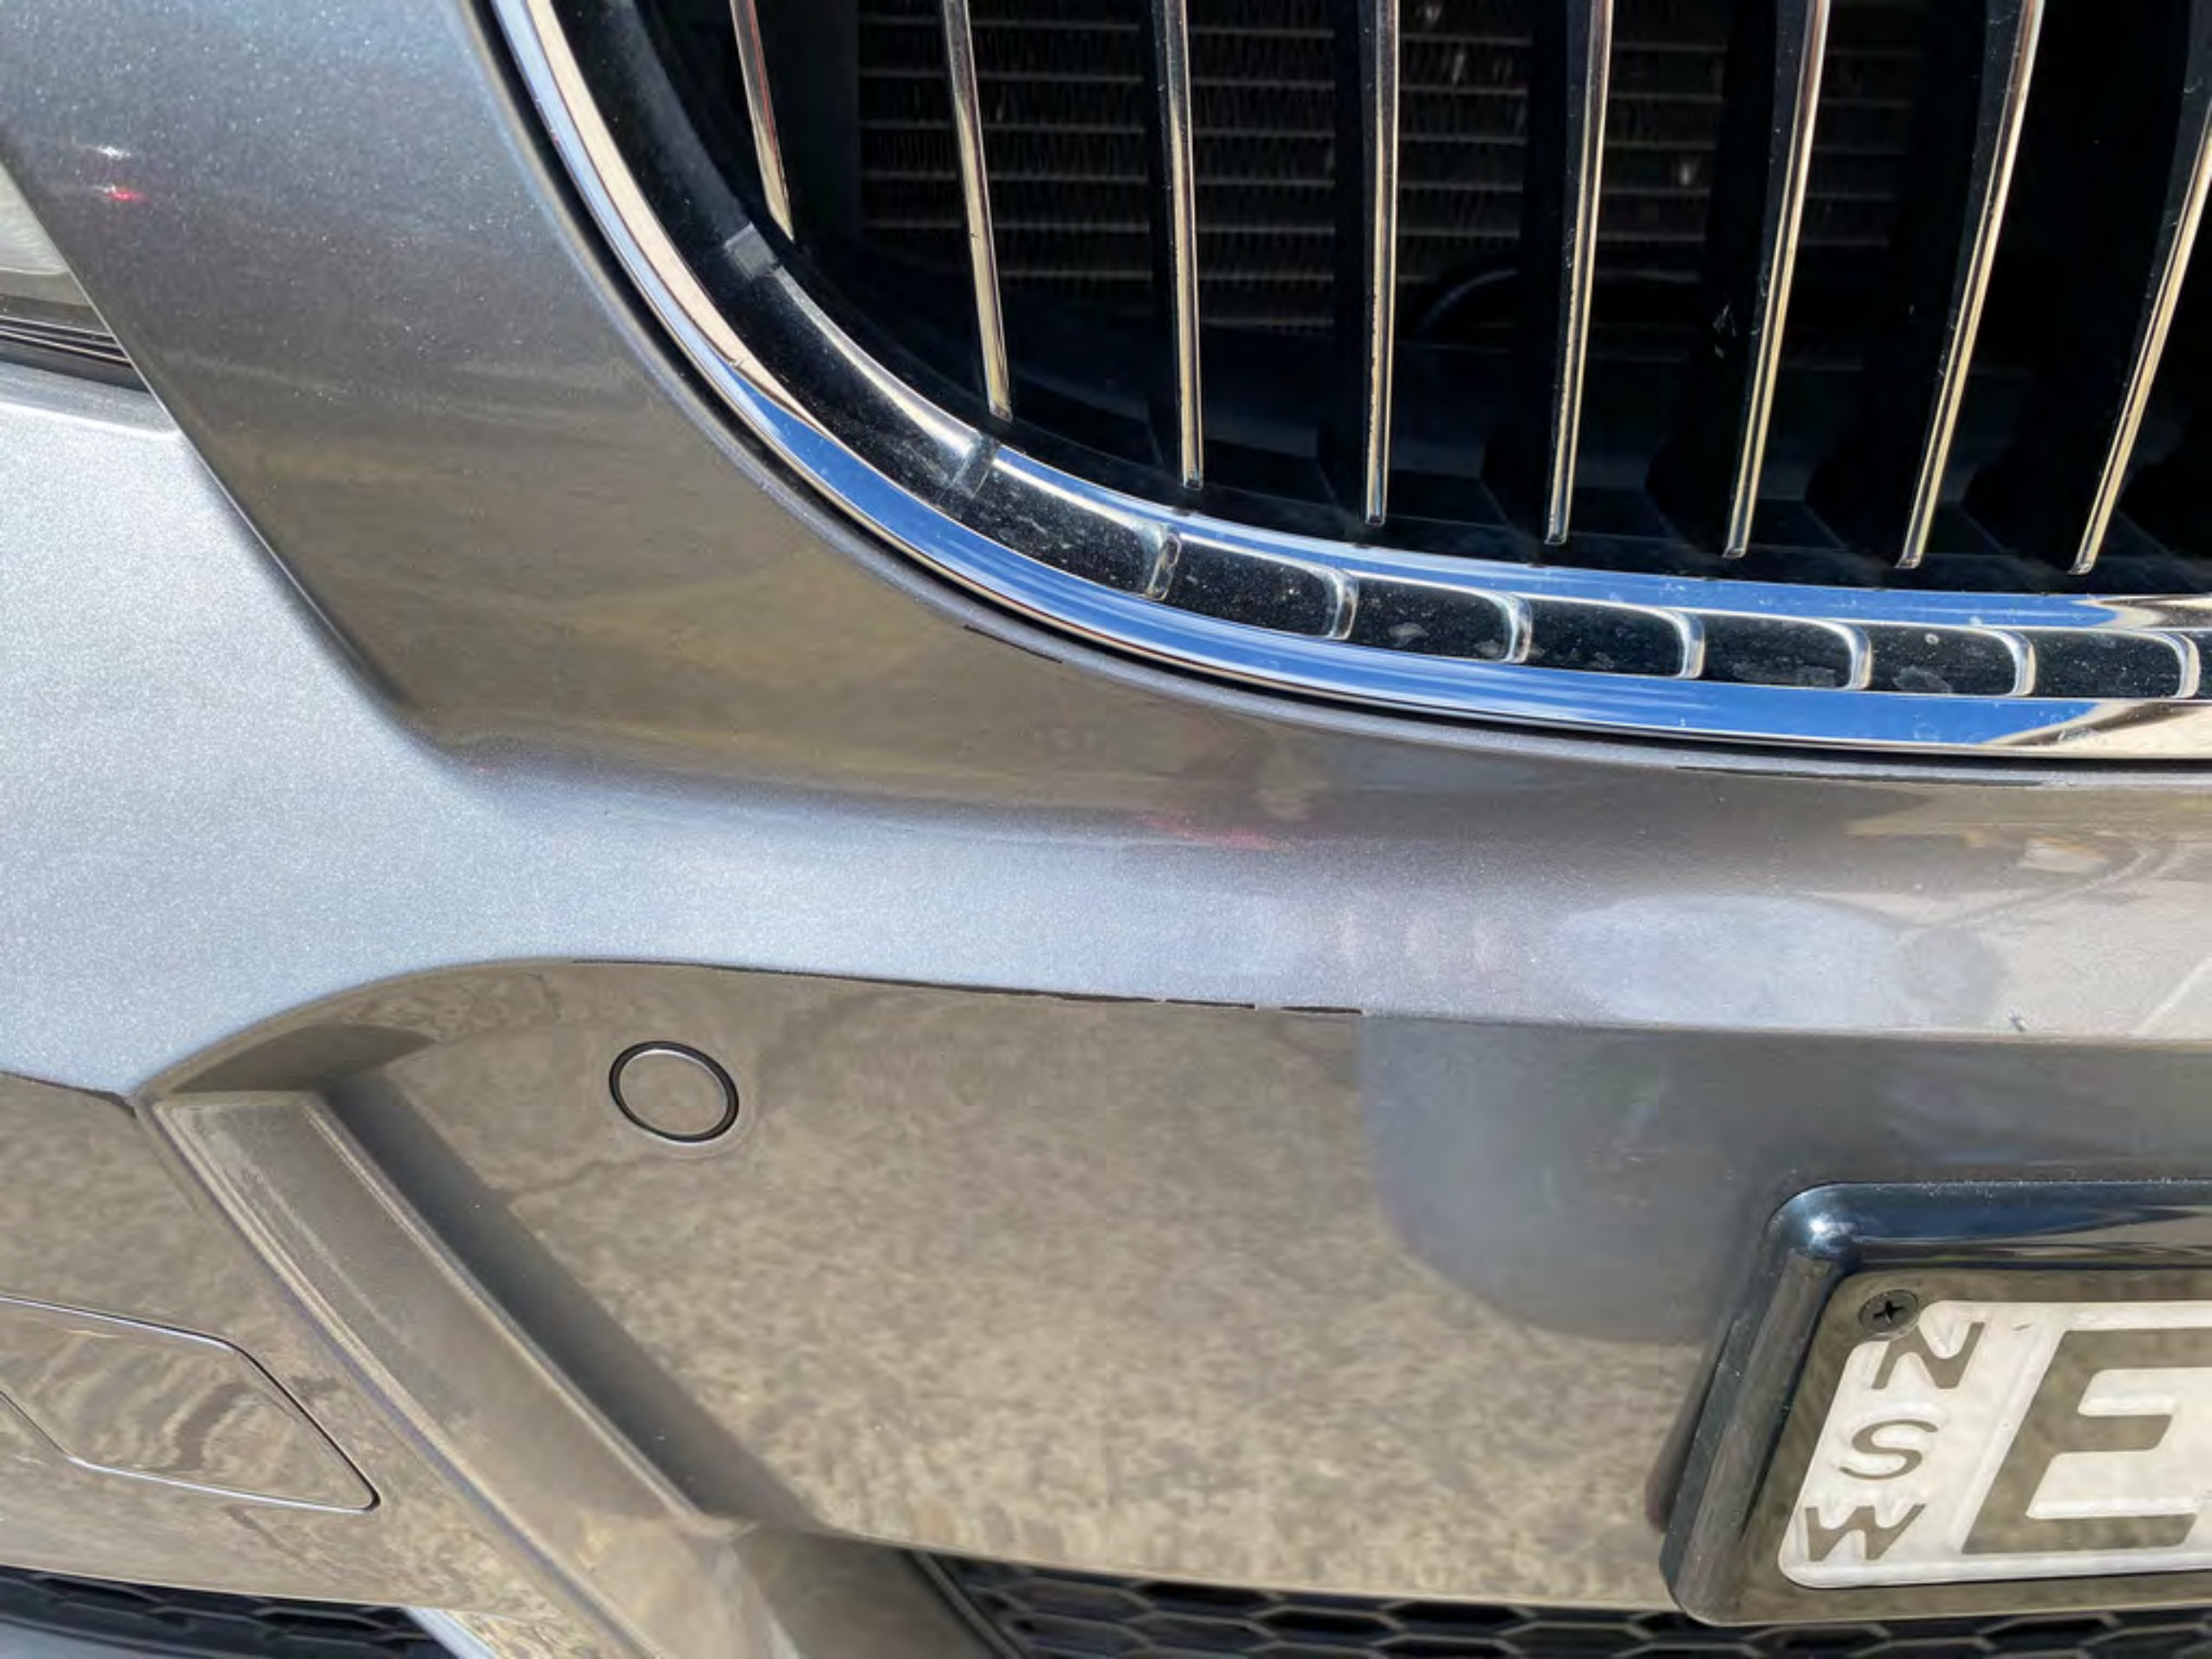
Paint  
grazed

Paint  
chipped
